RESIDENTIAL BUILDING SURVEY

XXXXXXXXXXXXXX,
XXXXXXXXXXXXXX,
Earls Court,
London,
SW5

**Late Victorian
Purpose Built
Apartment**

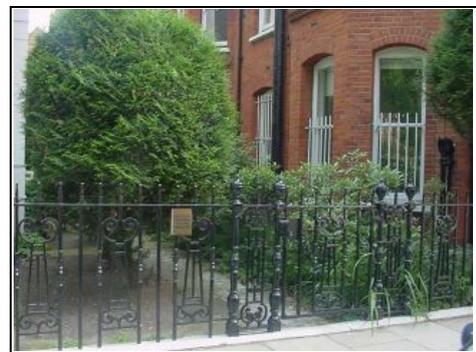
Garden area - is this communal?

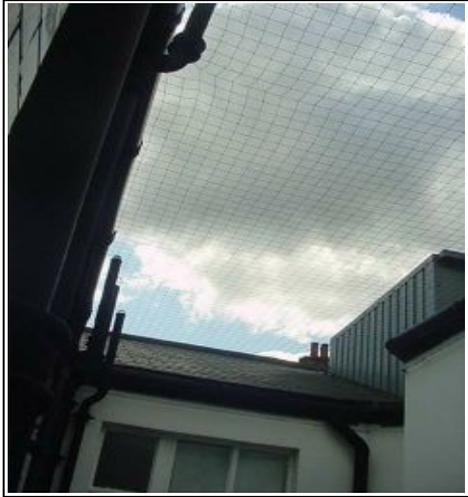
This area is covered in anti-bird netting

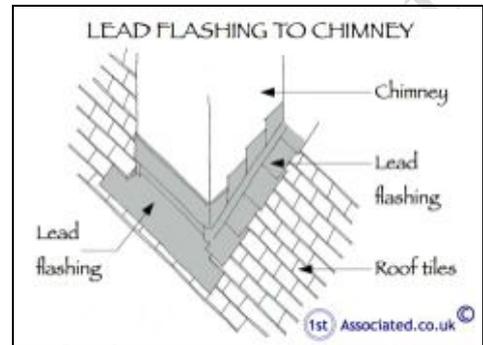
1.0) Chimney flashings

The flashings around the chimney are allowing water into the property. We would have much preferred to see a mastic plumb mate used here rather than cement mortar.

Flashing to chimney

ACTION REQUIRED: There should be an annual inspection of the roofs, in our opinion, and the associated elements of the chimneys and parapet walls. Repair work such as this should be logged to be carried out. Whilst the dampness getting in via the chimney would be preventative, as we cannot see dampness within the building as yet, you do need to be made aware of this.

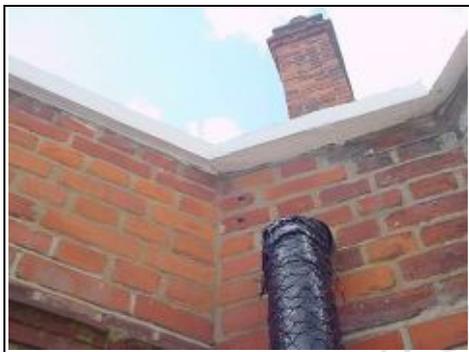
There are brick built parapet walls around the property. We can see these have been repaired over the years. There is a box gutter behind them and this is where we suspect the problem with the roof is but we have not been able to access this area.

Parapet wall with box gutter behind it. The different brickwork indicates it has been rebuilt

ACTION REQUIRED: The efflorescence, dampness and general deterioration of the parapet wall needs to be brought to the attention of the management company before you purchase the property and a written reply given as to whether the parapet wall/box gutter forms part of the planned maintenance programme.

ANTICIPATED COST: This will be a shared cost. We would start by repairing the flashing to the box gutter and also look at the joints on the parapet wall; please obtain quotations.

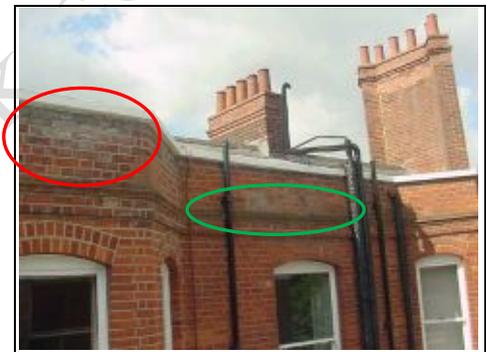
Greening of the brickwork (green)
Efflorescence (red)

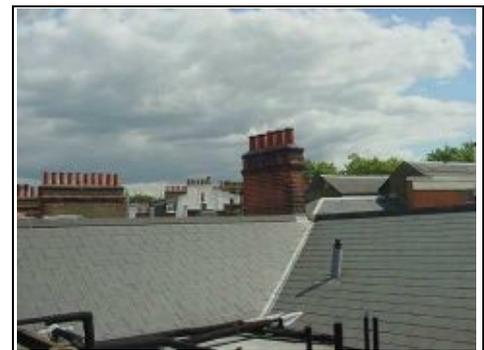
The property has a modern man made slate roof. We could see areas where the slates had broken or come away and there was light visible from within the roof space indicating to us that some dampness was getting in.

Manmade slate roof

ACTION REQUIRED: You need to speak to the management company to establish who repairs this. We assume it's an owner's responsibility and should be taken out of the maintenance/sinking fund. We would recommend that your legal advisor specifically asks if there is an insurance backed guarantee with the roof as we have concerns with the way the roof has been fixed, as the pins restraining the slates are usually facing upwards as opposed to facing downwards as in this instance.

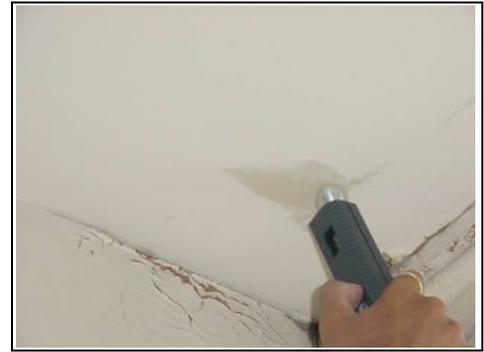
We carried out electronic damp resistance meter tests internally and found the readings to be slightly above what we would expect.

Testing for dampness

ACTION REQUIRED: Speak to the management company to find out when they last carried out work. If the area still allows water in then we would suggest this area is covered with lead and a fall formed in the lead.

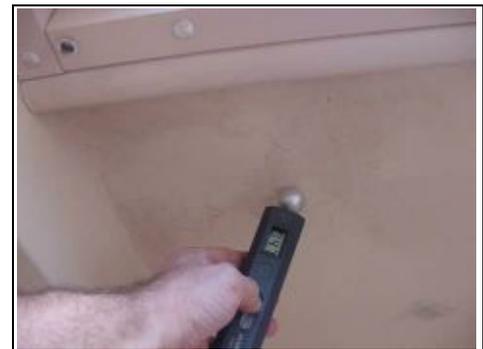
Dampness under the window in master bedroom

We would therefore look at, as an alternative, adding dry lining or false walls, as in the sketch below. This will not resolve the problem but would effectively hide it for some time.

ANTICIPATED COST: Costs to dry line the internal area will be considerably cheaper, in the region of a few hundred pounds, as opposed to many thousands of pounds just to gain access to the underside of the walkway; please obtain quotations.

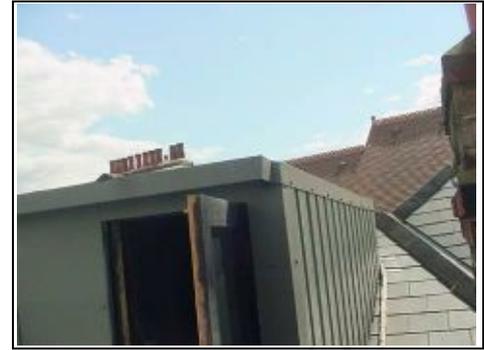
Safety and fire exit

ACTION REQUIRED: We would recommend that the ladder is replaced with a better quality one. Your Legal Advisor to check and confirm with the management company if this is the type of work that they will do. Also check and confirm if they have a fire safety certificate as we were surprised to see that many of the fire extinguishers did not have a position, in fact many were being used as door stops.

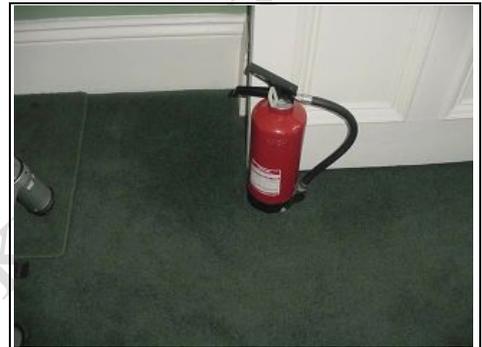
Fire extinguisher used as door stop

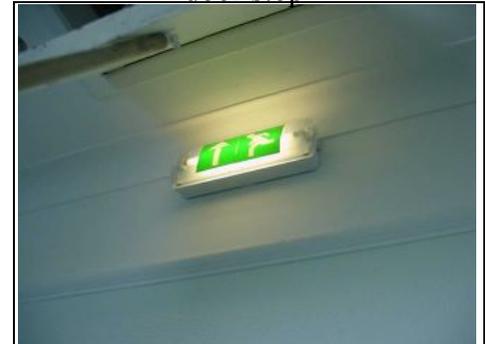
This arrow literally does mean up!

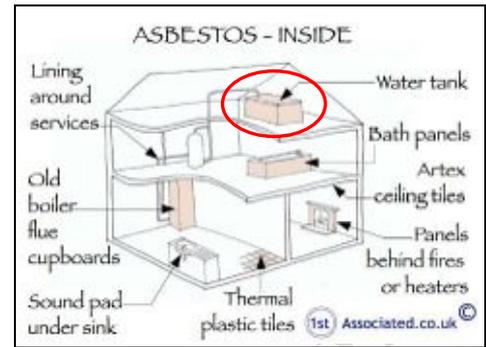
Asbestos internally

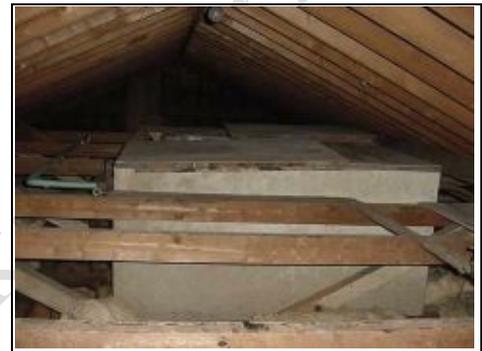
Asbestos water tank

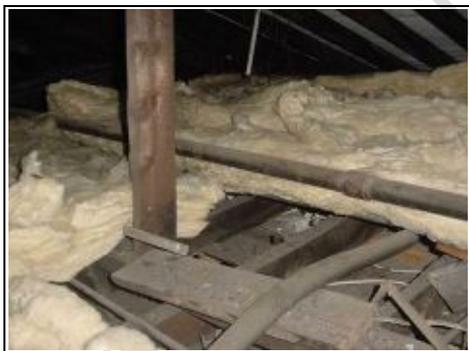
There are ceiling lights throughout the property. These can give off heat and we have recently surveyed a house that had the roof destroyed by fire because of this type of light.

Ceiling lights have been covered with insulation which is not ideal

ACTION REQUIRED: We recommend they are replaced with LED lights.

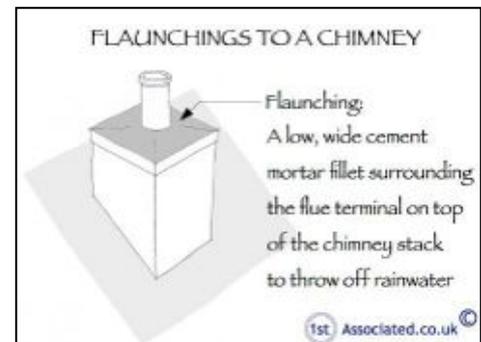
Flaunchings

Unfortunately we were unable to see the top of the chimney known as the flaunching, we therefore cannot comment upon them.

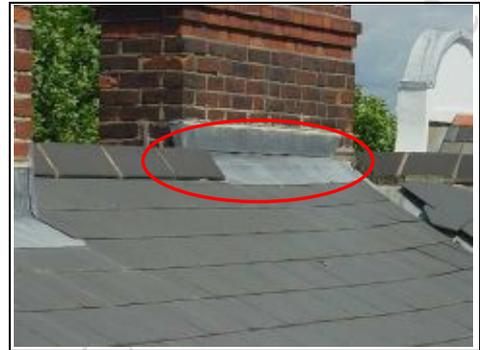
There are three other chimneys to the left hand side rear of the property. These are all brick built with numerous chimney pots and lead flashings. Our comment would be that the lead flashings do not appear to have been carried out by a skilled craftsman.

Poor quality flashing around chimney

ACTION REQUIRED: Please see our comments within the Executive Summary regarding the chimney flashings

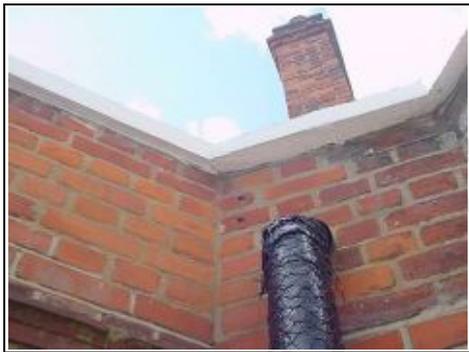
There is a box gutter behind the parapet wall that we believe is allowing dampness into the property

Parapet wall with box gutter behind

ACTION REQUIRED: Please see our comments within the Executive Summary.

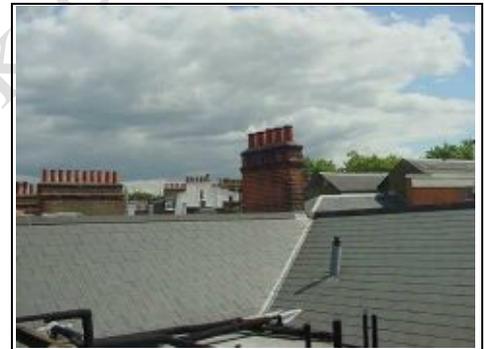
Main roof

The main roof is pitched and clad with manmade slates and, from roof level this looks in slightly below average condition considering the roofs age type and style due to the broken/slipped slates.

We would also comment that this is a manmade slate roof that has been re-roofed in relatively recent times and should have an insurance backed guarantee. Our concern is as we mentioned in the Executive Summary is the way the roof has been fixed and also that it is deteriorating already.

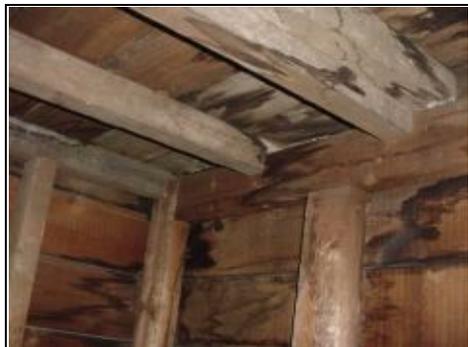
Flat roof to fire escape is allowing water in

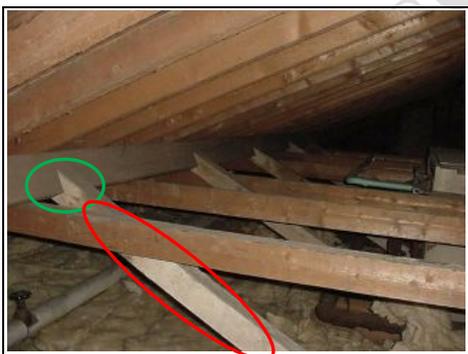
Extra timbers/struts (red) have been added in to the purlins using a bird mouth cut (green)

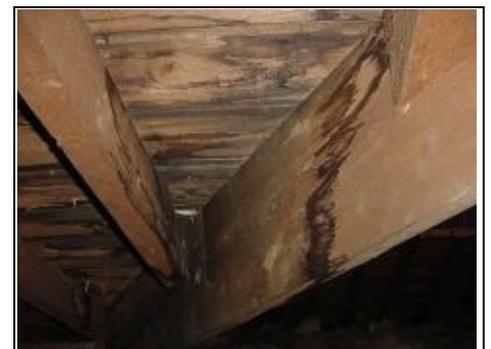
Dampness coming in to the relatively modern flat roof extension for the fire exit

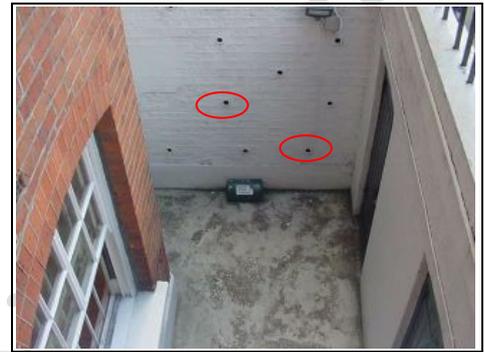
Looking into the lower ground floor where the damp proof course would be if there was one.

In this case we cannot see a DPC. Note the weep holes in the wall that allow water to pass through so that pressure does not build up but this can also lead to dampness getting into this property.

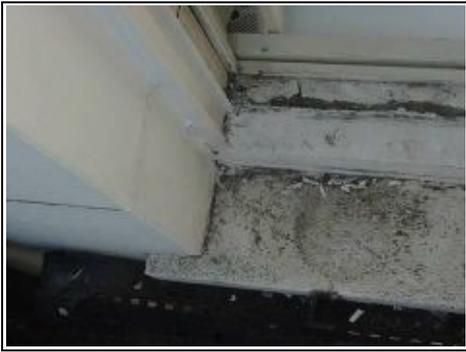
Window needs redecoration

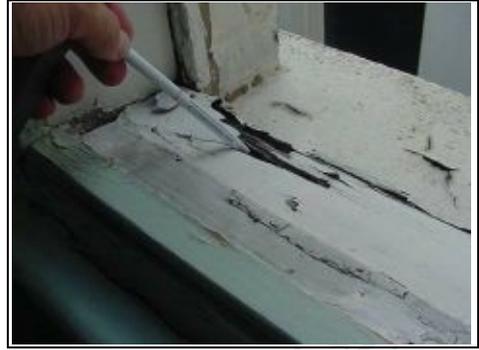
Rotting bathroom window

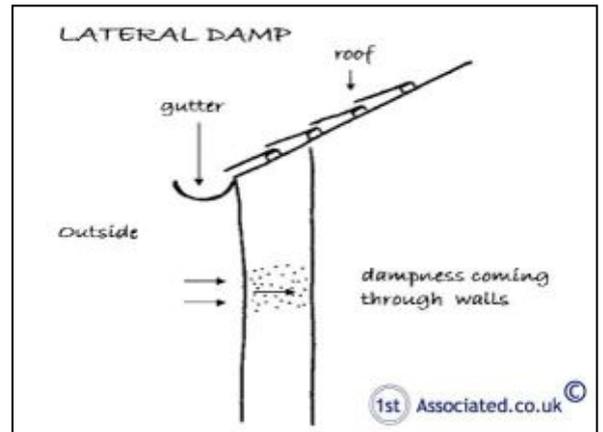
We used a damp meter on the external walls. We have found minor penetrating dampness due to the condition of the walls.

Lateral dampness

ACTION REQUIRED: Please see our comments in the Executive Summary with regards to lateral dampness coming through into the master bedroom and the likelihood that this will be difficult and expensive to resolve.

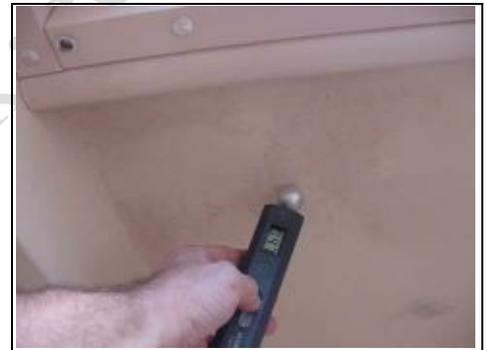
Testing for lateral dampness

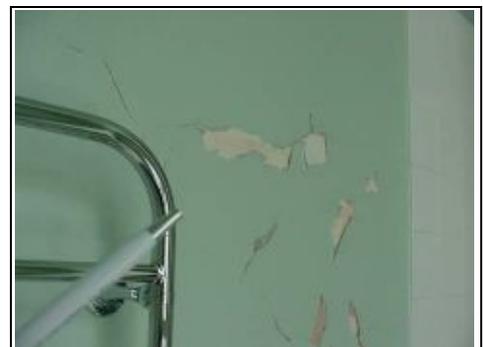
At the time of the inspection there were obvious signs of condensation in the bathroom and the en suite.

Condensation causing the paint to peel in the bathroom

ACTION REQUIRED: Please see our comments within the Executive Summary.

ACTION REQUIRED: We would recommend humidity controlled extract fans be added to kitchens, bathrooms and drying areas.

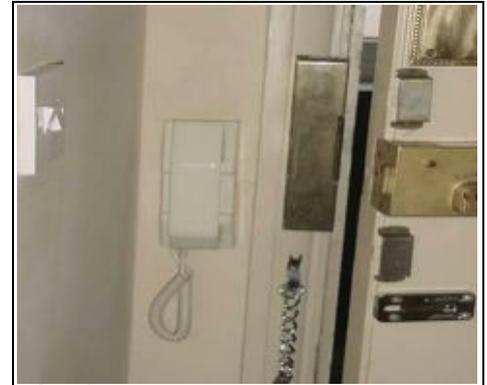
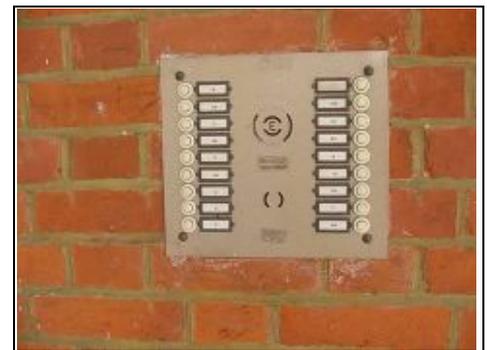
We noted there is a voice entrance system although we would much prefer to see a video entrance system. There is also a closed circuit TV camera in the communal areas.

Door entry system

ACTION REQUIRED: Your Legal advisor should ensure that there is a regular maintenance plan. This should be forwarded to you before you commit to purchase the property.

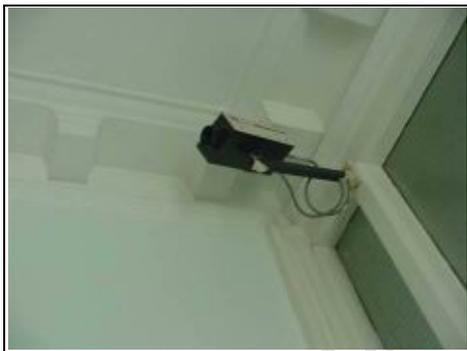
Closed circuit TV

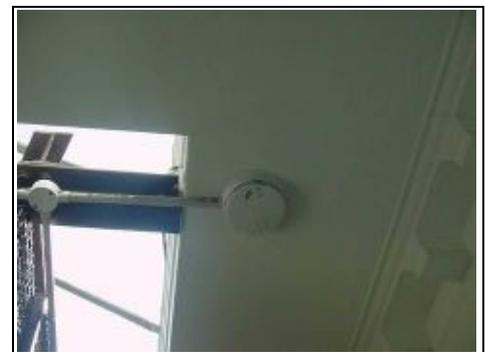
Hard wired smoke alarm in communal corridor

We would recommend, for your own safety, that smoke detectors be installed. We would always recommend a hard wired fire alarm system and are also aware that some now work from a wireless signal which may be worth investigating. Whilst fire is relatively rare it is in a worst case scenario obviously devastating.

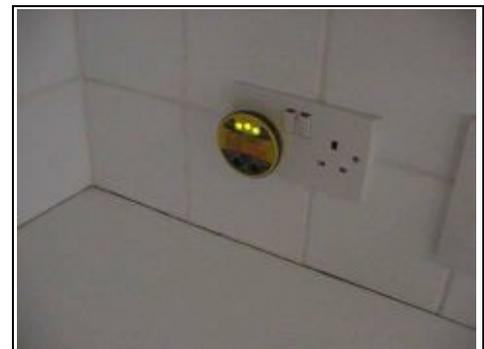
Earth Test

We carried out an earth test in the kitchen area to the socket point that is normally used for the kettle, this proved satisfactory.

ACTION REQUIRED: As the property is changing occupancy an Institute of Electrical Engineers (IEE) test and report should be carried out by a NICEIC registered and approved electrical contractor or equivalent and it

is important to carry out any of recommended work.

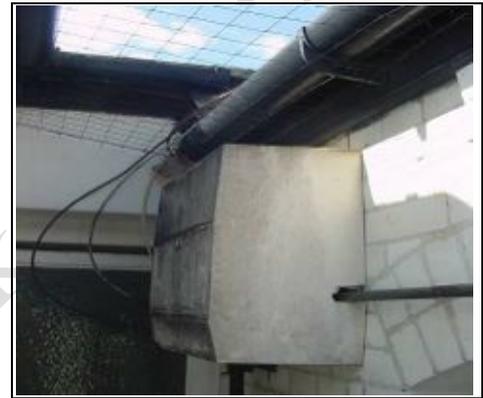
Gas meter

We are advised that the property has mains gas. The consumer unit is located in the internal central area. This is one of the more unusual areas we have seen them located in over the years!

ACTION REQUIRED: As a matter of course it is recommended that the entire gas installation is inspected and made good, as necessary, by a Gas Safe registered contractor. Thereafter the installation should be serviced annually.

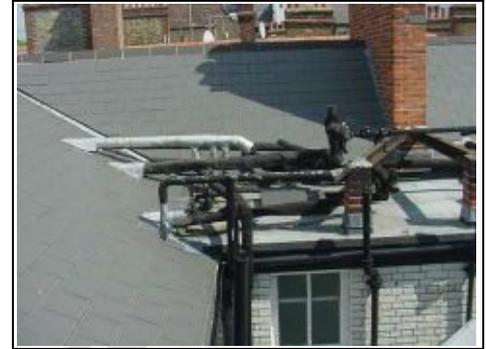
Shared heating system

This type of property originally had a shared central heating system and may still be the case in this instance. However we did find a British Gas wall mounted boiler located in the kitchen and so it appears they have progressed to an individual heating system.

Our limited inspection of the hot water and central heating system revealed no evidence to suggest any serious defects but we would nevertheless recommend that the system be tested and overhauled before exchange of contracts and that a regular maintenance contract be placed with an approved heating engineer.

ACTION REQUIRED: Please see our comments within the Executive Summary.
