RESIDENTIAL BUILDING SURVEY

XXXXXXXXXXXXXXXXXX,
Marylebone,
London ,
W1U xxx

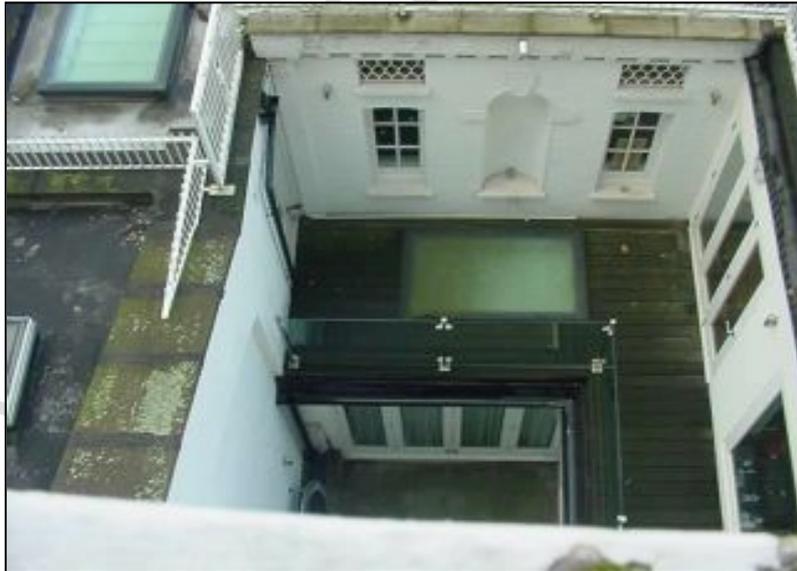
Courtyard of Apartment Two

We can see that the courtyard to Apartment Two and the shared terrace to the rear of the property have a coping stone that looks to have leaked over the years. We can see that the joints of this have been tarred to the left hand side and the parapet wall has been completely tarred to the right hand side.

ACTION REQUIRED: We would recommend that lead cappings are added to the parapet walls including the one on the main roof.

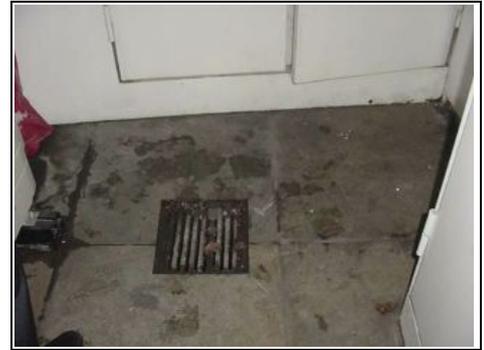
Only one drain for this apartment

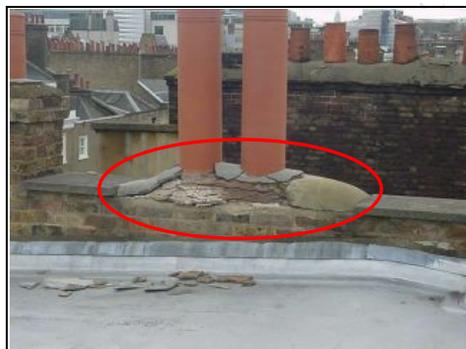
This property has substantial chimneys. The chimney to the left hand side is damaged and deteriorating. It looks to have a modern cement mortar detail that is prone to cracking.

Left chimney requiring repairs

ACTION REQUIRED: It may well be that the best detail is a lead capping around the chimneys and also to the parapet walls, we will discuss this in the next section.

ANTICIPATED COST: For a cement repair this will cost a few hundred pounds. A lead repair would approximately double this cost; please obtain quotations.

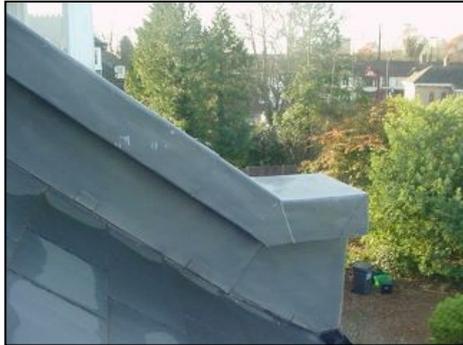
Example of lead capping to a parapet wall on another property.

ANTICIPATED COST: Lead work can be expensive but does offer the best watertight solution in our opinion. We would expect costs in the region of £10,000 to £20,000 for a complete solution. For temporary tar repairs, as

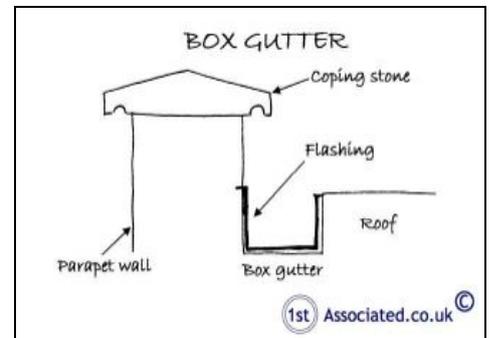
Box gutter

To the front of this Asphalt roof is a box gutter detail where we think rainwater is getting in. The problem may be caused by the poor detailing to the box gutter around the dormer windows, see further on in this section.

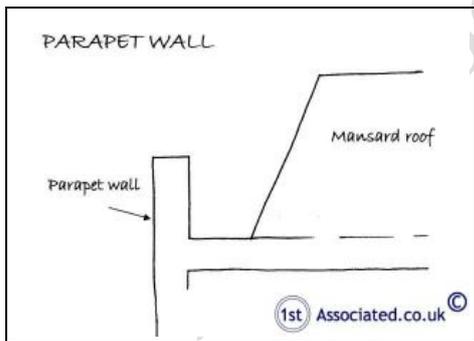
Parapet wall

We simply could not see the box gutter well enough but these are renowned for problems.

ACTION REQUIRED: We would specifically ask if there has been any maintenance carried out on this area from basic clearing of the gutter to the renewing of the finish. We would always recommend that a

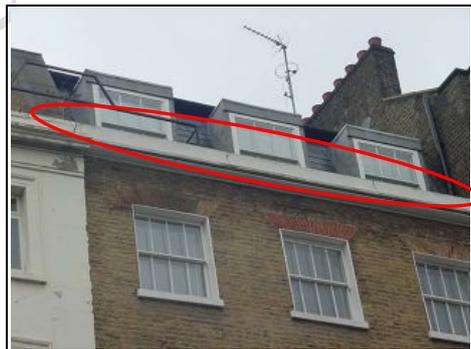
Box gutter

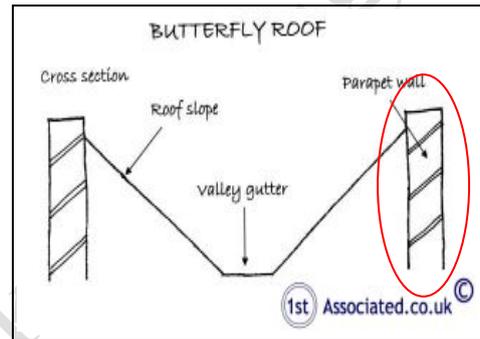
The adjoining property still has the original butterfly roof. There is cracking visible between the concrete fillet that has been used and the parapet wall of this property.

Butterfly roof

ACTION REQUIRED: Ideally this should have a lead flashing as dampness can get into the top floor apartment from your neighbour's property. We recommend speaking to the neighbour to advise them of the problem. If they are not happy to carry out the work it may well be worth you carrying out the work.

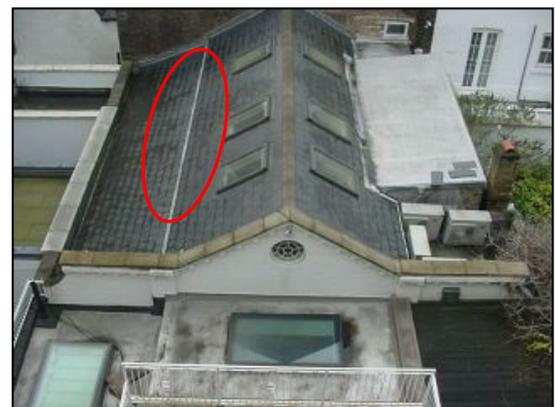
Rear pitched roof
Awkward box gutter (red)

As mentioned there is a pitched roof to the rear of Apartment Two which forms the cathedral ceiling within the apartment. This has been re-roofed at some point with a manmade slate, this would typically have been during the 1990's. We noted that some slates have already been displaced to the rear right hand side.

To the left hand side there is an awkward gutter that we believe is leaking. Again as with the main roof, box gutters really can be problematic particularly in this case where any water that discharges from the gutter actually goes into the walls.

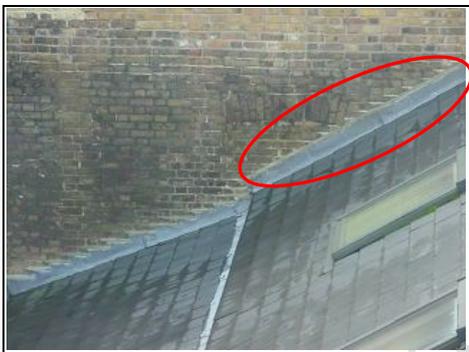
We can see that the lead flashing has been put onto the pitch roof using a straight cut rather than a stepped cut. We tend to find that straight cut lead does not work as well as a stepped lead flashing which is simply a better quality of workmanship and the steps follow the line of the brickwork. The step lead flashing is a subtle difference but we believe it does indicate that the quality of workmanship is not particularly good with regards to this roof.

Straight line flashing to left of rear roof instead of the correct stepped flashing.

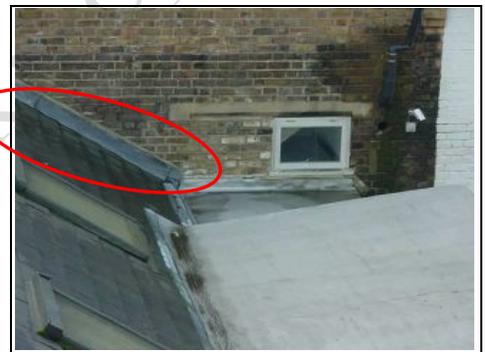
Straight line flashing to right of rear roof instead of the correct stepped flashing.

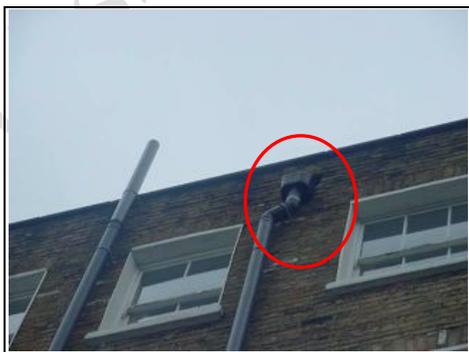
We could not see lead work behind the hopper head.

No lead behind hopper head

ACTION REQUIRED: We would recommend that lead is added to this area.

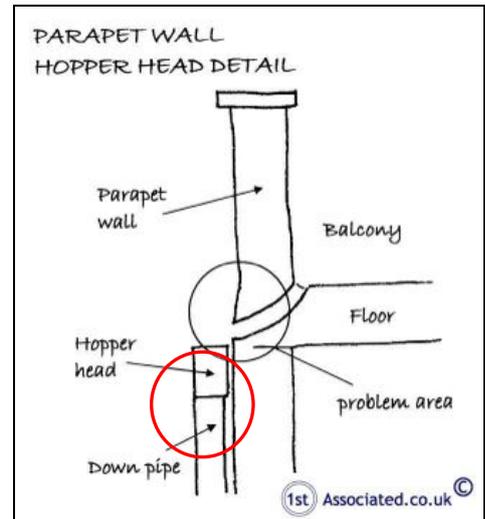
Parapet wall hopper head

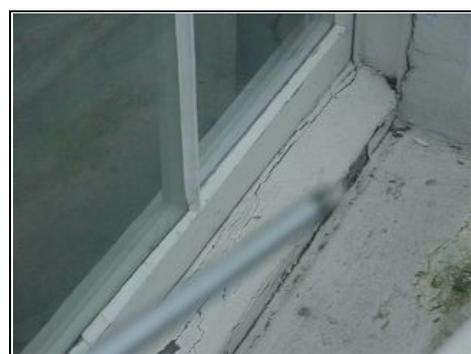
Windows in need of redecoration – rear right

ACTION REQUIRED: Given the way that the windows sit in the wall, 100mm back from the fascia, indicates their date as being late 18th century, however they may have been replaced with a Victorian sliding sash window. Either way they need re-decorating in the summer of 2014 to stop damage and deterioration to the timber beneath.

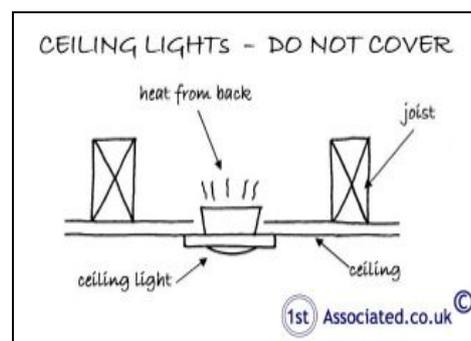
For example, we would draw your attention to one new piece of electrical legislation which is the requirement to have a fire resistant ceiling light where there are habitable rooms above.

There are lots of instances of this where this would apply within the property and we have personally come across situations where fires have been started due to ceiling lights like these.

Ceiling lights

ACTION REQUIRED: A full Institute of Electrical Engineers (IEE) test and report should be carried out by an NICEIC registered and approved electrical contractor or equivalent. The ceiling lights should be checked and also anything else that the NICEIC electrical contractor believes is necessary.

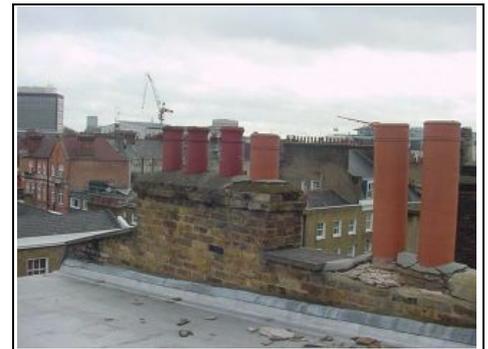
This chimney is brick built finished with a lead flashing and several chimney pots. From what we could see from ground level it looked in below average condition considering its age, type and style due to the condition of the flaunching

Chimney-left

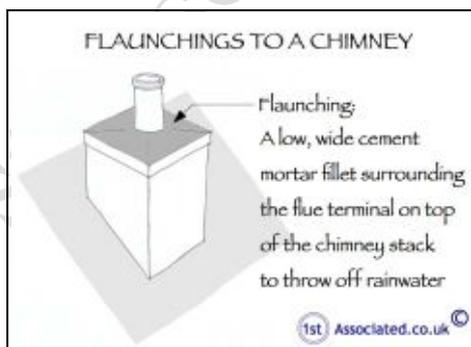
Flaunching

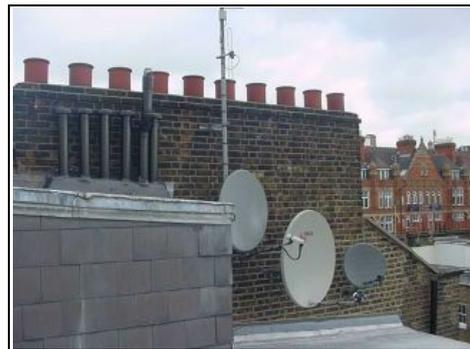
This is a substantial chimney and again we have identified them as one chimney as this is how they originally would have been. The brickwork and the chimney pots look to be in average condition although we have not been able to see the flaunching properly.

Chimney - right

ACTION REQUIRED: Carry out period inspections.

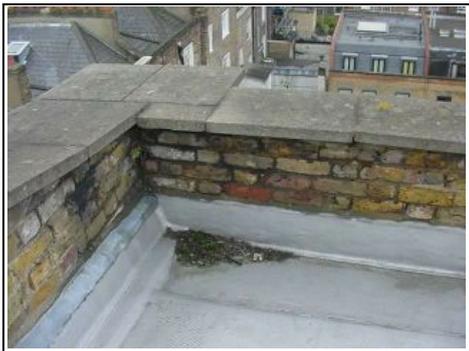
Rear parapet wall with paving slabs to the top

ACTION REQUIRED: We are recommending that any parapet walls with coping stones should be capped using lead as this stops any dampness getting in through the joints and through the brickwork.

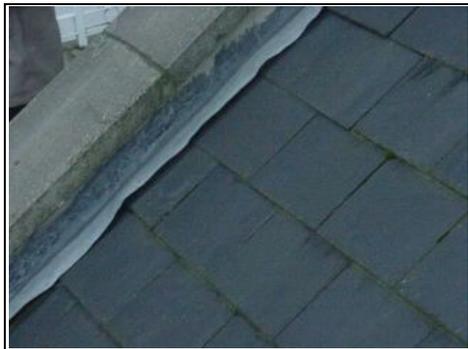
Lead flashing is lifting

ANTICIPATED COST: A few hundred pounds.

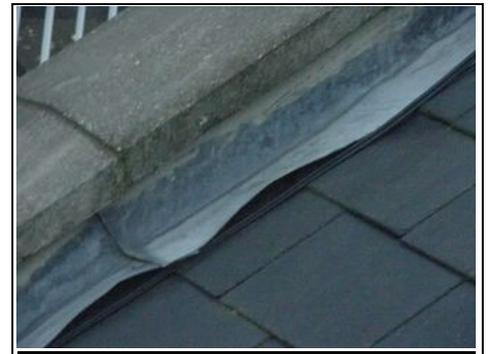
It almost looks as if someone has tried to remove/steal it

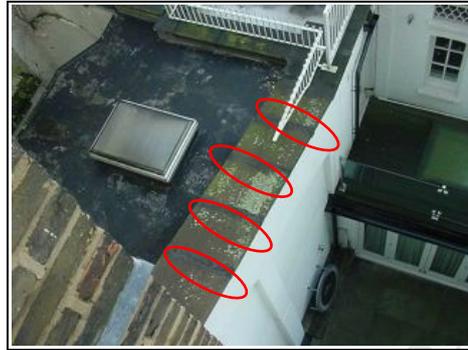
Parapet wall to courtyard has been tarred over the joints

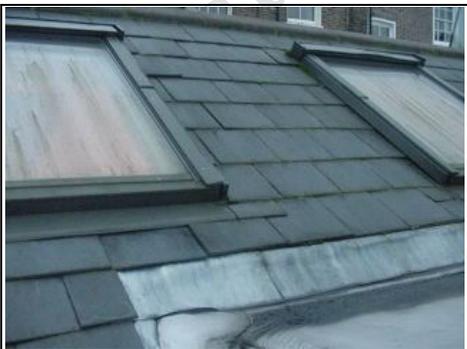
Mould on roof window above Apartment two

ACTION REQUIRED: Please see our comments within the Executive Summary.

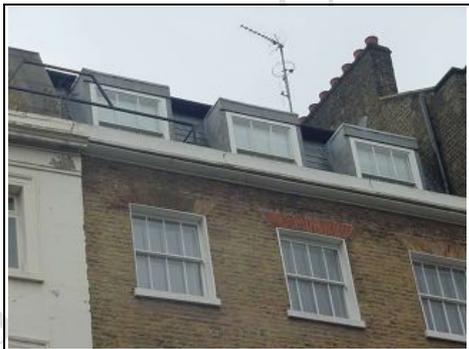
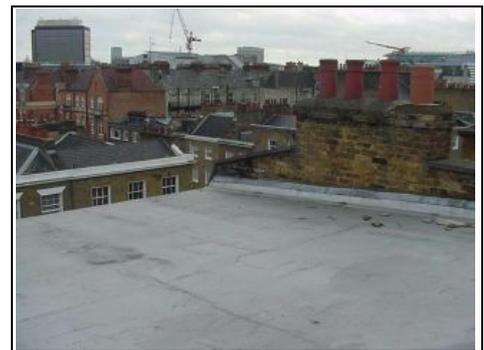
The main roof is Asphalt and is in slightly below average condition considering the roofs age type and style. From the staining visible beneath, it looks as if water has come in and patch repairs have been carried out. We believe further repairs are likely to be required either here or to other areas as detailed within the Executive Summary.

Main roof

ACTION REQUIRED: Please see our comments within the Executive Summary and carry out periodic inspections and maintenance of the roof, as required.

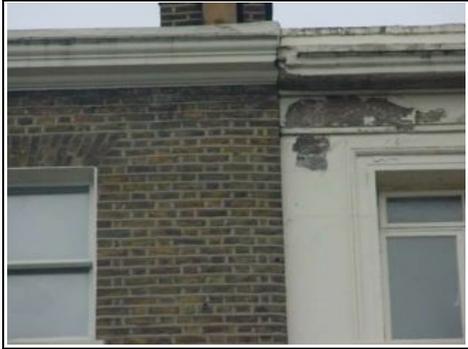
Problems with roof detail please see our comments in the Executive Summary with regards to the box gutter

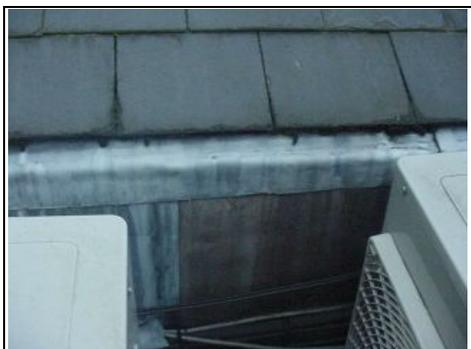
The rear roof is clad in manmade slates and is in average condition with some displaced slates.

Vertical lead

ACTION REQUIRED: Please see our comments within the executive Summary.

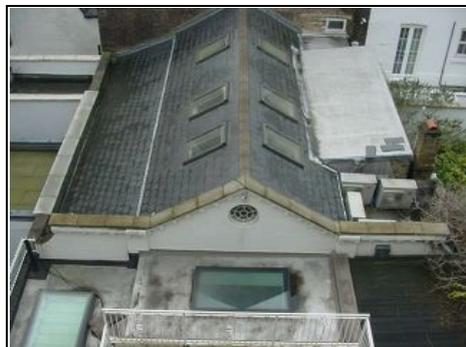
Rear pitched roof over
Apartment Two

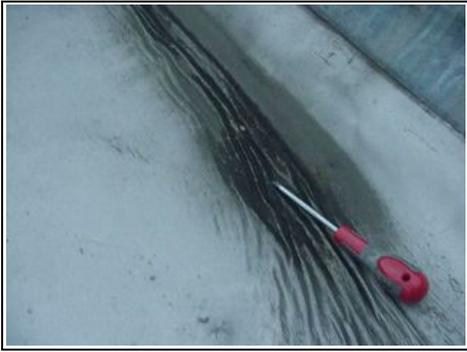
Rucking to the flat roof over
Apartment Two

We have suggested within the Executive Summary that the main roof is tested to pin point the leak. This is an electric testing system where the roof is covered in a liquid and a charge passed over it via a metal detector type device to see if there is any water getting in. We feel that this will be beneficial here as although there are no obvious signs of water getting in, it is best to be on the safe side.

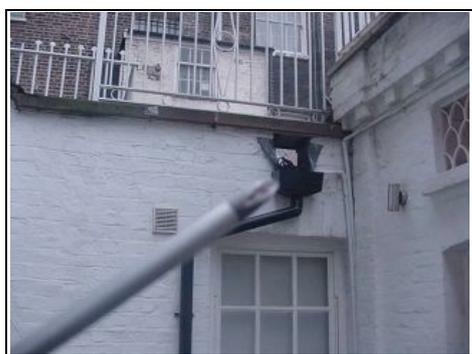
Hopper head left hand side wall of Apartment Two

ACTION REQUIRED: Please see our comments within the Executive Summary referencing the hopper heads and the hopper head detailing.

We have recommending that lead is added around the hopper heads but also we would recommend these are checked next time it rains heavily to see if they are overflowing as it may simply be that they need to be a larger size. The original cast iron hopper heads

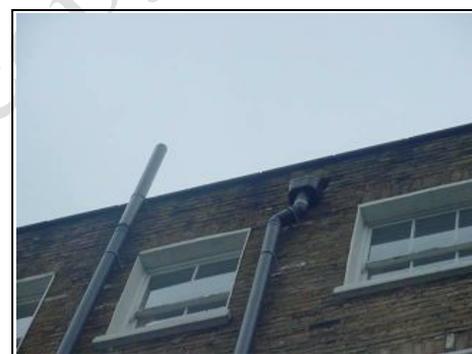
Hopper head taking water off the roof

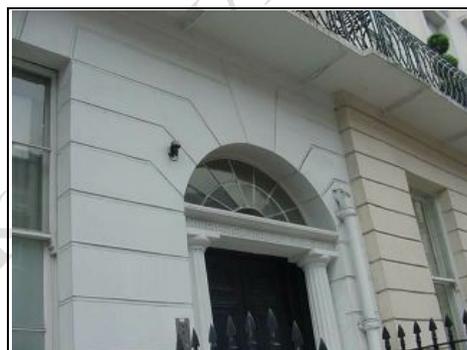
The external walls at lower level are finished in a Stucco render. This looks to be a replacement cement based render which is harder and can suffer from what we term as a hardboiled egg situation where the outer skin does not move in the same way that the inner skin does.

Stucco render

This generally seemed to be in average condition but would benefit from redecoration. We would recommend that this is carried out with the redecoration of the windows (please see further on in the report) in the summer of 2014.

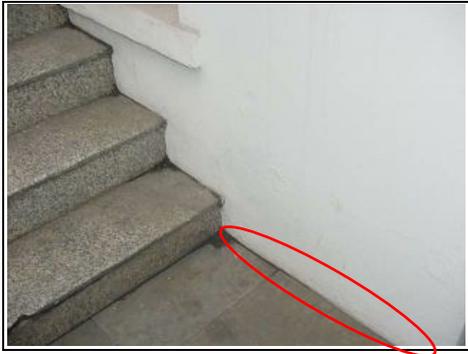
We would much prefer to see a bell mouth type detail to the base of the render. However in this case it is not really applicable as this is a style that outweighs the practicalities.

Poor render detail- this is why there is dampness in the property

ACTION REQUIRED: Please see the Executive Summary regarding changing the detailing to the front of the property.

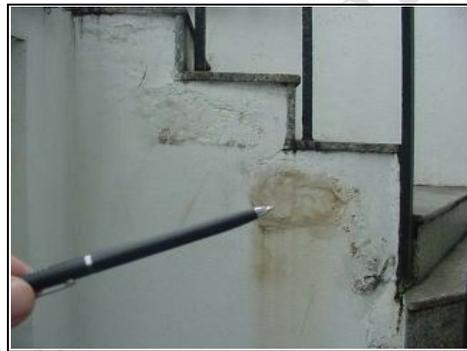
Damp coming from the stairs into the wall. Asphalt tends to be the only way to resolve this

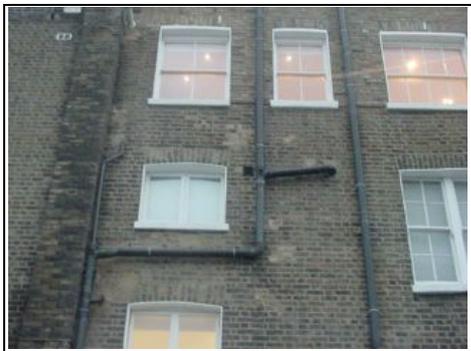
Sash windows to the rear of the property look in reasonable condition

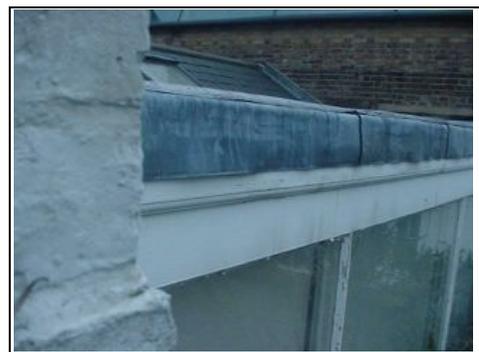
Poor detailing

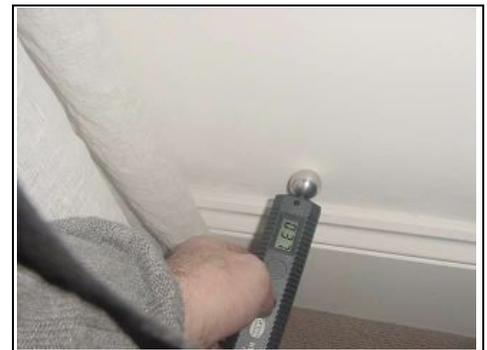
A random visual inspection and tests with a moisture meter have been taken to the perimeter walls. In this particular case we have found minor dampness to the lower ground floor. Looking at the detail externally we think that levels are higher but they are effectively hidden by the dry lining

Testing for dampness but the walls are dry lined

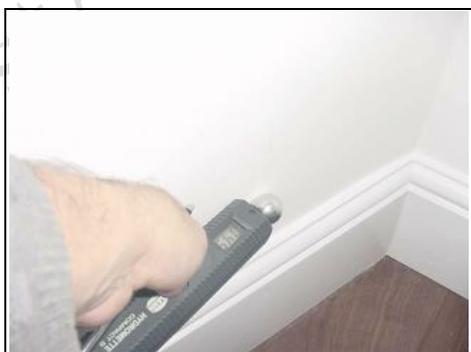
Testing for dampness in Apartment Three - slightly higher readings

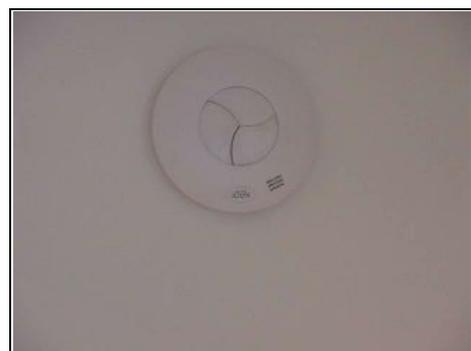
Extract fan in apartment Five

ACTION REQUIRED: We would

recommend humidity controlled extract fans be added to kitchens, bathrooms and drying areas.

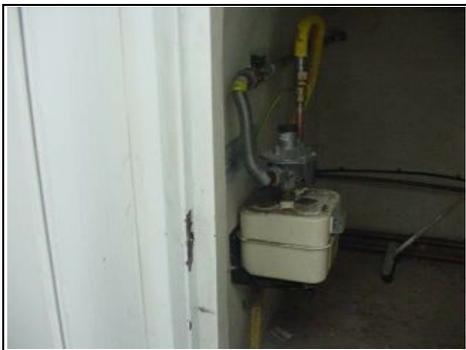
There are vaults to the property that go under the road. These are damp and have been used for various items of service equipment.

Various services in the vaults under the pathways

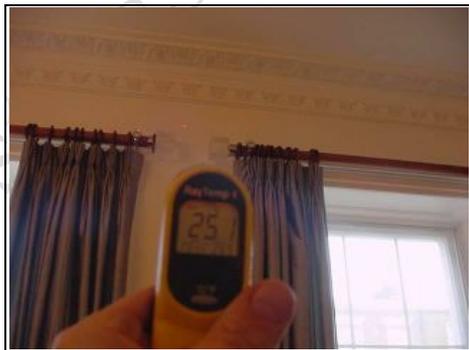
There is a significant difference in the lower level and high level temperatures in some of the apartments. We believe that whilst these walls were originally solid they have now been dry lined with insulation etc. Also the upper flats are effectively insulated by the flats above them and warmed by the flats below them.

Taking surface temperature in Apartment Four

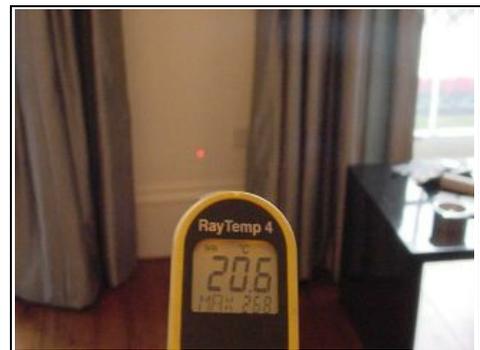
Five degrees warmer at the top of the room than the bottom of the room

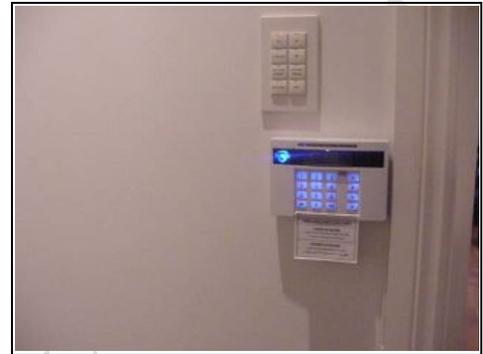
A security system has been installed. A good alarm system should not only help reduce break-ins but also your insurance. We are not experts in this field and therefore cannot comment further.

Security alarm in
Apartment two

ACTION REQUIRED: Further information should be obtained from the vendor and the installer.

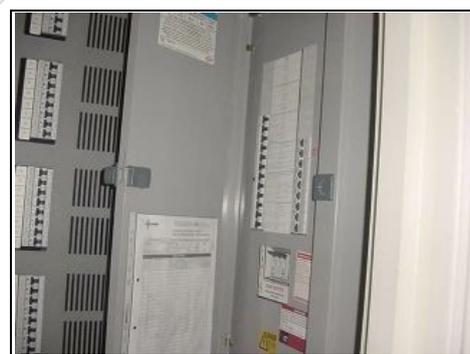
From what we could see each apartment has separate fuse boards which looked reasonably new (past thirty years) although regulations are changing all the time.

Fuse Board in Apartment Five

ACTION REQUIRED: Please see our comments in the Executive Summary with regards to the electrics and ceiling lights.

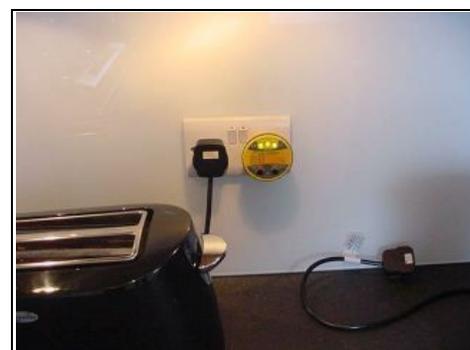
We carried out an earth test in the kitchen area of apartments, one, three and four, to the socket point that is normally used for the kettle, in each case this proved satisfactory.

Earth test

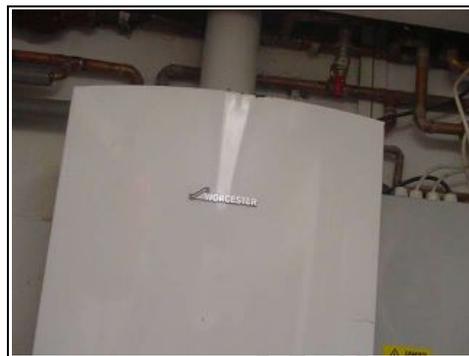
Worcester boiler in Apartment two

Our limited inspection of the hot water and central heating system revealed no evidence to suggest any serious defects but we would nevertheless recommend that the system be tested and overhauled before exchange of contracts and that a regular maintenance contract be placed with an approved heating engineer.

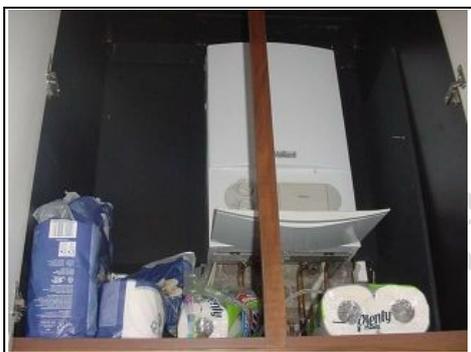
Vaillant boiler in Apartment Four

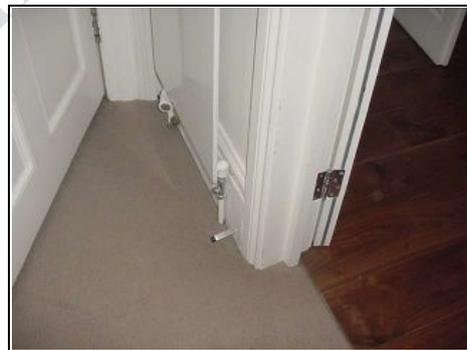
Thin radiator in Apartment Four, very efficient

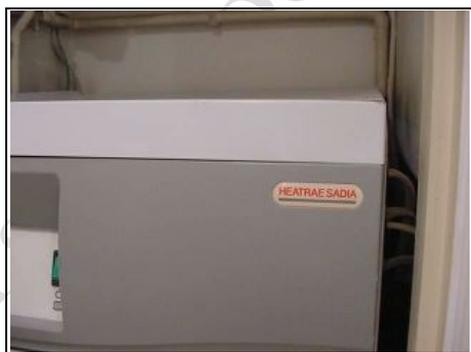
Floor mounted boiler next to bathroom in Flat Three

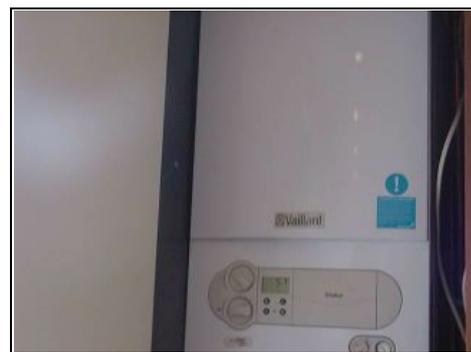
Vaillant boiler in Apartment Five

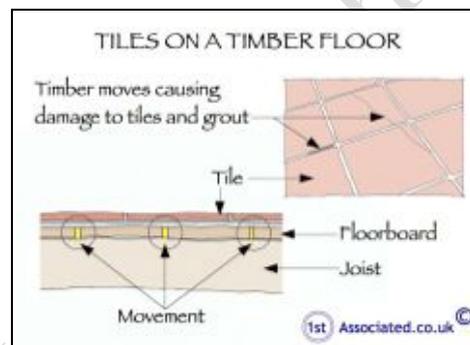
We do come across instance where bathrooms have been upgraded where there is a tiled floor onto timber where the tiles or the joints of the tiles crack.

Tiles on a timber floor

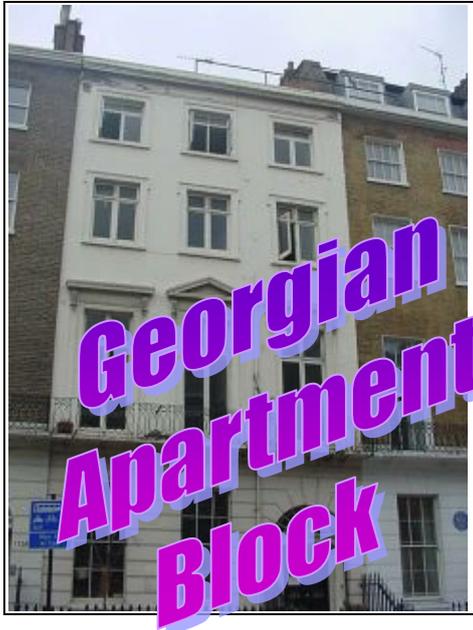
Rendered building - left

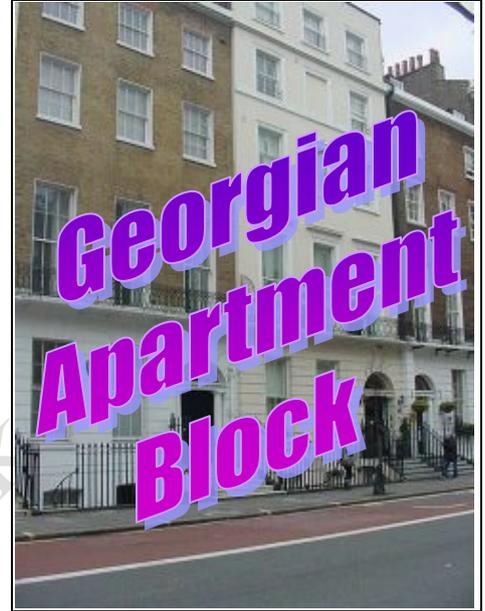
Rendered building - right
