RESIDENTIAL BUILDING SURVEY

**Marylebone
London
W1**

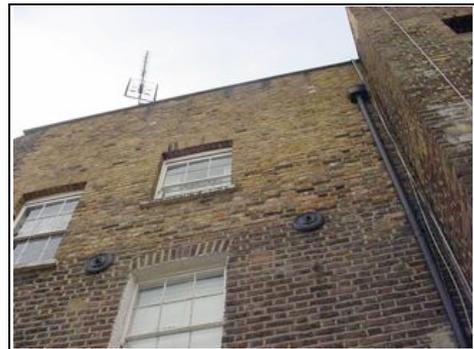
Limited view of the Rear
Tie bars

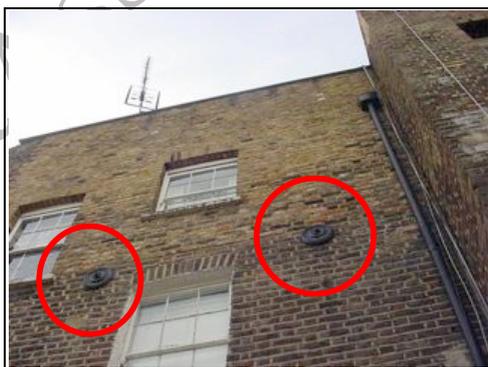
However, in this particular case we would like to carry out some further investigations as we have been unable to see the roof. We can comment that the surrounding buildings appear to have had repairs and we also noted the surrounding buildings, including this building, have had tie bars added to the wall to give additional support.

Tie bars to rear of property

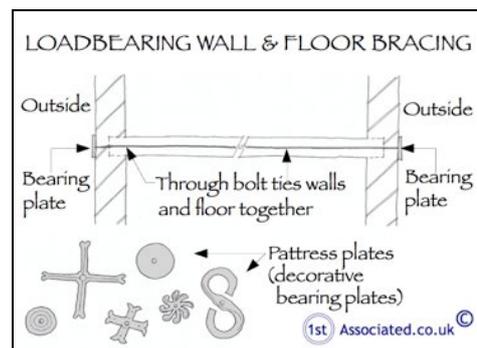
Tie bars

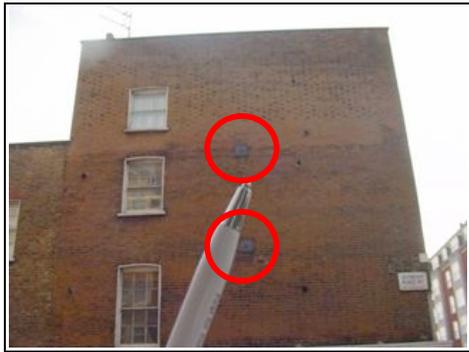
Tie bars to gable end

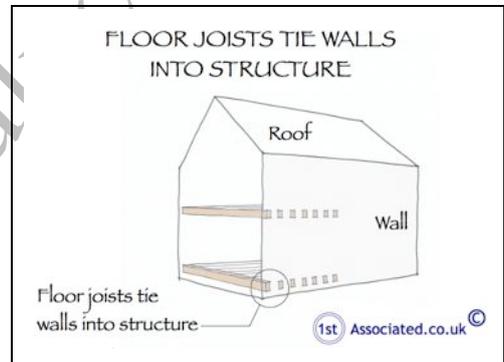
Floor joists tied into walls

In addition to this, often gable end walls were not tied in properly, there can be some work which has been carried out to the end gable of this building and to the rear building considerable work; all of this appears to be long established.

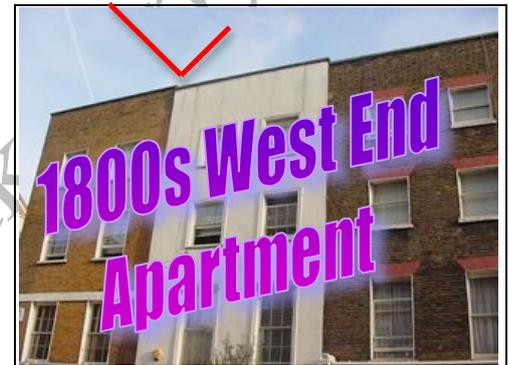
We were unable to access the main roof or view the roof and believe the roof to be a Butterfly roof. Butterfly roofs are problematic roofs; please see our comments in the Executive Summary.

Main roof

ACTION REQUIRED: We would be more than happy to return when access is agreed and available to view the roof.

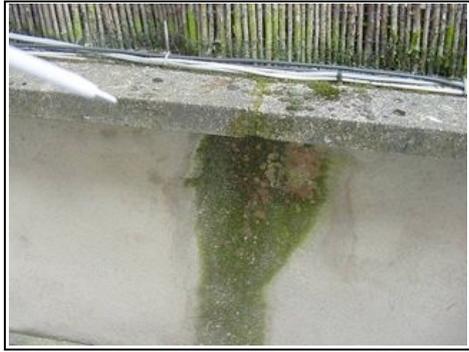
Joint has gone on kerb stone

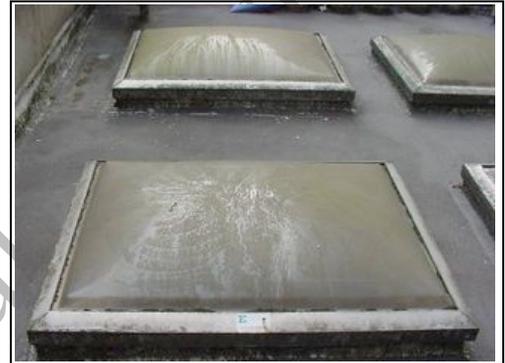
The property has a purpose made roof light, which looked in average condition. The important factor with roof lights is the flashing around them.

It seems inevitable with roof windows that they will sooner or later leak. If this doesn't occur then they seem prone to condensation.

Roof lights general view

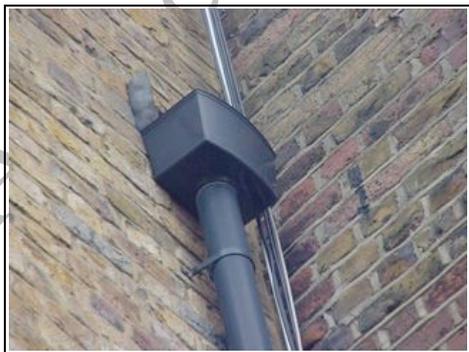
There may be some minor leaks but most people would be happy to live with these providing repairs are carried out within the next six to twelve months.

Close up of hopperhead

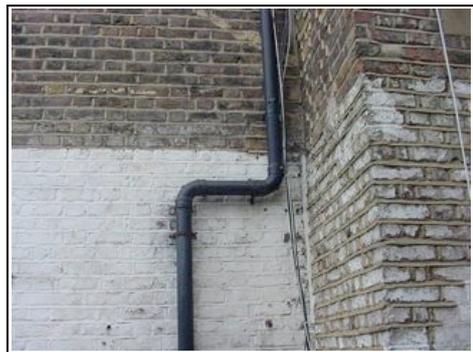
Awkward bend in downpipe

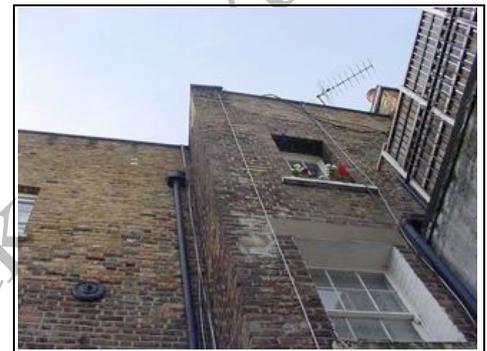
Rear Flemish Bond brickwork we believe has been repointed in a cement mortar

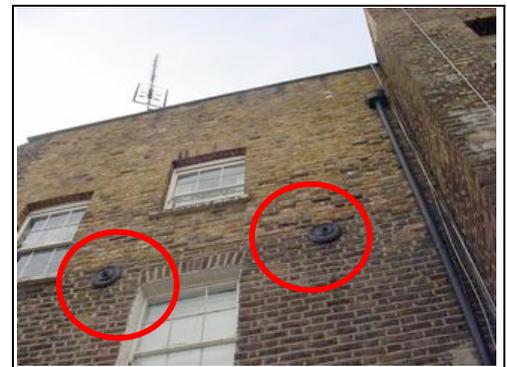
Wall ties to rear

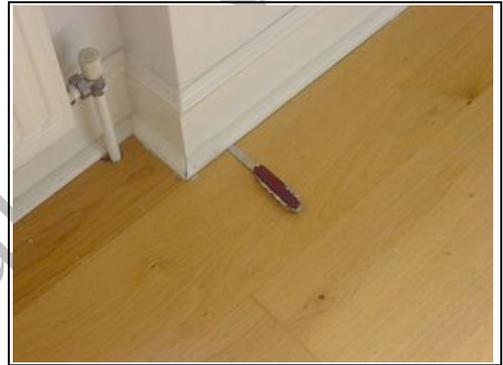
Quadrant bead

There is laminate flooring throughout the property with a slight springiness to it. We noted that there are quadrant beads to the skirting indicating that this has been fitted after and means we cannot comment on the floorboards and the construction.

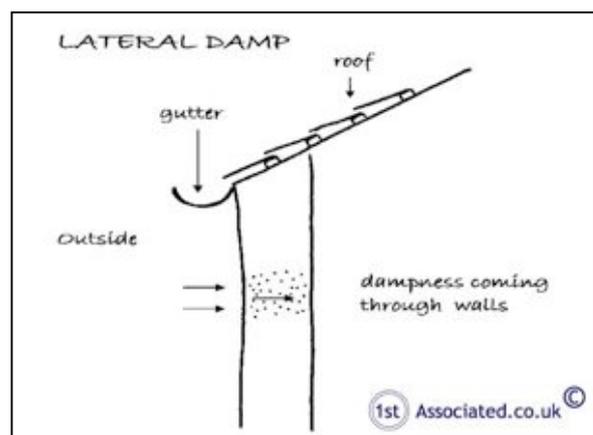
Lateral dampness

We used a resistance meter on the external walls. We have found dampness to be in line with what we would expect for this age, type and style of property. Interestingly we

would comment that we were expecting to find some dampness due to the cracking that we could see in the render from the outside of the property.

ACTION REQUIRED: Please see our comments in the Executive Summary.

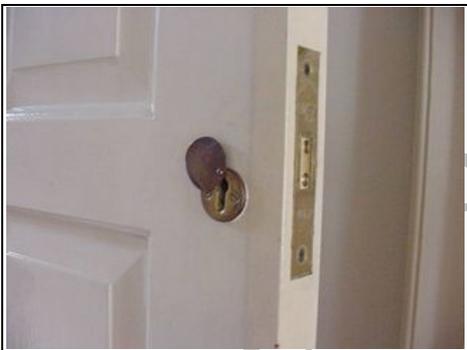
Top lock

The front door appears to have been damaged. There appears to have been three locks with damage to the middle one.

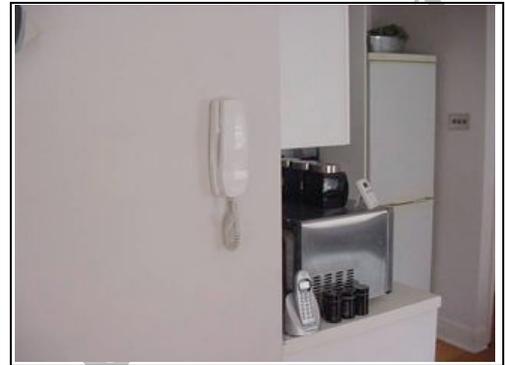
Entry phone system

A security system has been installed. A good alarm system should not only help reduce break-ins but also your insurance. We are not experts in this field and therefore cannot comment further.

ACTION REQUIRED: Further information should be obtained from the vendor and the installer.

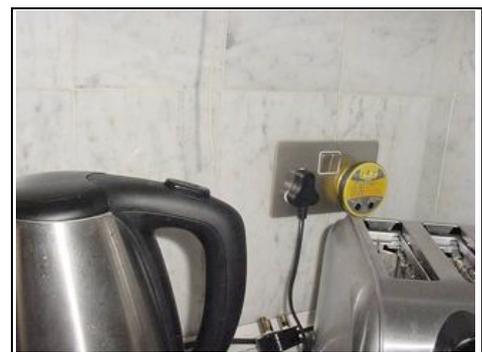
Earth test

We carried out an earth test in the kitchen area to the socket point that is normally used for the kettle, this proved satisfactory.

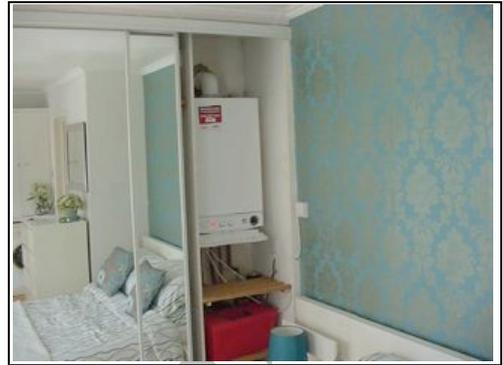
Boiler

The boiler was located in the bedroom, it is manufactured by Main and the model type is one we rarely come across.

Our limited inspection of the hot water and central heating system revealed no evidence to suggest any serious defects but we would nevertheless recommend that the system be tested and overhauled before exchange of contracts and that a regular maintenance contract be placed with an approved heating engineer.

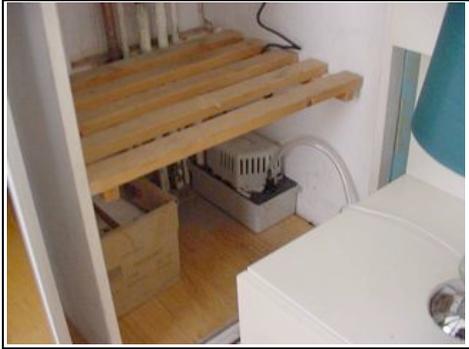
Machine in cupboard

We could see a machine in the cupboard, which we cannot identify. We have asked another Surveyor to comment but they were unaware of this device either.
