**TAILOR MADE  
RESIDENTIAL BUILDING SURVEY**

**XXX  
Notting Hill,  
London.  
W2 XXX**

**FOR  
Mr X**

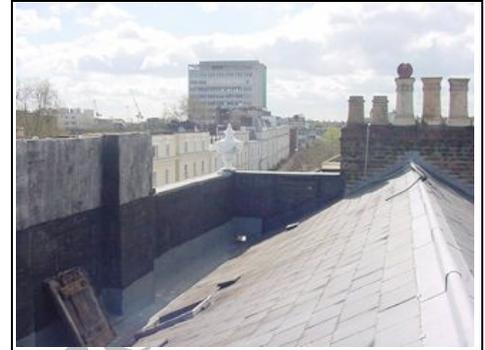
Front main roof

There are two main roofs to the property which are pitched (we will refer to these as the front and rear main roofs), these are in below average condition and have been poorly patched repaired over the years.

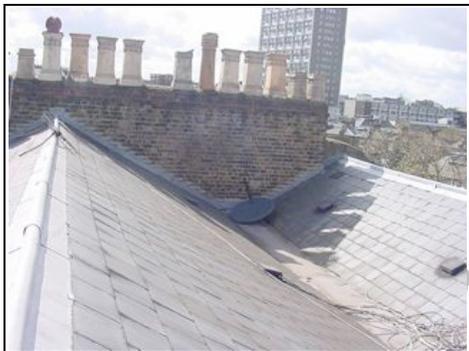
Where front roof and rear roof meet with a valley gutter

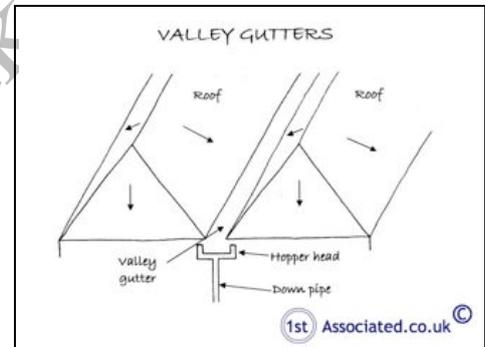
Valley gutter

A valley gutter is where two roofs meet as shown in the adjoining sketch and they are renowned for being problem areas. This one looks to have been leaking over time.

- 1.) The felt repairs to the slate roof to be replaced with slates.
- 2.) Where the valley gutter meets the slate roof and where the box gutter meets the slate roof, these areas need to be stripped back to approximately 2ft and a timber decking put in.

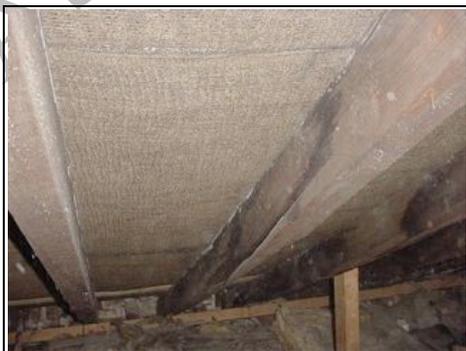
1.1.2) To the left hand side we can see that props have been added and we believe there is a bow in the roof. We also noted a split timber. There are also back to back timbers visible which are used to add strength to the timbers where problems have occurred.

Split central rafter

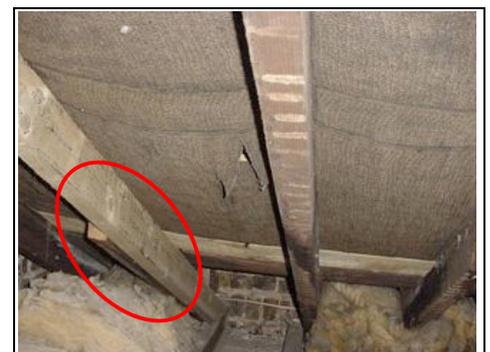
Back to back timbers

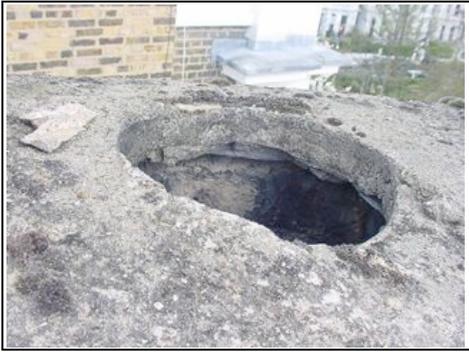
There is also general cracking and deterioration around the chimneys particularly to the top where the flaunching is.

**ACTION REQUIRED:** Carry out repairs to the chimneys.

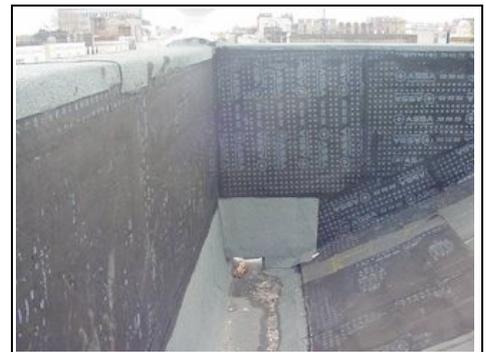
Parapet walls surround the roof to the front, sides and rear. Where we can see the parapet walls they are deteriorating and the render is coming away. In many areas they have simply been felted over, we assume to make them watertight and prevent rainwater getting in.

**ACTION REQUIRED:** Strip back the felt, check the condition of the parapet walls, re-render the parapet walls and possibly add cappings to them.

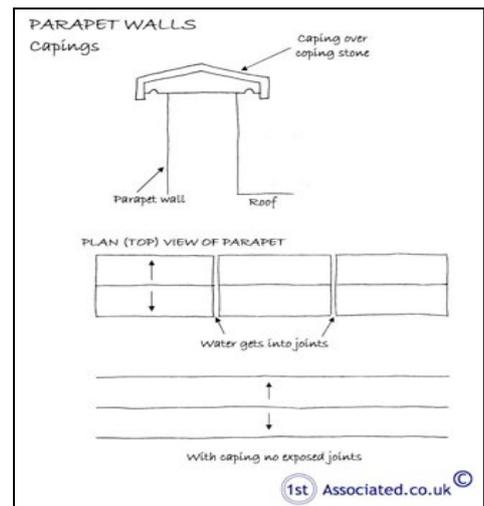
Cappings to parapet wall

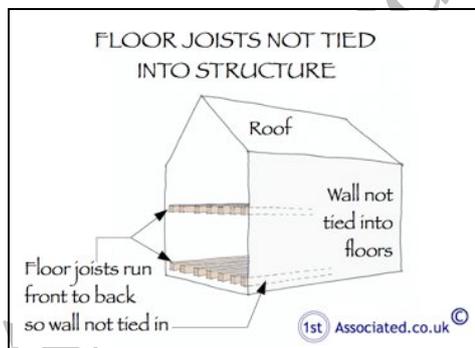
We can see there has been some cracking and movement in the left hand gable. This generally occurs where the gable ends are not bonded in to the main structure of the building.

Wall not tied in

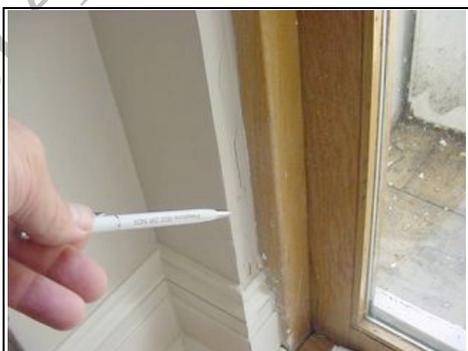
We found the damp readings to the lower ground floor to be over and above what we would expect in this standard of property.

Dampness

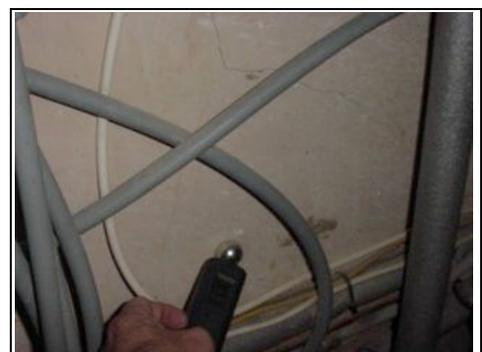
Dampness

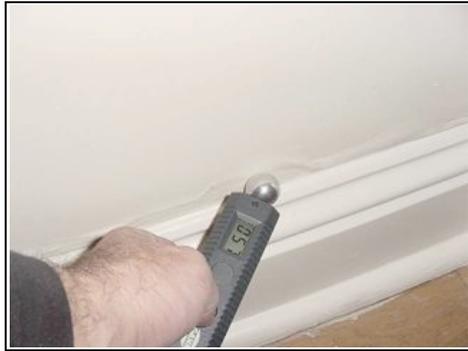
Dampness on the rear left side lower ground floor

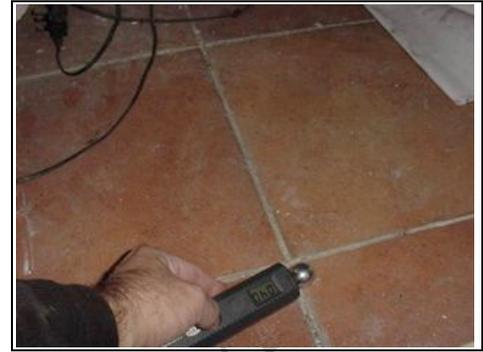
We noted under the stairs that the floors have been raised. This could be:-

Checking dampness to floor on rear lower ground floor right side under the stairs

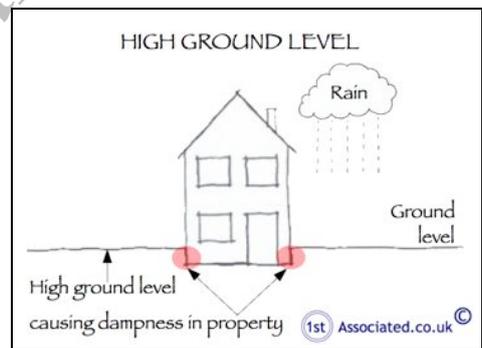
High ground level

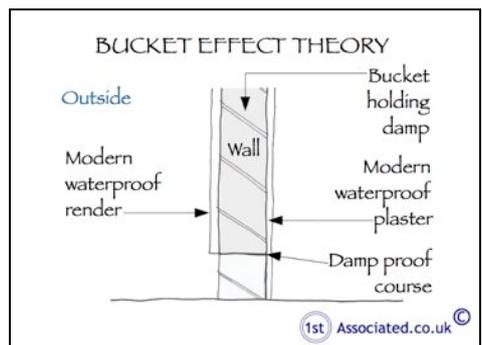
Bucket effect

We would advise on this age, type and style of property we recommend that you avoid using specialist damp proof companies that add chemicals and waterproof layers to resolve damp problems which can cause what is known as the “bucket effect” or “bucket theory”.

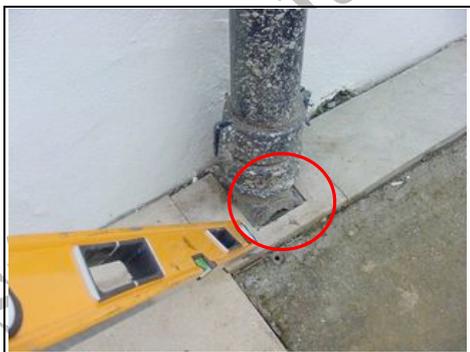
We feel there may be drainage problems as we can see some drainage rods on the ground to the left hand side of the property. Also some of the manholes have been either covered over or are difficult to access which is very unusual as normally Building Control, when looking at any new works such as drainage, will ensure that proper access is available to the drainage points.

Covered over rodding eye

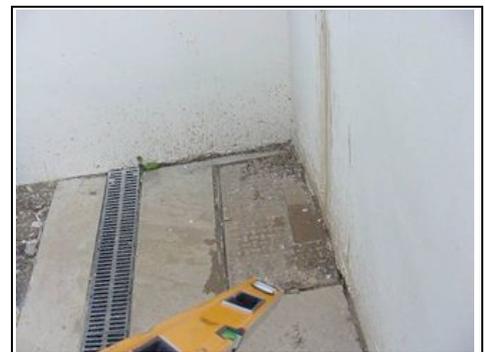
Wall over manhole

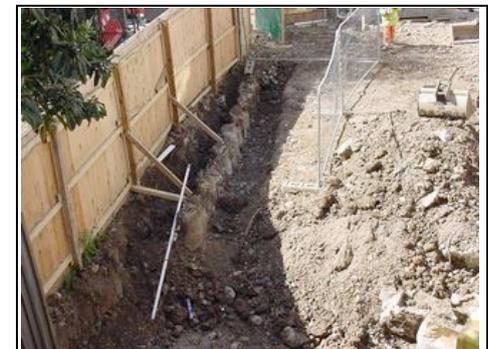
Path to rear on left side has been exposed

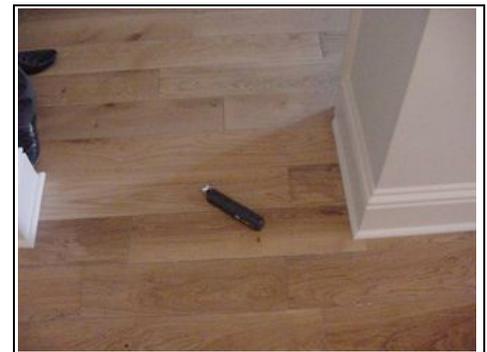
We can see that there are slightly raised areas where the floor is settled onto the structure of the building which are hidden by the floor covering, nevertheless you can still feel a slight rise in the floor in each of the apartments.

Floor raised area

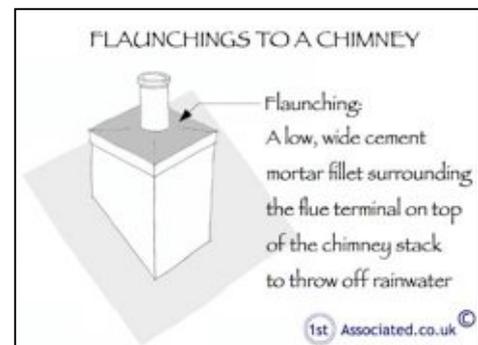
The flaunching seems to be deteriorating to the right hand chimney, which we were able to inspect properly, including a missing chimney pot which we believe is causing dampness within the chimney breast but is not visible due to the dry lining to the walls.

Flaunchings

**ACTION REQUIRED:** Please see our comments within the Executive Summary.

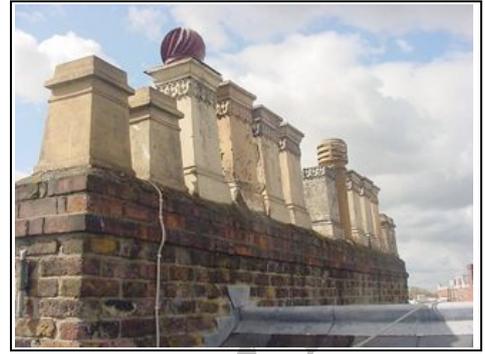
Chimney -left

We did not have a close view of the back of the chimney. From what we could see from within the roof it looked to be allowing dampness in.

We noted that there appears to have been some patch repair work including a new flashing which may have resolved this dampness.

**ACTION REQUIRED:** Double Check the pointing, flaunching and chimney pots. Please see our comments within the Executive Summary

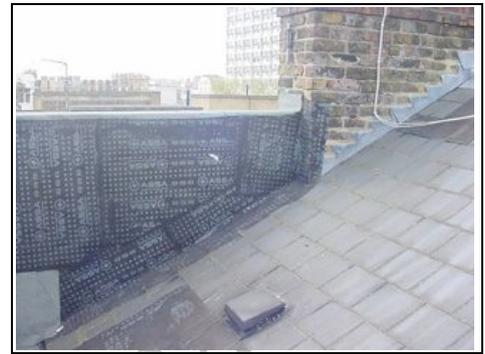
In this case there are parapet walls to the front, sides and rear of the property originally brick built, now with a render finish. We can comment that generally they are in poor condition, some have been felted over completely and others are left in a deteriorating condition.

Felt covered parapet wall

**ACTION REQUIRED:** Please see our comments within the Executive Summary.

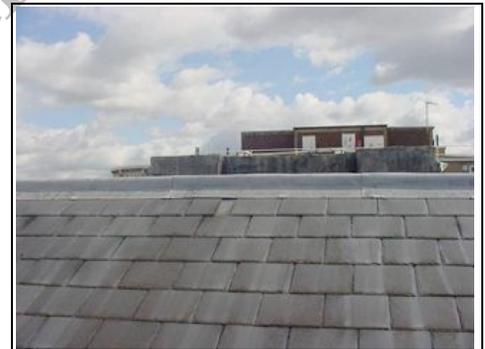
The main roof is pitched and clad with slate and is divided into the front and rear roof. We have viewed the roof from the roof itself and this looks in below average condition considering the roofs age type and style.

Slate roof

**ACTION REQUIRED:** Please see our comments within the Executive Summary.

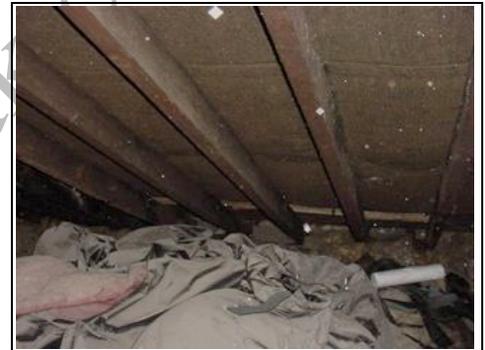
When we inspected the loft space we found a Hessian base Bitumen membrane. This type of membrane has been used since the 1960s. We generally found it to be in average condition, with damage in some areas which is what we typically find.

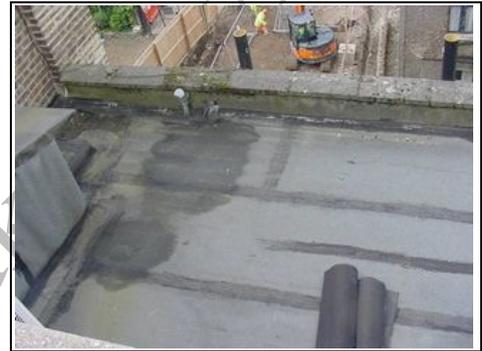
The flat Asphalt roof to the rear looks to have been patched and repaired. We could also see areas of ponding to the roof.

Flat roof - rear  
Ponding visible

**ACTION REQUIRED:** Ad hoc repairs to both flat roofs

**ANTICIPATED COST:** Set aside a sum of £1,000 to £2,000 for repair work.

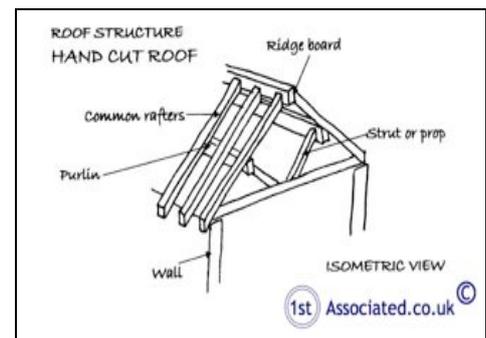
This type of roof structure has what is known as a cut timber roof. This is a roof that is purpose made and hand built on site. Without the original design details we cannot categorically confirm that there are no defects in the design, however it is in line with what we typically see although the condition is below average.

Hand cut roof

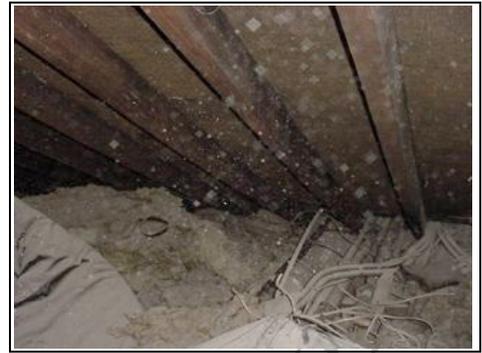
Our examination was limited by the general configuration of the roof, the insulation and general items. What we could see was generally found to be in below average condition considering its age. We believe there are problems with the rafter feet and there is also some bowing to some of the timbers.

General view of inside of roof

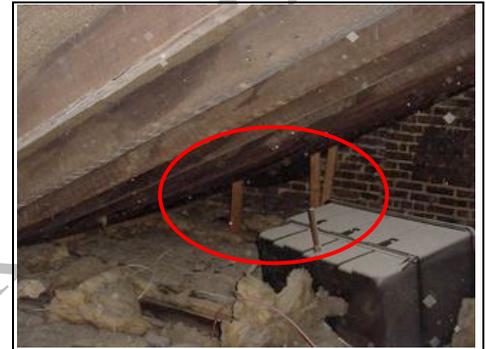
Props added to left hand timbers

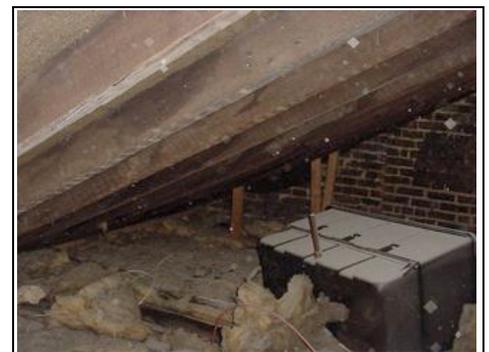
We could see old disused water tanks within the roof space both plastic and cast iron.

Old water tank

**ACTION REQUIRED:** Remove old water tanks.

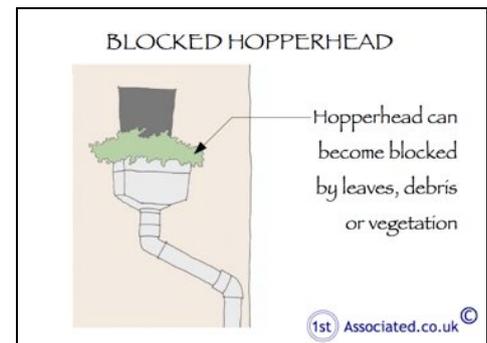
Unfortunately in this case the property has been recently painted and as such this hides any rainwater pattern staining but from what we could see the hopper heads are modern plastic hopper heads and tend to be smaller than the original hopper heads and can overflow.

Typical problems with hopper heads

**ACTION REQUIRED:** We would recommend that the property is inspected next time it rains heavily to see how the rainwater is cleared from the property.

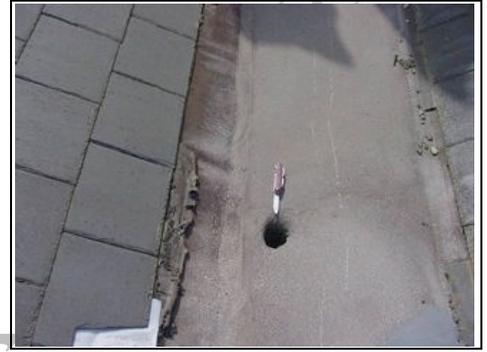
The downpipe opening in the valley gutter is relatively small. We often come across this and it can block and cause back-ups in the valley gutter.

Small opening in valley gutter downpipe

**ACTION REQUIRED:** Please see our comments within the Executive Summary.

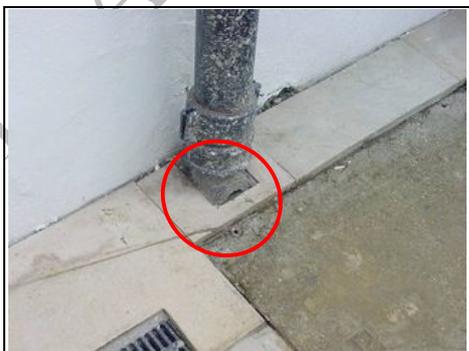
There are problems with the rodding eyes at the base of the soil and vent pipes where the paving has been positioned too high.

Rodding eye blocked off at base of soil and vent pipe

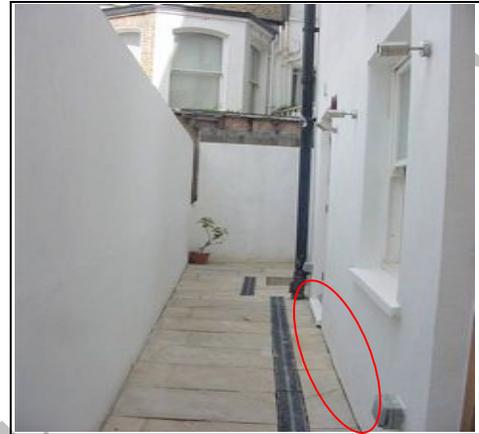
To the base of the render we could not see a bell mouth detail which can lead to dampness of the perimeter. However this could be hidden by the paving slabs to the rear. We were pleased to see a running gully.

No bell mouth

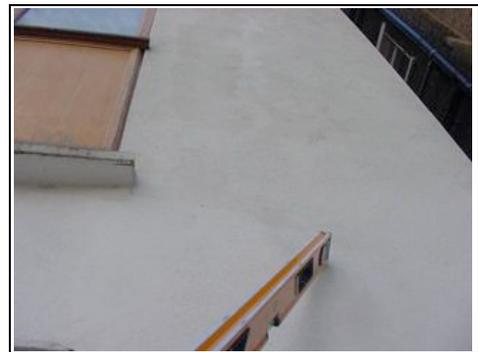
The property has been painted which has effectively covered up areas, such as cracks etc. we would usually be able to inspect. To the rear part painting has taken place and we can still see cracks.

Painted render

**ACTION REQUIRED:** Please see

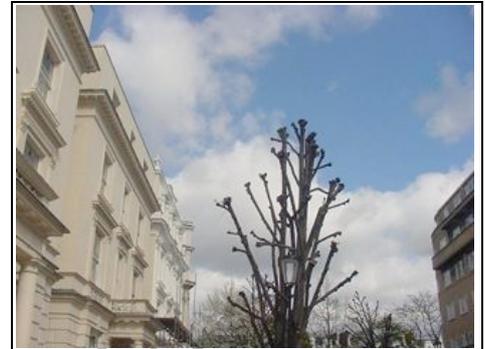
There is a Pollarded tree to the front of the property.

Pollarded tree

These tend to have a thicker trunk due to the repeated pollarding, cutting/pruning of the branches and also an expansive root system which can affect property.

**ACTION REQUIRED:** Most insurance companies would expect you to advise them of this.

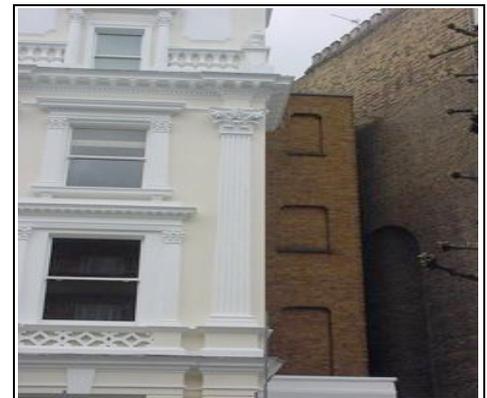
The timber windows would benefit from redecoration.

Sliding sash windows

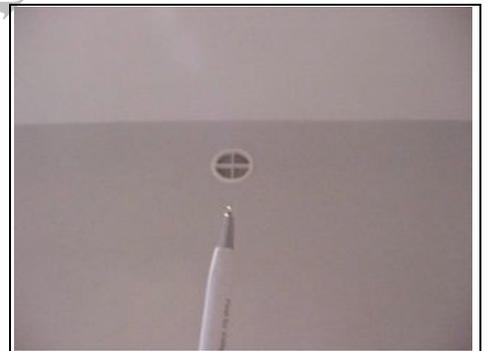
There are vents within some of the studwork which need to be investigated further. We assume they are part of an air movement system within the property. We have not had any details of this.

Wall vent

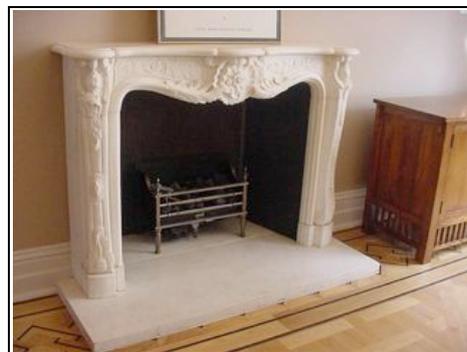
At the time of the survey no chimneys were in use. Any chimneys that you do not propose to use should be capped and ventilated to prevent dampness. Note for

Fireplace upper ground floor apartment

example the missing chimney pot on the right hand side which needs capping and venting correctly.

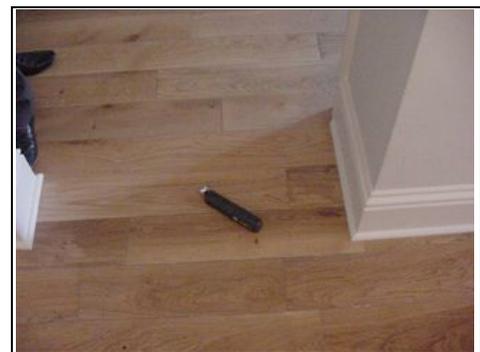
#### Raised area settled onto structural walls

We can however see that there are slightly raised areas where the floor is settled onto the structure of the building which are hidden by the floor covering, nevertheless you can still feel a slight rise in the floor in each of the apartments.

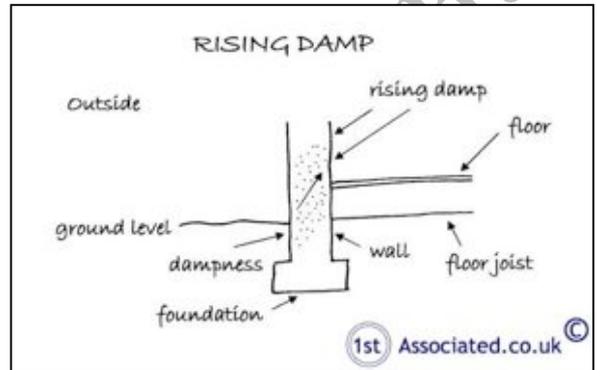
Rising damp

A random visual inspection and tests with a moisture meter have been taken to the perimeter walls. In this particular case we have found dampness higher than expected to lower ground floor.

We were very limited in our inspection due to the dry lining and the false ground floor which is effectively hiding the area beneath. In some areas however, dampness can be seen to be coming through, for example to the rear bedroom.

We believe that the ground levels are high and that the bell mouth level is low as the pavement has been laid over the existing ground level.

**ACTION REQUIRED:** Please see the Executive Summary.

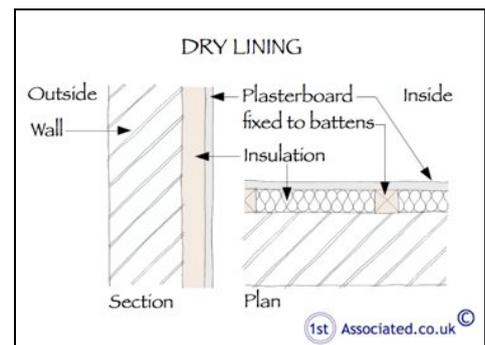
Dry lining

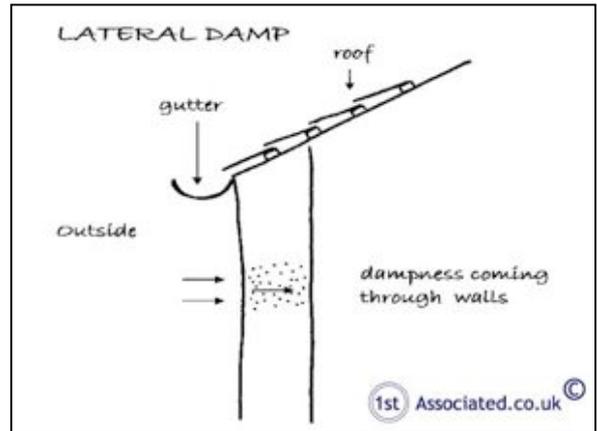
Lateral dampness

We used a resistance meter on the external walls. We have not found significant dampness but we did find some dampness particularly to the left hand side.

We think the dampness may be due to adhoc re-pointing which is required and also in this particular case to the left hand side of the building a lack of sunlight and air movement means that the dampness remains for considerable periods of time.

**ACTION REQUIRED:** Please see our comments in the Executive Summary.

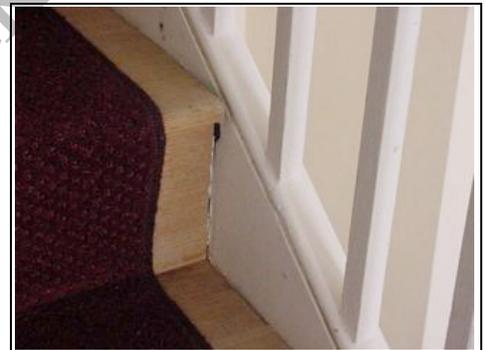
There is a central main staircase that looks to be original. We did note that the stairs look to have been overclad and in some areas this has been poorly carried out.

Stairs look to have been overclad and have a poor fit

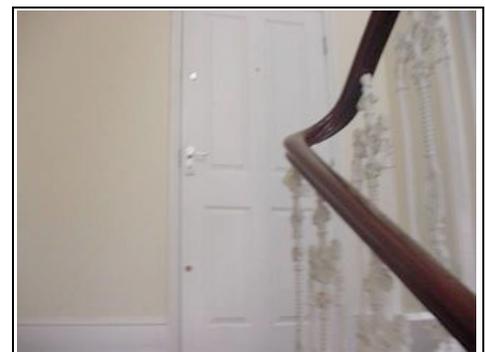
We were advised by the maintenance company that they had carried out maintenance on the property on the staircases but when questioned we were advised that this was only the re-polishing of the hand rail.

Handrail recently re-polished

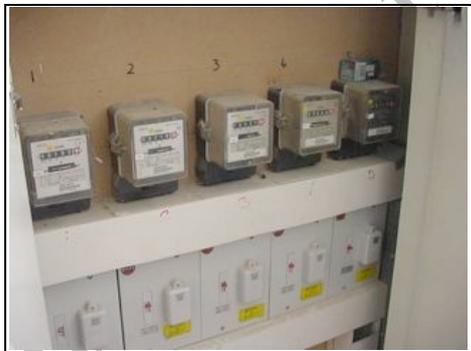
Electric metres in entrance lobby

Each apartment had its own fuse board. These were dated circa XXX. There are metres in the entrance lobby area.

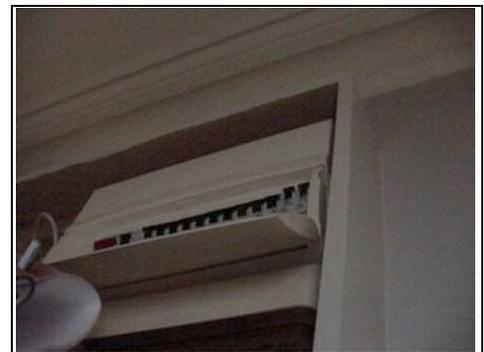
These are old-ish fuse boards and far better are now available.

Electric fuse board,  
top floor flat

**ACTION REQUIRED:** We would recommend an upgrade as well a full Institute of Electrical Engineers test and report.

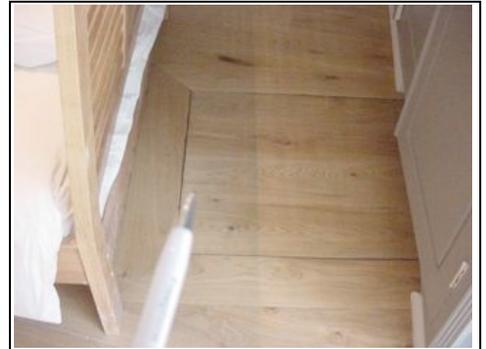
Manhole under flooring in bedroom

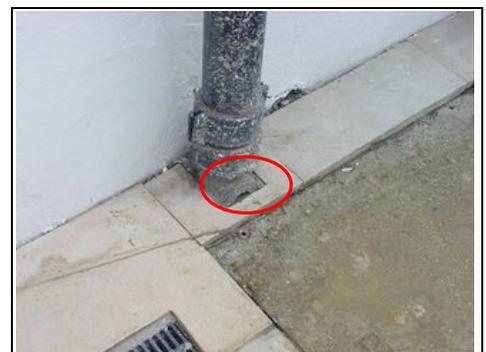
Rodding eye - blocked
