RESIDENTIAL BUILDING SURVEY

XXXXXXXXXXXXXX,
Wandsworth,
London,
SW18 xxx

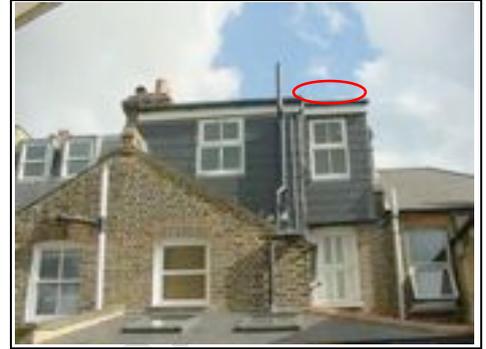
The main roof, due to the way the extension has been carried out, has a flat roof that cannot be seen. However we can see popping/blistering occurring to the plaster internally which often occurs where there is either condensation or dampness getting in via a flat roof.

The flat main roof cannot be seen because of the roof extension

ACTION REQUIRED: We would recommend that a roof hatch is added to the roof to allow access and viewing of the roof. A decision can then be made upon the quality of the flat roof. We are more than happy to comment on this if you forward the photos to us once this work has been carried out.

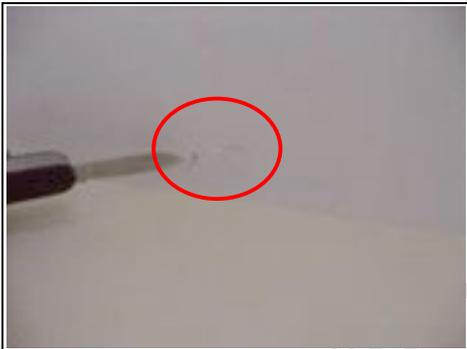
Popping/blistering to the perimeter in second floor bedroom

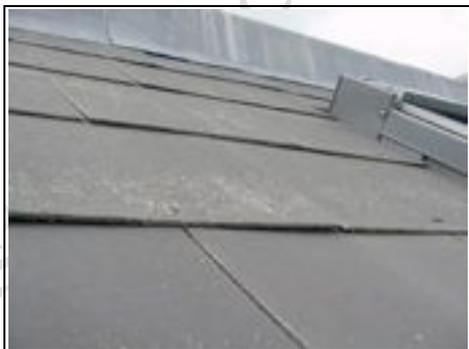
We can see that the slates are starting to deteriorate and the whiteness/greyness is starting to come through which will in due course present as a patchy coloured roof (see photo) rather than the dark grey slate roofs that are traditionally seen on this type of property. We would comment that we feel that the roof slates come from the cheaper end of the market as we rarely see discolouration like this.

Manmade slates starting to deteriorate

ACTION REQUIRED: We would recommend that you employ a roofer for one day to overhaul the roof before the winter of 2013 to check and replace the slates as necessary.

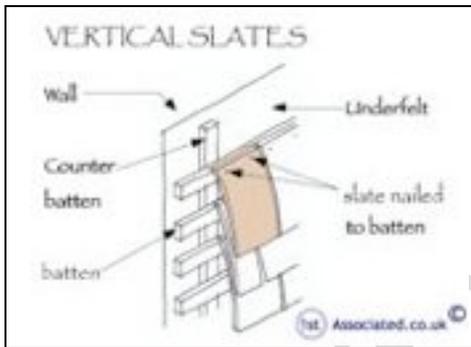
We also noted vertical slates to the rear of the property to the roof extension.

Vertical slates

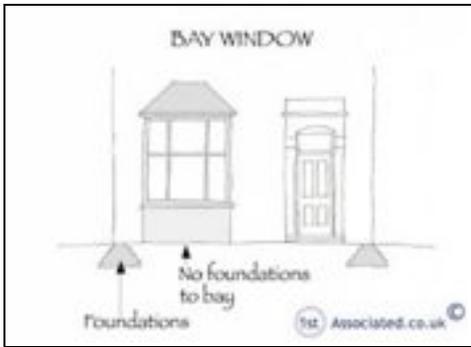
It is relatively common for front bays to move particularly in the London clay areas.

Bay window

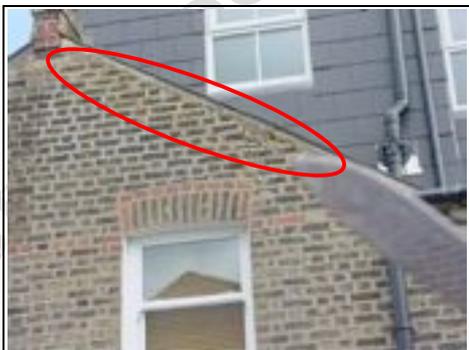
We can see movement to the rear of the property. We feel that this is likely to be due to the alterations that have taken place to the rear of the property. We would also add that there does look to be one part of the gable end that has been rebuilt to about four courses. We can also see what we believe to be tell-tales that monitor movement.

Gable end rebuilt to four courses

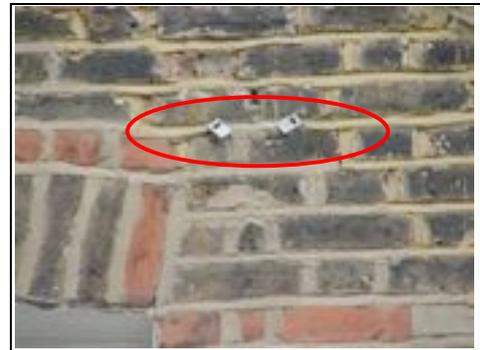
Surveyors 'tell-tale' device for monitoring movement in gable wall

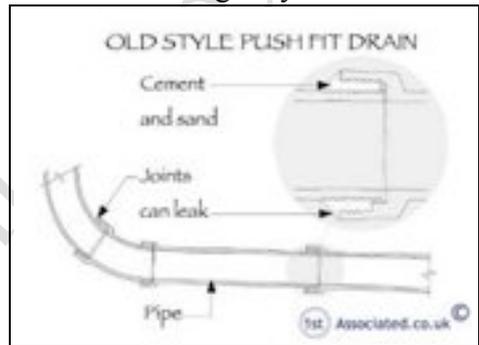
This is a fairly common problem in older properties where often a push-fit drainage system has been used and this has leaked over the years. We were advised by the owner that to the best of their knowledge the drain had been replaced either side of the house but not under the house which is fairly typical of what happens.

Push fit drain

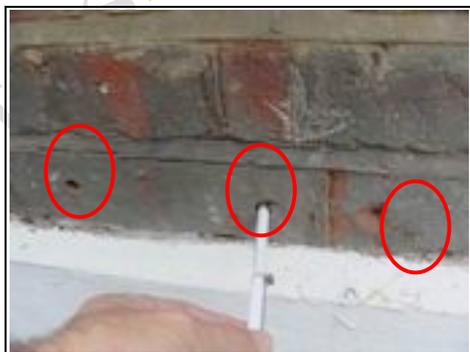
We can see that liquid damp proof courses have been inserted (wrongly, in our opinion) to the front of the property.

Holes drilled for liquid damp proof course

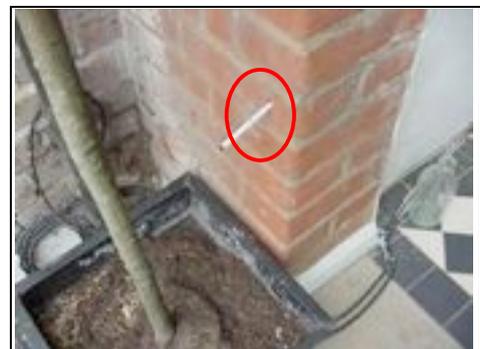
Damp proof course has been inserted vertically as well as horizontally

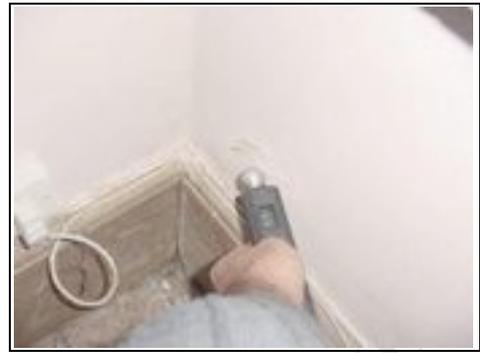
This, we believe, is due to long term dampness problems in the property that we feel is more likely to be due to high ground levels and the cement mortar smothering the brickwork and not allowing it to breathe (see below).

Damp to the bay at the front of the property

ACTION REQUIRED: Lower the ground level around the entirety of the property. The cement mortar needs to be removed gradually (generally the mortar will fall out on its own anyhow) using a soft brush by a time served bricklayer who has experience with this age of property. The property should then be re-pointed in an appropriate lime based mortar until it is completely re-pointed.

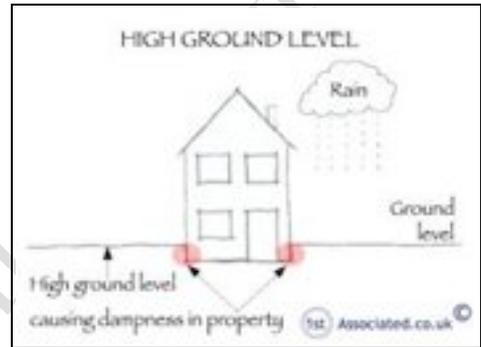
High ground level

ANTICIPATED COST: The low level areas where you should start will be a few hundred pounds each year until it is complete. High level areas will require scaffolding so costs will be greater; please obtain quotations.

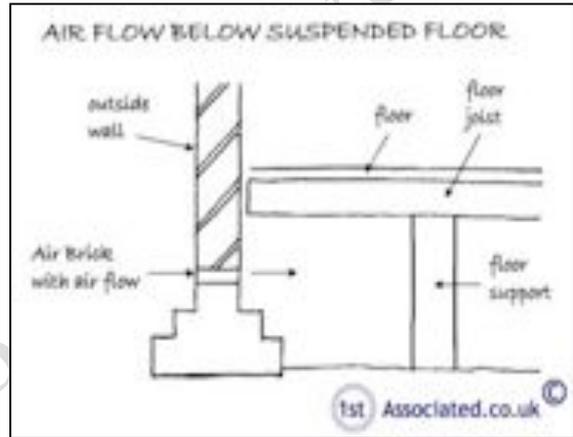
The property has a suspended timber floor. Air bricks are essential to have a through flow of air. We noted that the airbricks are acting as gutters allowing rainwater to get underneath the suspended timber floor which can cause rot and deterioration to the timbers as well as encouraging woodworm.

Suspended timber floor

We recommended earlier that the entirety of the ground level is lowered, once this happens it should also reduce the problem of air bricks acting as gutters.

ACTION REQUIRED: We would recommend that a section of the floor is opened up and checked in due course. It would be ideal to carry this out prior to purchasing the property or it will have to be

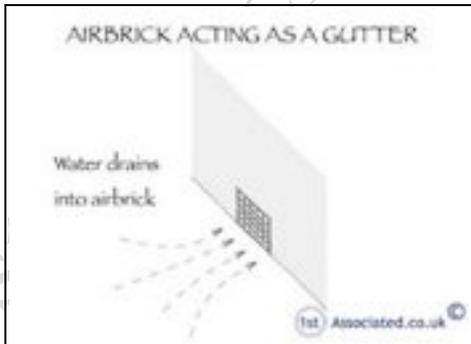
Air brick acting as a gutter

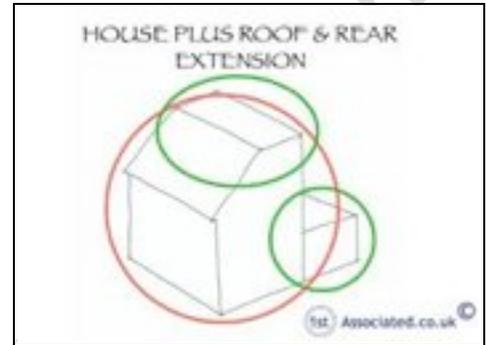
We have come across a few problems where properties of this era have been extended and altered with extensions that are built to modern thermal efficiency standards using modern materials (as they have to be). This has resulted in problems of condensation, damp and mould in the colder original part of the property and particularly in rooms that are not used

The green circles represent the extensions

ACTION REQUIRED: In our experience to date the best way to deal with this problem is to have large humidity controlled extract fans within the bathrooms, kitchens and any areas that are used for drying of clothes.

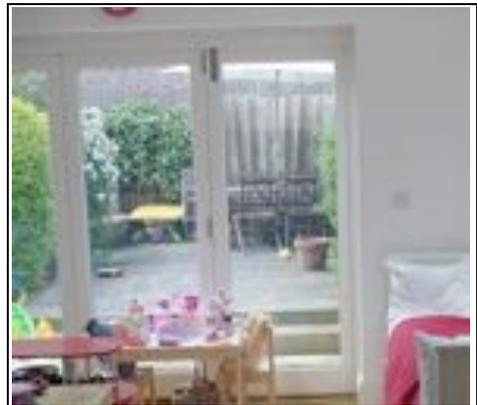
To the rear of the property is a large open plan area. We have found that whilst this type of design looks good it can be difficult to warm the area to the sort of temperature levels that we heat properties to today (this does of course vary from individual to individual). We particularly find that sliding folding doors can allow a lot of coldness in.

Sliding, folding doors

ACTION REQUIRED: The only way to find out if this is suitable for your requirements is to literally live in the property but do be aware that you may have to increase the number of radiators and/or buy thick thermal lined curtains for the sliding doors and/or thermal blinds for the roof windows.

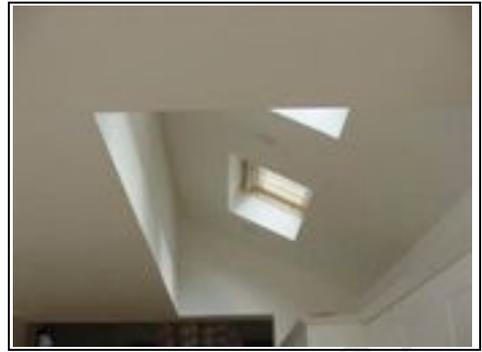
Roof windows may need thermal blinds

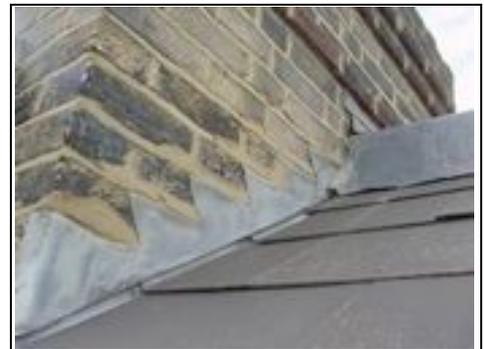
The chimney has been re-pointed in cement mortar

ACTION REQUIRED: Periodically inspect the chimney.

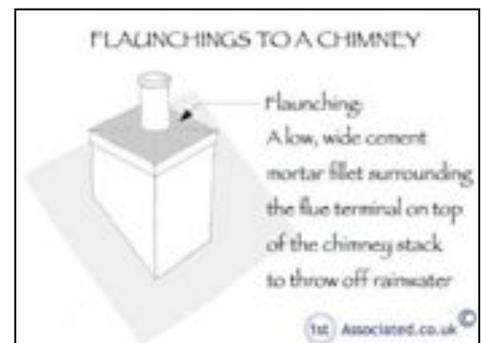
Flaunchings

Unfortunately we were unable to see the top of the chimney known as the flaunching, we therefore cannot comment upon this.

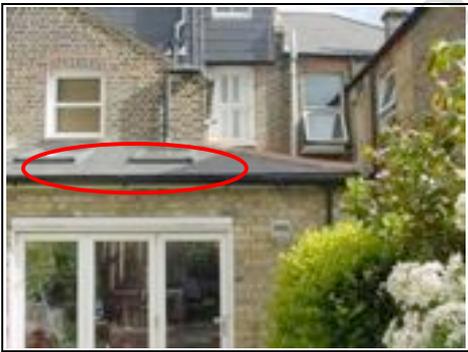
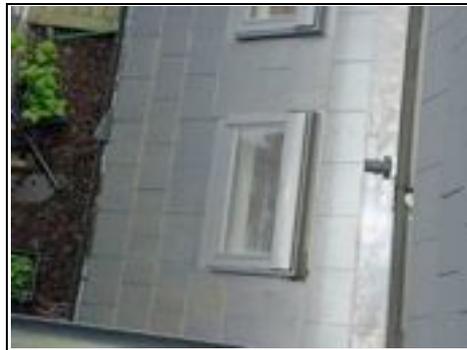
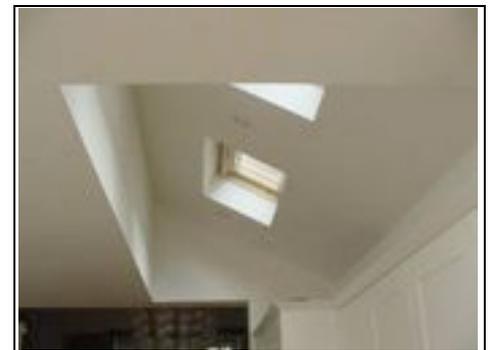
Roof windows to rear extension

Where roof windows are used in a kitchen we often find that condensation can occur during the winter months.

As a general comment it seems inevitable with roof windows that they will sooner or later leak. If this doesn't occur then they seem prone to condensation. Keep a cloth handy!

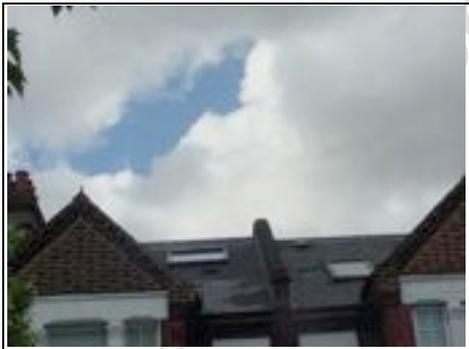
Pitched main roof

The front pitched roof is clad with manmade slates and, from ground level, this looks in below average condition considering the roofs age type and style.

ACTION REQUIRED: Please see our comments within the Executive Summary.

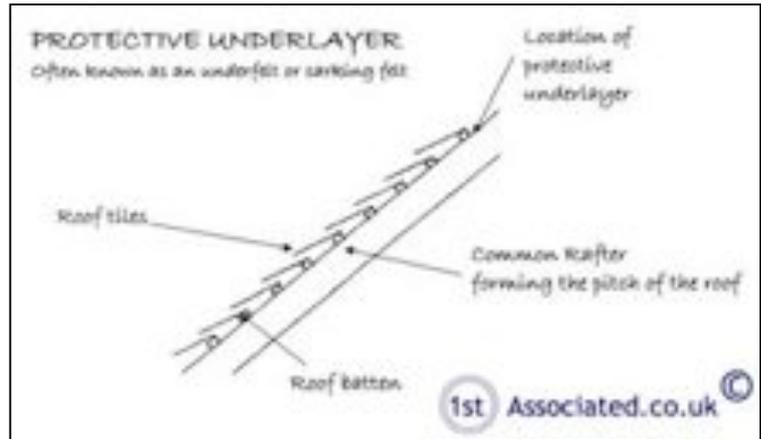
Protective underlayer

When we inspected the loft space we found a Hessian base Bitumen membrane. This type of membrane has been used since the 1960s. We generally found it to be in average condition, with damage in some areas which is what we typically find. To some extent we were surprised not to see a modern breathable underlayer.

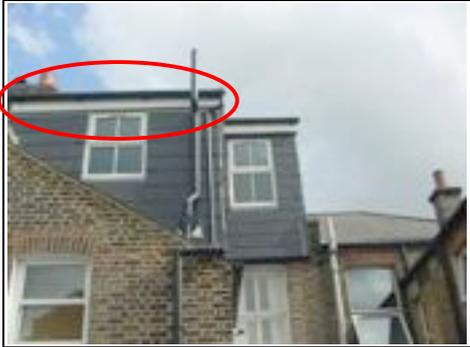
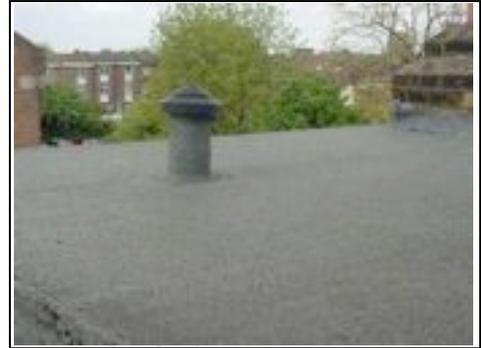
Rear flat roof

This is a very flat, Flat Roof. Please see our comments within the Executive Summary.

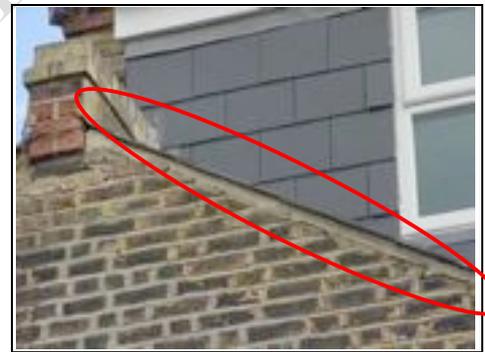
Rear pitched roof to gable wall

We were unable to see this roof properly.

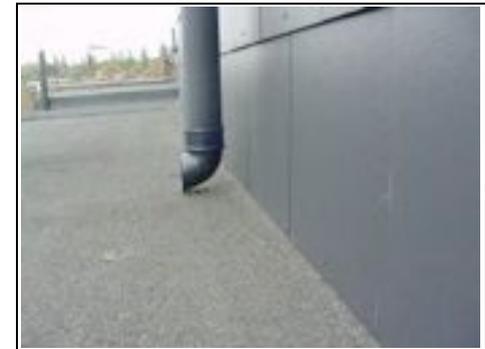
Downpipe discharges rainwater onto the flat roof. A slate should be placed under it.

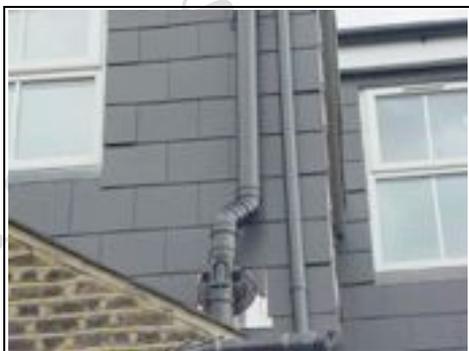
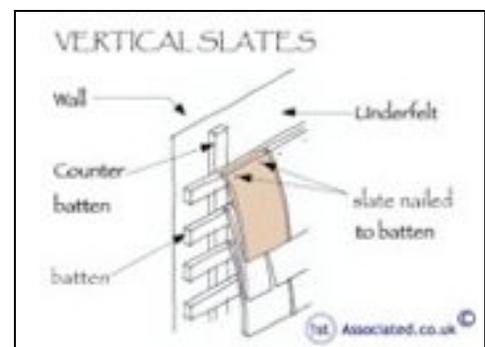
The walls of the rear roof extension are clad with manmade vertical slate. Please see our comments within the Executive Summary.

Vertical manmade slate

Vertical slates

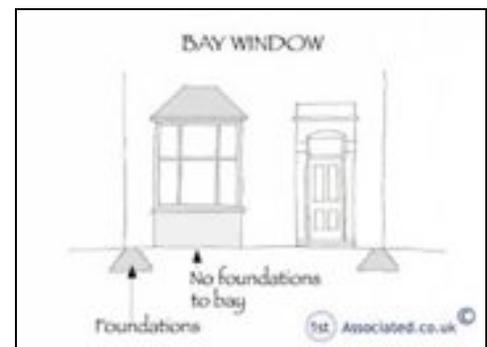
Bay windows in this era of property typically do not have foundations underneath them and have been subject to movement. We are aware that some insurance companies underpin bay windows with a modern foundation. We think this is excessive and unnecessary.

Bay window

ACTION REQUIRED: Please see our comments within the Executive Summary regarding movement.

ACTION REQUIRED: We would recommend that you speak to the Local Authority about the tree and ensure that it is maintained advising them about the problems to the bay window.

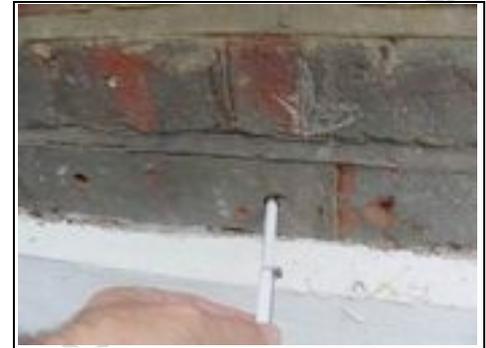
All modern properties should incorporate a damp proof course (DPC) and good building practice dictates that a differential of 150mm (6 inches) should be maintained between the damp proof course and ground levels. In this case, we can see liquid damp proof courses have been inserted.

Holes where DPC has been inserted

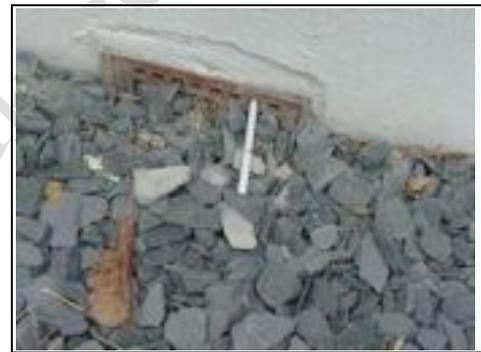
Air bricks to the front are too low acting as gutters

ACTION REQUIRED: Ensure the air bricks are clear and please see our comments within the Executive Summary.

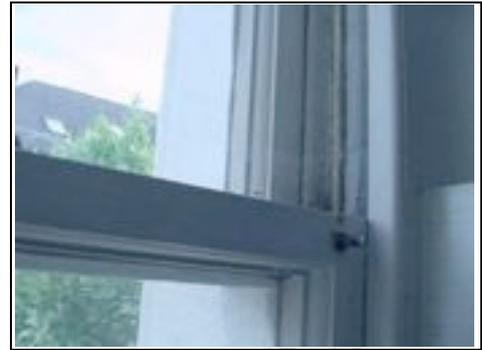
We would specifically comment we could not open the timber sliding sash windows. Please see our comments within the Executive Summary.

We could not open the timber sliding sash windows

The external decorations are in average condition. We would recommend redecoration to the sliding sash windows in the summer of 2014.

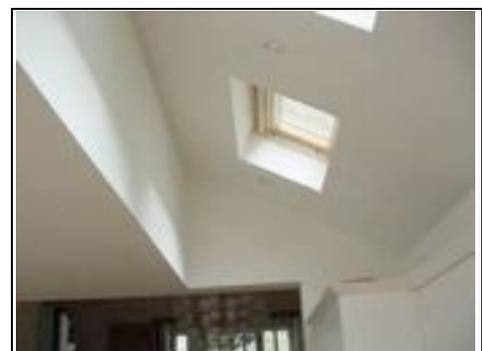
High ceiling in the kitchen area will make it difficult to heat this area

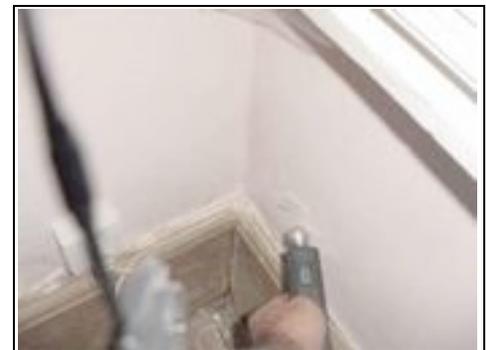
A random visual inspection and tests with a moisture meter have been taken to the perimeter walls. In this particular case we have found dampness.

Testing for rising damp

ACTION REQUIRED: Please see the Executive Summary regarding the high ground level and air bricks.

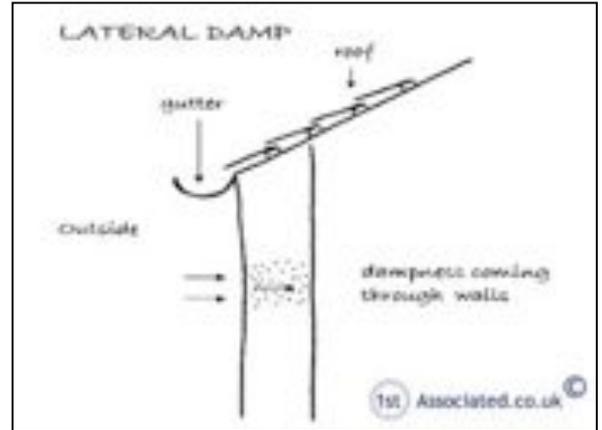
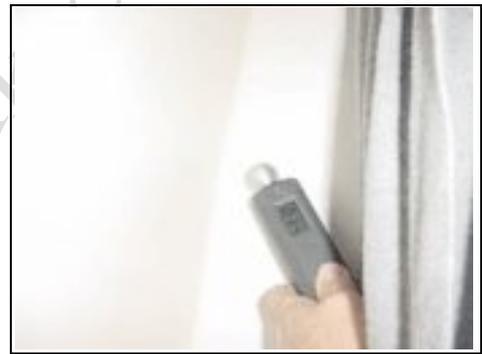
We used a damp meter on the external walls. We have found some lateral dampness that we believe relates to the climbing plant, the cement mortar re-pointing and the deteriorating re-pointing.

Lateral dampness

Testing for lateral dampness

ACTION REQUIRED: Please see our comments in the Executive Summary.

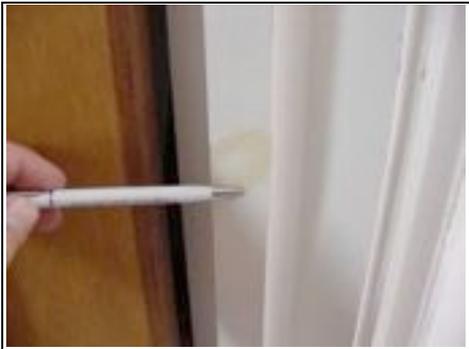
Knots grinning through to door frame in the second floor roof extension

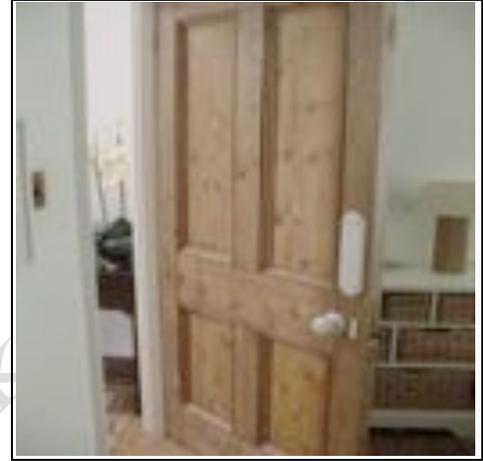
Stripped door

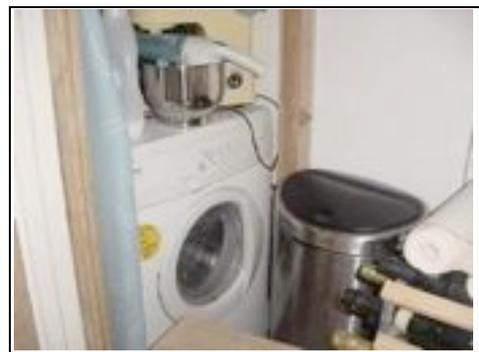
There is a storage area where the washing machine is hidden away.

Cupboard under the stairs hides the washing machine

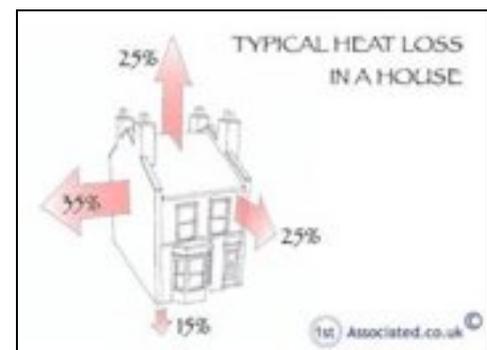
The walls to this property are solid in the sense that they do not have a cavity as a modern property would have. Also they are unlikely to have any substantial insulation. Unfortunately it is generally very difficult to improve the insulation without affecting the external or the internal appearance of the property.

Typical heat loss

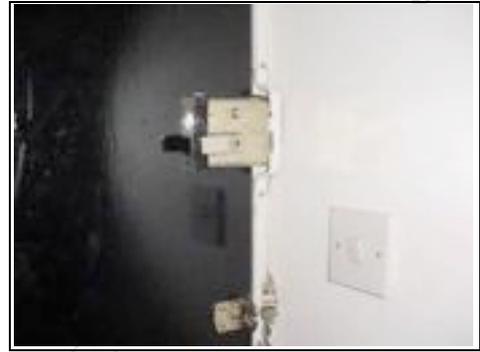
London bar lock

London bar lock on front door

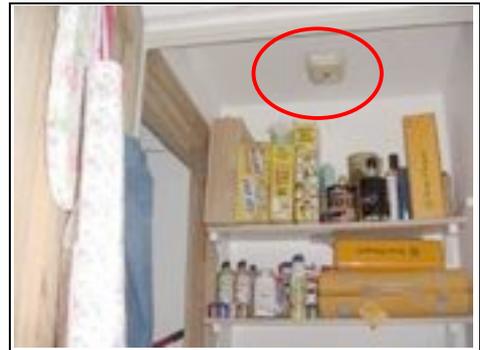
Some smoke detectors were noted. The current Building Regulations require that they be wired into the main power supply. Obviously in a property of this age this is difficult, as it would mean having surface mounted wires or cutting wiring into the plaster.

Smoke alarm

ACTION REQUIRED: We would recommend, for your own safety, that smoke detectors be installed. We would always recommend a hard wired fire alarm system and are also aware that some now work from a wireless signal which may be worth investigating. Whilst fire is relatively rare it is in a worst case scenario obviously devastating.

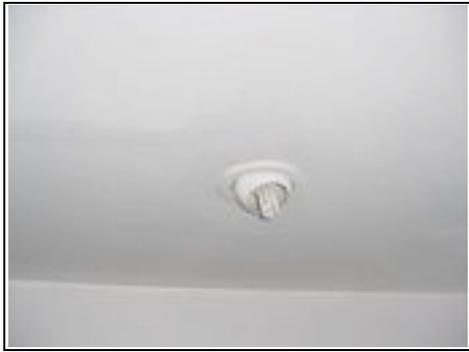
We noted 1970's ceiling lights in the bathroom on the first floor.

Older style ceiling lights, such as these, can cause problems as the heat given off has in some cases lead to outbreaks of fire as explained in the opposite sketch.

1970's ceiling lights

ACTION REQUIRED: As the property is changing occupancy an Institute of Electrical Engineers (IEE) test and report should be carried out by a NICEIC registered and approved electrical contractor or equivalent.

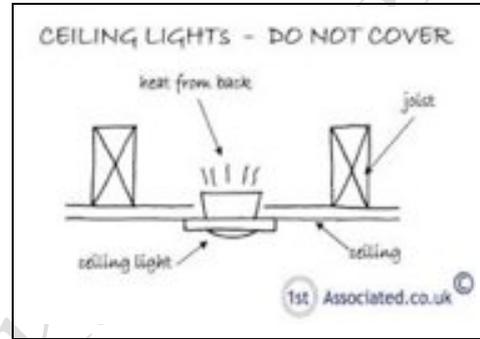
Ceiling lights

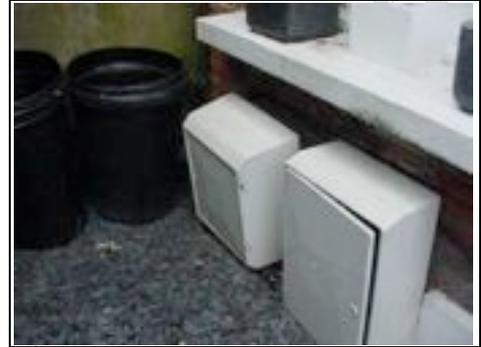
We are advised that the property has mains gas. The consumer unit is located to the front of the property under the bay window.

Gas and electric consumer unit to the front of the property

ACTION REQUIRED: As a matter of course it is recommended that the entire gas installation is inspected and made good, as necessary, by a Gas Safe registered contractor. Thereafter the installation should be serviced annually.

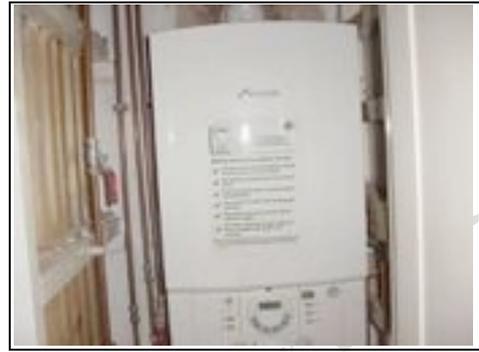
The wall mounted boiler was located in the first floor bathroom, it is manufactured by Worcester.

Worcester boiler in bathroom

Our limited inspection of the hot water and central heating system revealed no evidence to suggest any serious defects but we would nevertheless recommend that the system be tested and overhauled before exchange of contracts and that a regular maintenance contract be placed with an approved heating engineer.

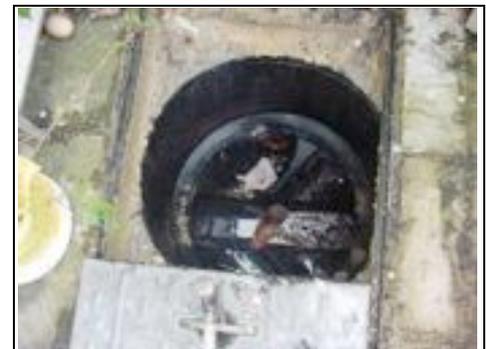
We duly lifted the cover and found it to be plastic built which is most unusual and indicated to us that work has been carried out on the drain.

Manhole-rear

We would recommend a closed circuit TV report is carried out. Please see our comments within the Executive Summary.
