RESIDENTIAL BUILDING SURVEY

London Borough of Ealing

Mr & Ms W

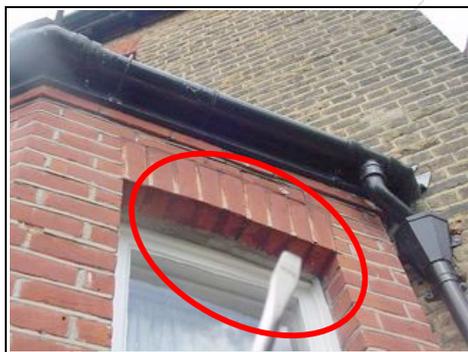
We found cracking to several areas; most notably the rear bay where we could also see a steel lintel has been added to the central window.

Soldier course above window has moved

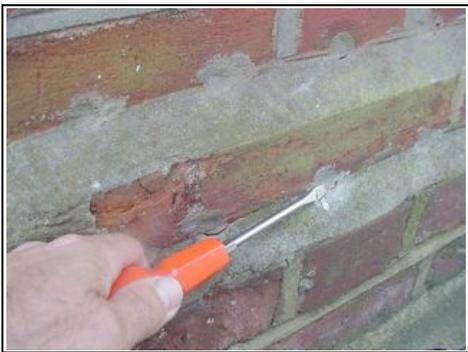
We found dampness internally. We can see that over the years they have tried to resolve the problem by injecting a damp proof course into the property. We don't feel this type of liquid injected damp proof course works on this type of older property. We feel the problem is likely to relate more to the cement mortar that is being used and the higher ground levels.

Two damp proof courses

ACTION REQUIRED: Reduce ground levels and use a soft brush to brush away the cement mortar and replace with a lime based mortar to allow the walls to breathe. The problem with the high ground is particularly to the rear of the property.

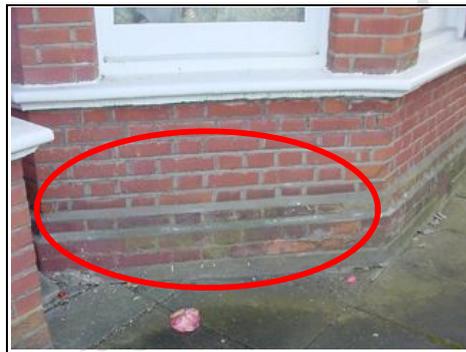
DPC to older part of property.
Thickening of brickwork indicates slate dpc originally

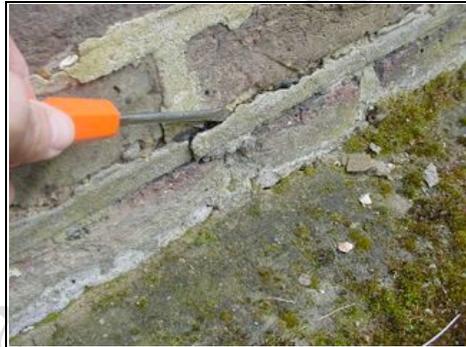
Cement mortar coming away

ACTION REQUIRED: We would recommend that a time served older bricklayer is employed to gradually repoint your apartment and the property as a whole in a lime mortar which will allow the building to breathe.

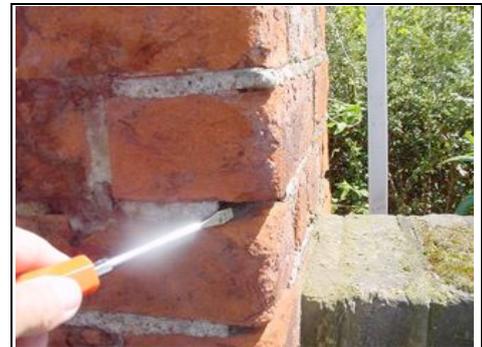
Weathered pointing

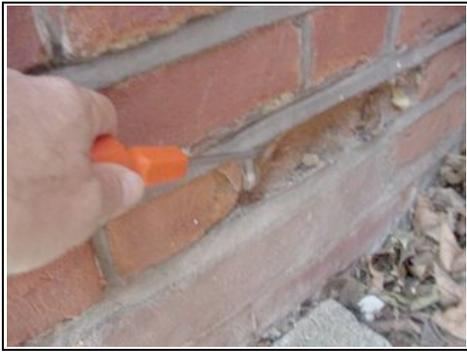
Spalling of brickwork caused by cement mortar

The use of cement mortar causes deterioration to brickwork and does lead to the face of the bricks deteriorating, which in turn leads to dampness. This is a very important point.

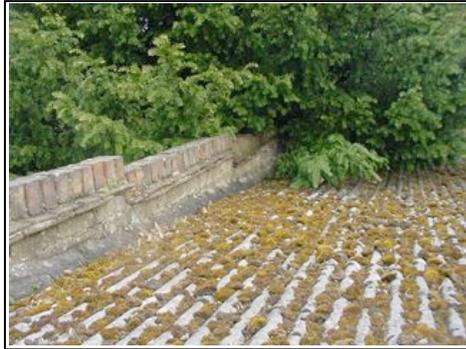
An asbestos roof was found to the garage block, including your garage, which is starting to deteriorate.

Deterioration to your asbestos garage roof

ACTION REQUIRED: We would recommend that your solicitor talks to the landlord/management company to see if they have an asbestos report and if they have a plan already in place and if they have a sinking fund/planned maintenance budget for this type of work.

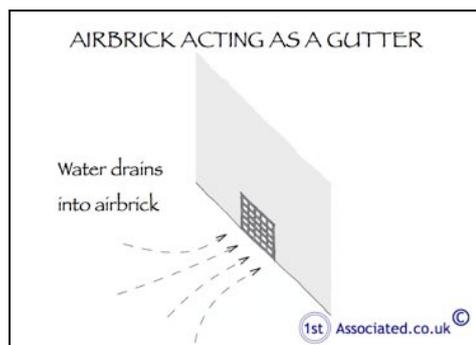
The property has a suspended timber floor. We can see that due to the high ground level mentioned earlier in this report the airbricks are at ground level and acting as gutters.

Airbrick acting as gutters

ACTION REQUIRED: This needs to be amended as soon as possible to stop the rainwater getting in and in addition to this you need to open up a section of the floor and check the condition of the timbers particularly around the perimeter of the building/the bay window areas.

ANTICIPATED COST: Reducing the ground level around the building will effectively also stop the airbricks acting as gutters so this cost has been included. To open up and check the timber floor in the region of £100 - £200; please obtain quotations.

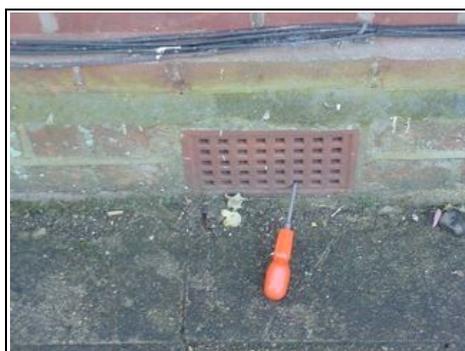
Airbrick acting as a gutter

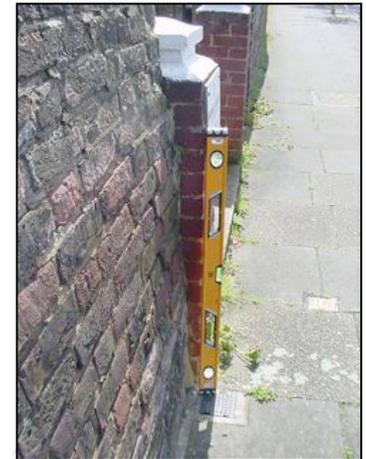
As I am sure you have noticed the boundary wall is leaning and has also had a general lack of maintenance. The right hand boundary wall (all directions given as you face the front of the property) leans over considerably mainly inwards. If it falls over it will be your responsibility or a shared responsibility.

Level shows how far out boundary wall is

ACTION REQUIRED: Your solicitor needs to establish who owns this boundary wall and who has the liability for it or shared liability; if it is a shared liability they need to establish if there is a sinking fund/planned maintenance fund.

ANTICIPATED COST: To rebuild the wall we would expect costs to be in the region of £1,000 plus. You may be able to rebuild it in sections over time; please obtain quotations.

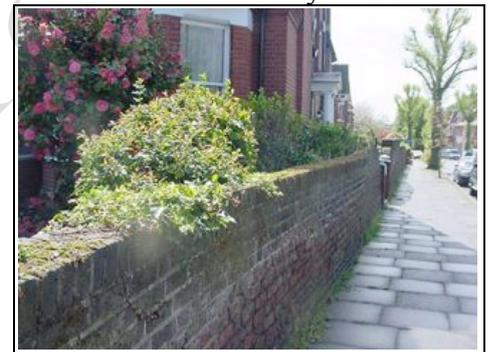
Kink and twist in boundary wall

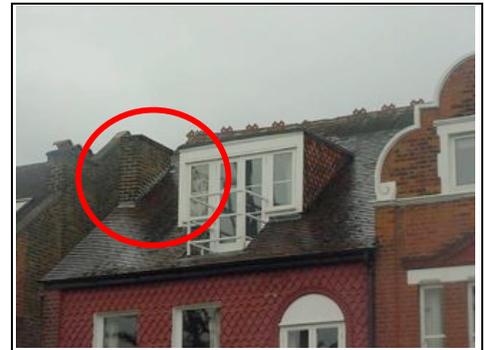
Chimney one

This chimney is brick finished with a lead flashing. Although it is difficult to view from ground level it does look to be in a different brick to the main property.

ACTION REQUIRED: Periodically inspect the chimney.

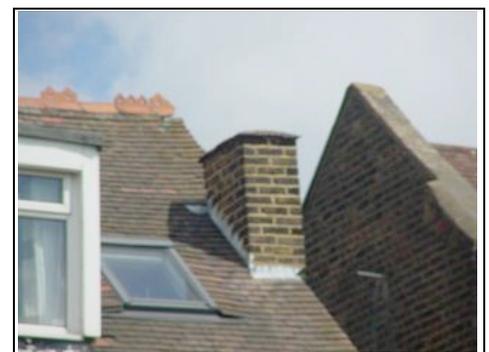
Chimney three

This is a small brick chimney with a lead flashing. The chimney looks to have been capped and to be in a stronger brick than the soft red brick.

ACTION REQUIRED: Periodically inspect the chimney.

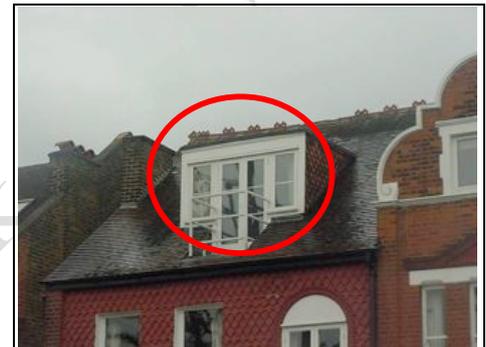
There are a number of dormer windows to the front and rear of the property to the other apartments. Our first comment would be that the dormer roofs have flat roofs and are not visible. The sides/cheeks look to be in a vertical tile.

Our main concern would be the flat roofs that we have not seen and these again should be part of a sinking fund/planned maintenance schedule. We would be happy to prepare a schedule if agreement is gained with all the other parties in the apartments if one doesn't already exist.

Dormer window to front

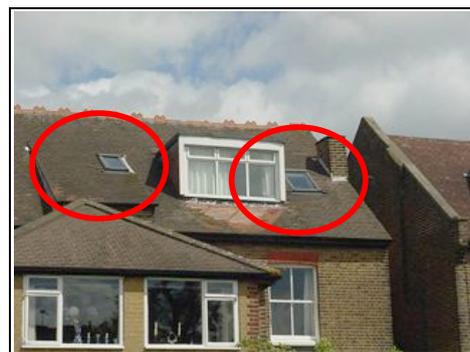
Roof windows to rear

There are two roof windows to the rear of the property indicating there are rooms in the roofs (as does the dormer windows). It really was too difficult to check their condition from ground level. Again we are sorry if we are repeating ourselves, but this should be included within a sinking fund/planned maintenance.

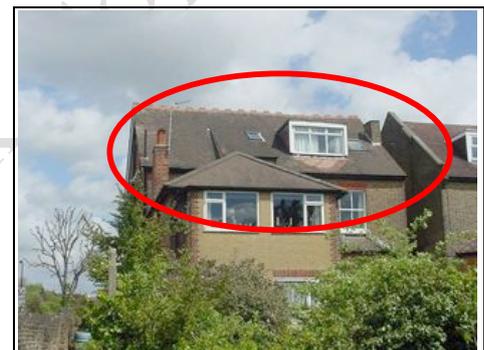
The main roof is pitched and clad with a small clay tile and, from ground level, this looks in below average condition considering the roofs age type and style.

With this age of roof there will usually be a few missing or displaced tiles, this is nothing unusual. Work looks to be needed to the perimeter where the wind catches the tiles

You will have a shared liability for all roofs

This is why it is important to understand how reactive maintenance such as this is carried out particularly at high level where scaffolding can be expensive. As we have mentioned many times some sort of overhaul or general work to the roof should be included in the sinking fund/planned maintenance.

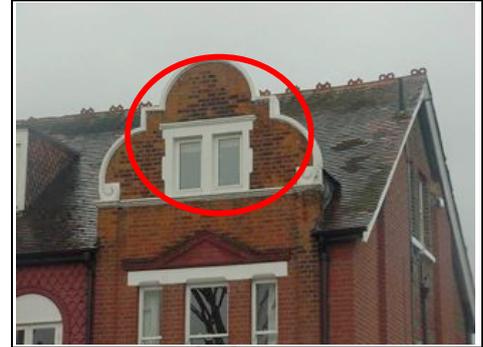
Dutch gable

We noted that the property has a Dutch gable. These are often used in properties with an 'arts and crafts' influence. There can often be problems with the detailing to the rear of the Dutch gable. Again this should be related back to an overall survey of the property and sinking fund/planned maintenance.

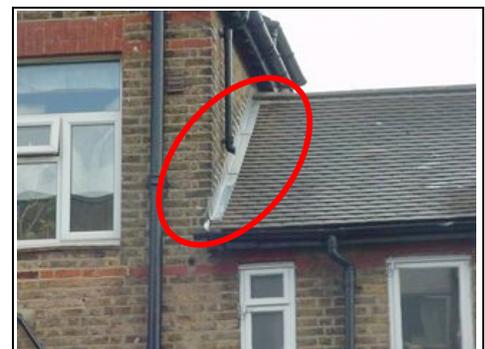
This is also a tiled roof, we were pleased to see that there was a flashing between this and the main building. It was difficult to view the roof properly but what we could see was in average condition. We would expect some tiles to be displaced from time to time.

Lead flashing between main building and rear extension 40

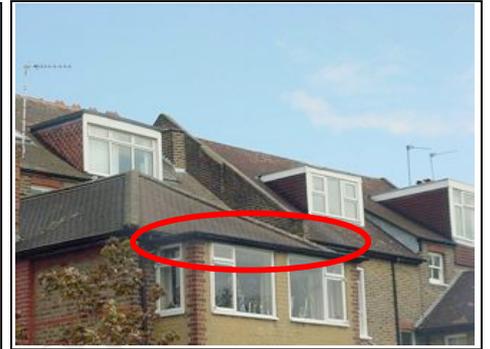
We noted there was a flat roof over the bay window. Again we could not see this as unfortunately we haven't been able to gain access to the apartment to check.

Hipped roof and flat roof (circled to rear bay) to extension

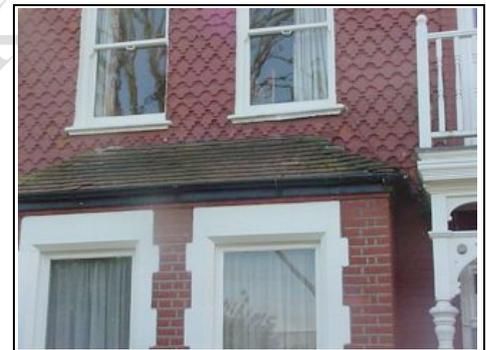
Front left bay roof

There was a small pitched tiled roof to the front of the property. There were no obvious signs of water damage or deterioration getting in internally.

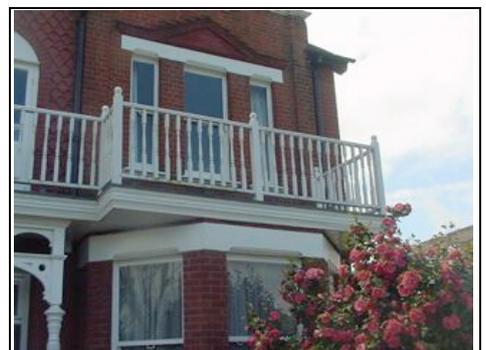
There were no obvious visual signs of dampness getting in internally. We have found problems where there are balconies due to the obvious flat construction and water can sit on them and get into the bay windows. As mentioned we couldn't see any physical signs.

Balcony/flat roof above front right bay

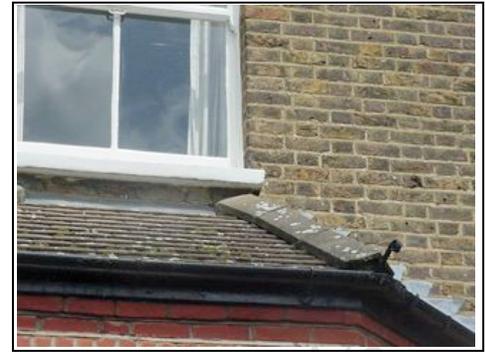
Rear bay window roof

This is a tiled bay window with a lead flashing which we were pleased to see. As you may already be aware there has been movement in this rear bay which can of course cause problems with the roof itself.

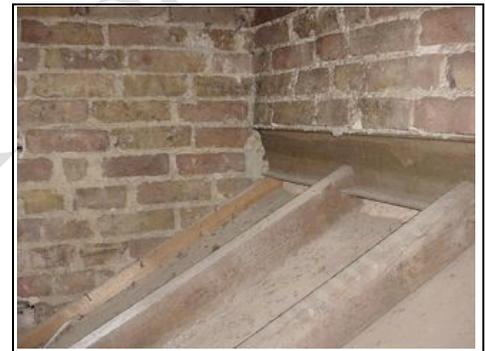
Metal lintel that would have been put in when refurbished

The roof area to the ground floor is accessed via the loft hatch located in the kitchen. There is no loft ladder, electric light or secured floorboards. We recommend that these be added, as it will make the loft space safer and easier to use. Great care should be taken when going into the roof space. The loft has been viewed by torch light, which has limited our viewing slightly.

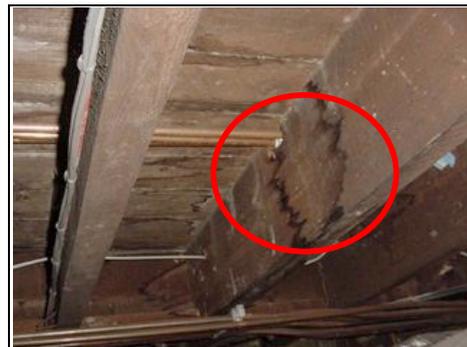
Leak from above or condensation from the pipes

Our examination was limited and please do remember this is the floor of the flat above as opposed to a roof however we did want to advise that a leak was visible and also part of the roof did look like it has had some minor woodworm.

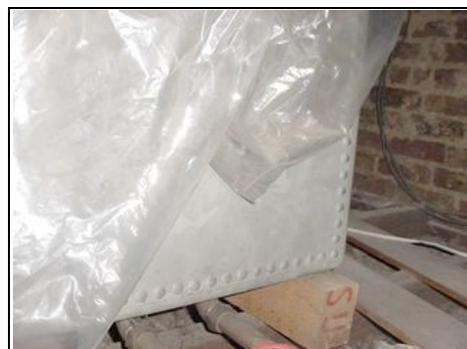
There is an old galvanised water tank which unfortunately we haven't been able to establish whether it is still in use or not. Mostly galvanised water tanks have been replaced with plastic due to them rusting, etc. We would recommend that replacement is budgeted for.

What we believe to be old water tank

ACTION REQUIRED: Replace existing water tank with a plastic water tank.

ANTICIPATED COST: In the region of £500 to £1,000. We would always recommend having a water tank in a property as it does give an emergency supply of water should there be problems with the water system. Quotations required.

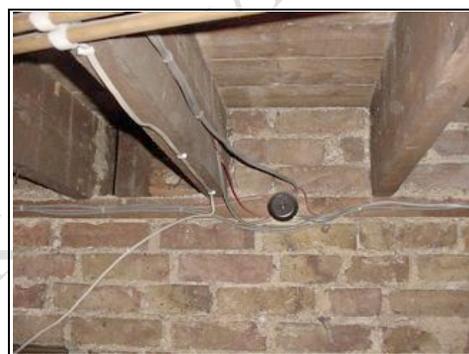
We can often identify the age of an electrical installation by the age of wiring found in the roof. In this case they were dated.

Dated electrics

ACTION REQUIRED: Please see our comments in the Executive Summary.

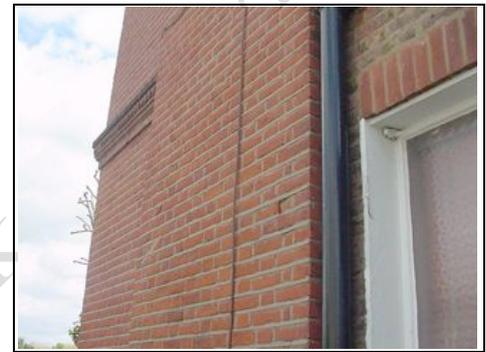
Downpipe

The property has a mixture of the original cast iron and in some areas modern plastic gutters and downpipes. We didn't have the benefit of viewing the property when it was raining so we are unable to comment any further. We would say that what we could see looked to be in average condition for their age, type and style. Cast iron of this age will need maintenance. If regularly maintained it lasts longer than plastic, in our experience.

There may be some minor leaks but most people would be happy to live with these providing repairs are carried out within the next six to twelve months.

ACTION REQUIRED: We would always recommend you stand outside the property next time it rains heavily and see how well the drains cope with the rainwater particularly looking at the guttering and the joints.

We would also recommend that the gutters and downpipes are cleaned out, the joints are checked and the alignment checked to ensure that the gutters fall towards the downpipes.

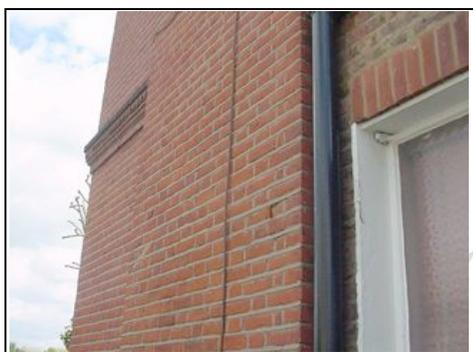
The property is built in a brick originally in a lime mortar in what is known as Flemish bond brickwork wrongly repointed in a cement mortar.

Soft red brick

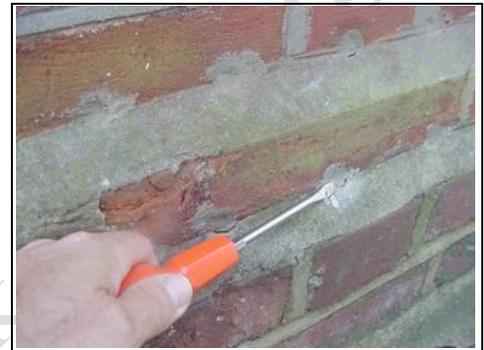
All modern properties should incorporate a damp proof course (DPC) and good building practice dictates that a differential of 150mm (6 inches) should be maintained between the damp proof course and ground levels. In this case, we are advised that there have been two damp proof courses injected (proof if there was ever one needed that they don't work). Ironically the thickening of the wall normally means it is likely to have a slate damp proof course so in theory it now has three damp proof courses. We believe the problem relates more to the cement mortar which is being used and the high ground levels.

Damp proofing injected twice

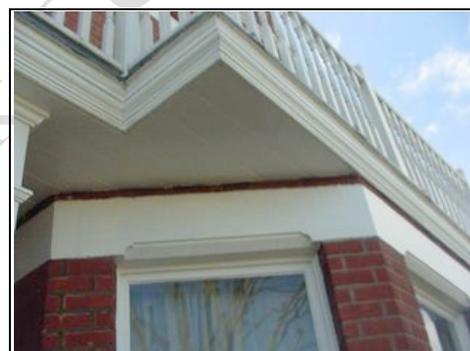
It is very difficult to see the high level fascias and soffits however we can actually see the fascias and soffits just above the front right hand bay window which look in average condition.

Fascias and soffit

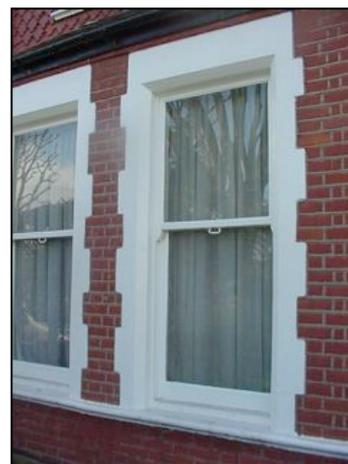
The property has single glazed timber sliding sash windows. We would specifically comment that there is slightly weathered paintwork; we would expect redecoration in the summer of 2014. This should be a shared cost and again should be something that forms part of the sinking fund/planned maintenance.

Sliding sash window

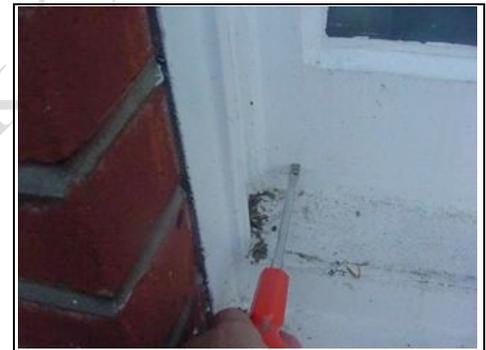
The windows were slightly soft in some areas when tested with a knife.

Knife test carried out with screwdriver!

ACTION REQUIRED: Please see our comments in the Executive Summary.

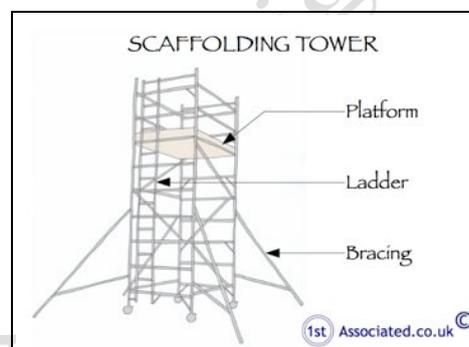
This would be a shared liability in a property such as this but very important. There is also likely to be a substantial cost due to the high level redecoration which is likely to need scaffolding. It could possibly be carried out off tower scaffolds.

Finally, ideally external redecoration is recommended every four to five years dependent upon the original age of the paint, its exposure to the elements and the materials properties. Where painting takes place outside this maintenance cycle repairs should be expected. Ideally redecoration should be carried out during the better weather between mid-April and mid-September.

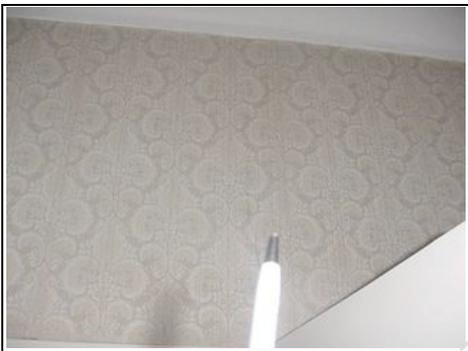
We did note some cracks in the walls which did indicate that there had been movement in the property. Movement in this age of property is not unusual and older type properties can cope with it. It is where there is a fundamental problem such as a leak to the drains where the property cannot cope or a new part of the property has been added.

Crack

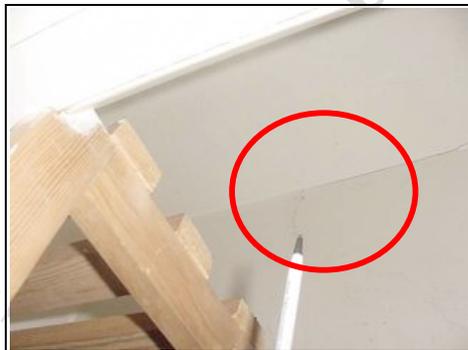
Crack in airing cupboard next to bathroom

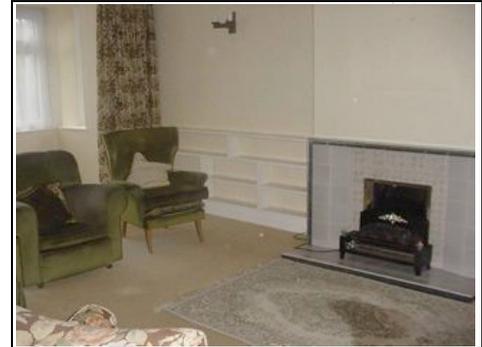
Fireplace

We could see a chimney breast to the right hand side which coincided with the chimney. We would have expected to see a chimney in the front left hand dining room and the front right hand bedroom as properties of this age would have had chimneys in every room. We believe the front right is an external chimney breast which may well have been covered up. We are not certain what has happened to the front left hand chimney breast. The only way to be certain is to follow them through the building by having access to the apartments above.

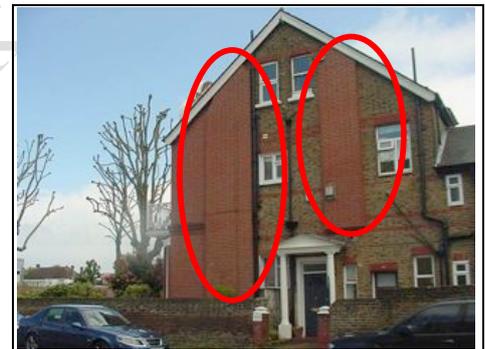
Where chimneys used to be

Finally, we will comment on the condition of the chimney breast where we can see the chimney breast. If we can see a chimney breast has been removed we will inspect for signs of movement and advise. However, often the chimney breasts are hidden so we cannot comment. Also additional support can be concealed very well when chimney breasts are hidden particularly when plastered over.

Your Legal Advisor needs to specifically check with the Local Authority for removed chimneys and associated chimney breasts and Building Regulations Approvals and advise by e-mail immediately if chimney breasts are found to have been removed. We would recommend opening up the structure to check the condition. If we are not advised we will assume the relevant Building Regulations Approval has been obtained.

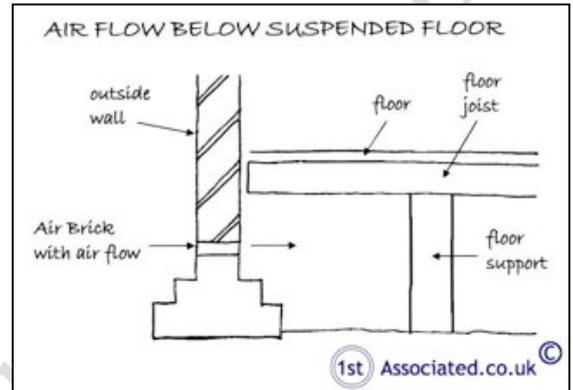
The floors of the property are suspended timber floors which require air movement underneath to minimise wet rot, dry rot and woodworm. Due to the dampness in the building there may well be a more than above average chance of having problems with the floor.

ACTION REQUIRED: Please see our comments in the Executive Summary. Air flow under a suspended timber floor

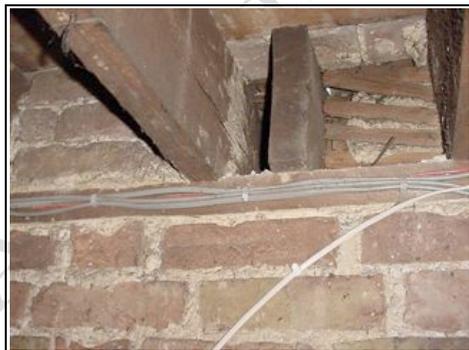
We could see embedded timbers to the first floor above within the roof space in the kitchen which is usual for this age of property.

Embedded timbers to first floor above

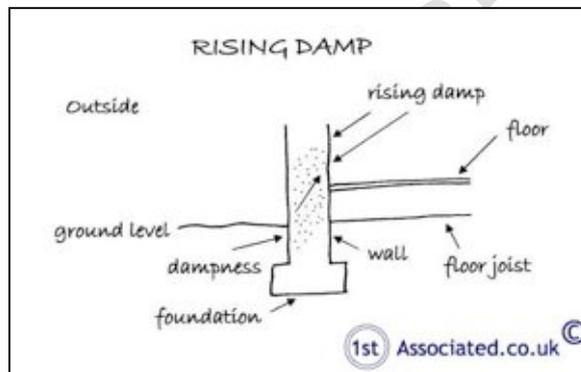
Rising damp

A random visual inspection and tests with a moisture meter have been taken to the perimeter walls. In this particular case we have found rising damp.

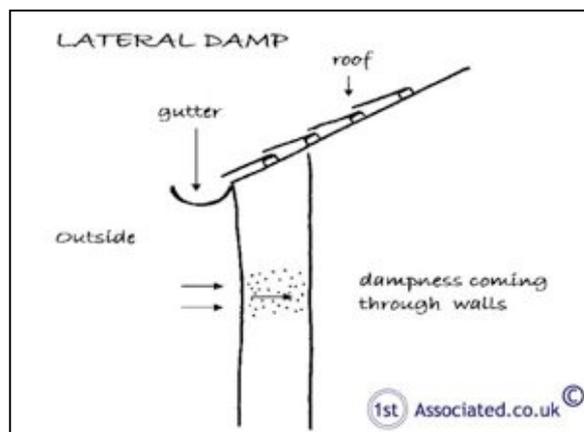
Lateral dampness

We used a damp meter on the external walls. We have not found lateral dampness which we were slightly surprised about.

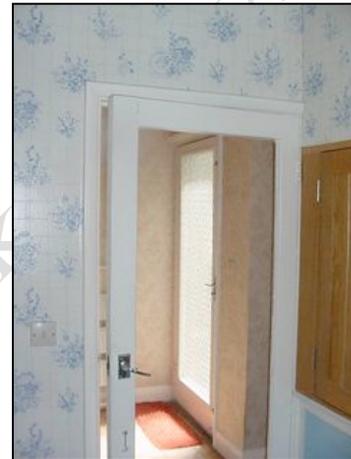
Glass removed from door

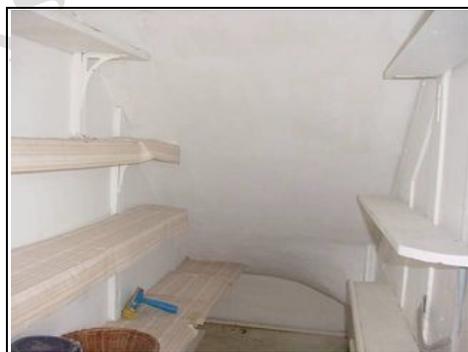
We could see that the underside of the staircase above you wasn't lined. It is normal today to have a half hour to one hour barrier to stop fire spreading from the ground floor to the first floor in a worse case scenario.

Under stairs from ground floor to first floor

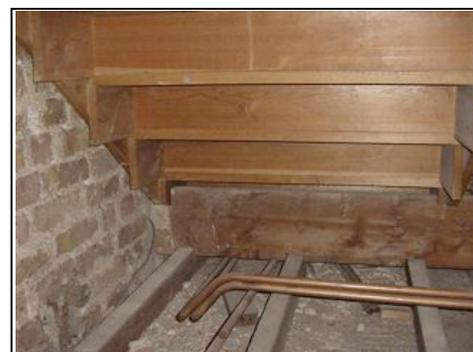
Unprotected staircase from first floor to second floor seen within roof above kitchen.

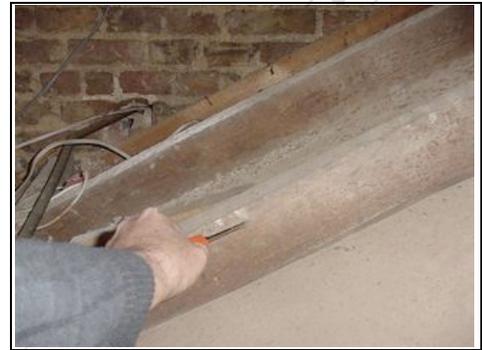
We found some minor woodworm within the roof void over the kitchen. We haven't been in the main roof which is where we would normally expect to find woodworm. Again it should be a sinking/maintenance fund issue.

Minor woodworm in roof above the kitchen

ACTION REQUIRED: If you wish to be 100 per cent certain that there is no woodworm the only way would be to check the main roof and under the floor.

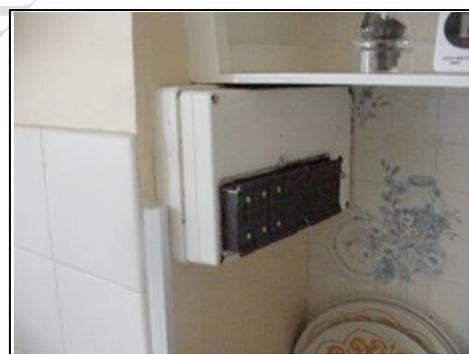
Fuse Board

The electric fuses and consumer units were located in the kitchen. The fuse board looked 1960's/1970's and better are now available. In multi occupied properties a defective fuse board can be particularly dangerous.

ACTION REQUIRED: Replace fuse board. As the property is changing occupancy an Institute of Electrical Engineers (IEE) test and

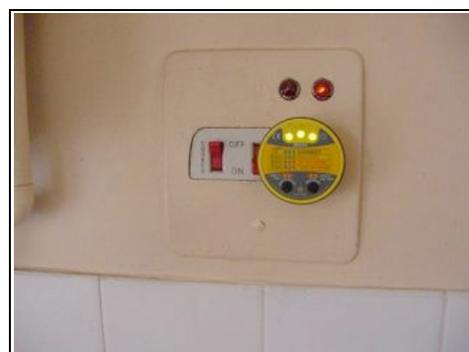
Earth Test

We carried out an earth test in the kitchen area to the socket point that is normally used for the kettle, this proved satisfactory.

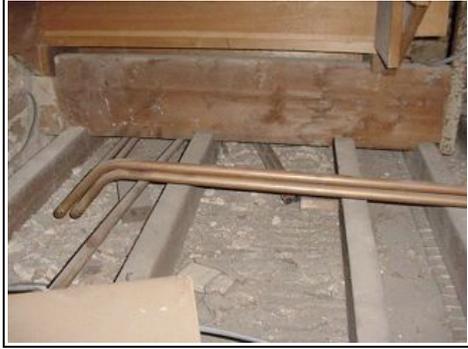
The plumbing, where visible, comprises copper piping. No significant leakage was noted on the surface, although most of the pipework is concealed in floors, walls and ducts. We did note copper piping within the roof space above the kitchen which was unsupported.

Unsupported copper pipes in
roof above kitchen

ACTION REQUIRED: We would recommend the unsupported copper pipes are supported.

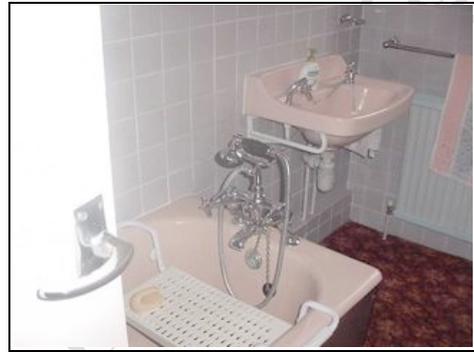
Bathroom

The property has a three piece bathroom suite, consisting of a bath, wash hand basin and WC which is dated and pink.

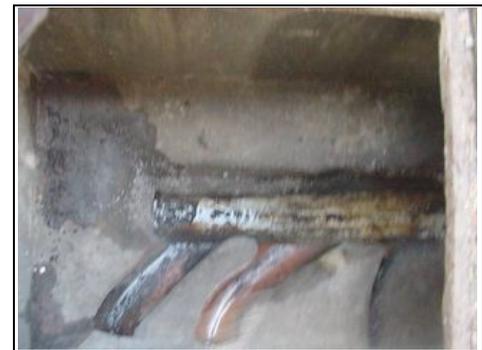
Manhole one

We duly lifted the cover and found it to be free flowing at the time of our inspection.

From what we could see it is brick built.

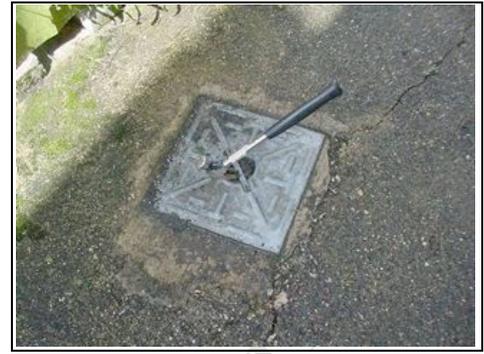
Manhole two

Unfortunately we were unable to lift this manhole without damaging it.

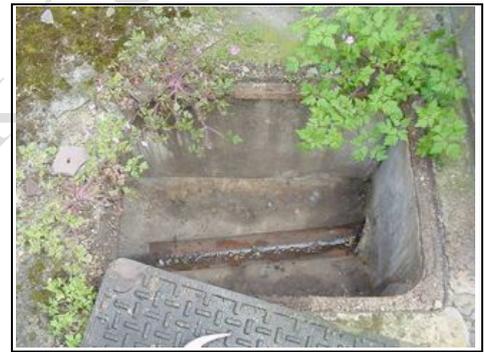
Manhole three

We duly lifted the cover and found it to be free flowing at the time of our inspection.

From what we could see it is brick built.

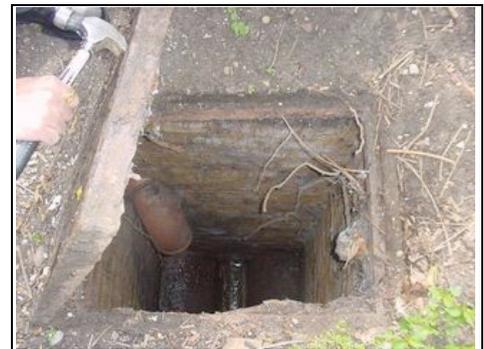
Manhole four

We duly lifted the cover and found it to be free flowing at the time of our inspection.

From what we could see it is brick built.

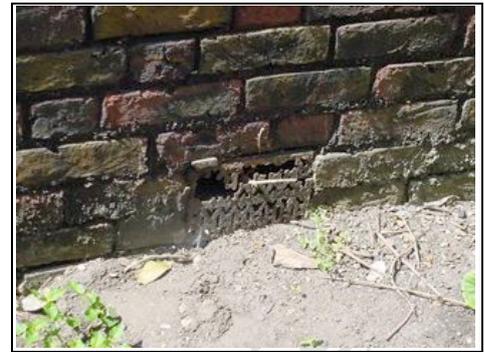
Vent in garden wall

We assume this is an old vent from a sewerage system. This is unusual but where we have seen such vents before it is from the drains below; there is a deep drain near it.

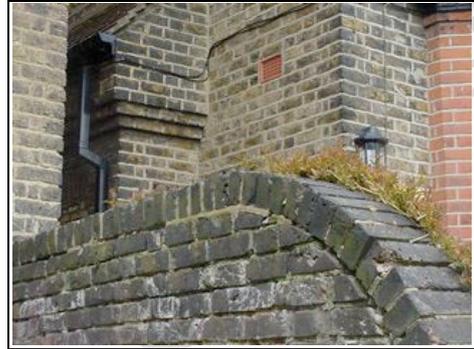
Plant life growing on wall and needs repointing

ACTION REQUIRED: Your legal Advisor needs to check and confirm.

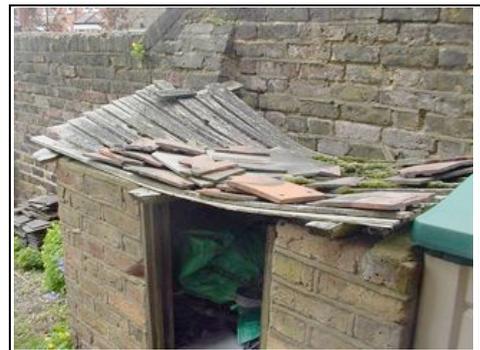
Old coal bunker

There is an old coal bunker to the right hand side of the property.

ACTION REQUIRED: Your legal Advisor needs to check and confirm with regards to who shares the cost of repair.
