JOB REFERENCE: JXXXX

RESIDENTIAL BUILDING SURVEY

XXX
London.
E11 XXX

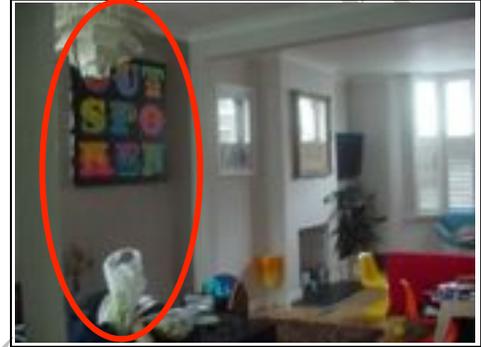
1.0) **Removed chimney**

The property has two chimneys, one to the front right hand side rear where there has been parts of the chimney removed. There should in theory be calculations in relation to this but very rarely do we find these have been carried out.

Chimney removed at ground level

ACTION REQUIRED: Your legal advisor to specifically ask if the chimneys have been removed with Building Regulations permission and if Party Wall Awards have been agreed. There can become problems where chimneys have been removed where next door want to remove their chimney as well.

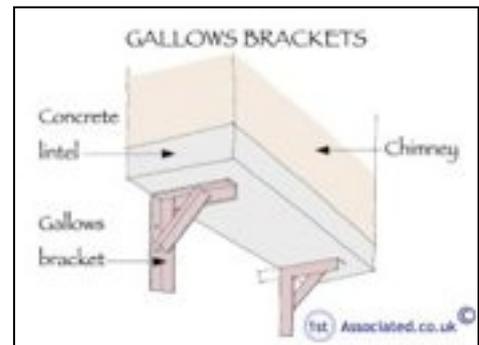
Sometimes gallow bracket supports are added. It seems to have stood the test of time with no obvious stress marks.

Gallows bracket

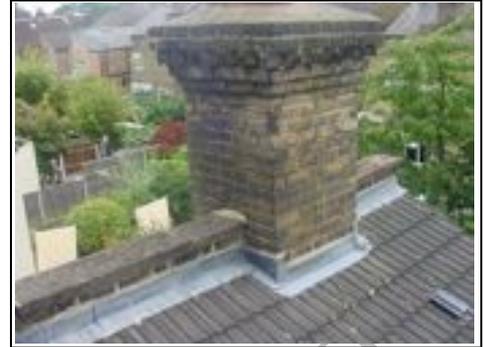
Repointing required to rear chimney

ACTION REQUIRED: Repoint and check flashings and flaunchings.

ANTICIPATED COST: £200 - £500 plus access which may require a tower scaffold; please obtain quotations.

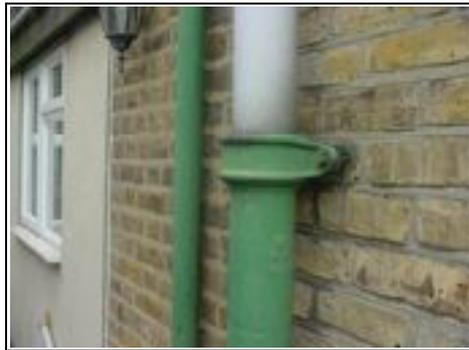
The gutters and downpipes and the soil and vent pipes are a mixture of the original metal and new plastic. We would have preferred to have seen all one or the other.

The metal rainwater pipes to the rear in particular would benefit from being improved.

Mixture of plastic (grey) and metal (green)

ACTION REQUIRED: General repairs recommended and perhaps replacement of the gutters and downpipes.

ANTICIPATED COST: £500 - £1,000 or if you wish to replace all the cast iron (which we would not recommend) we would expect another £1,000; please obtain quotations.

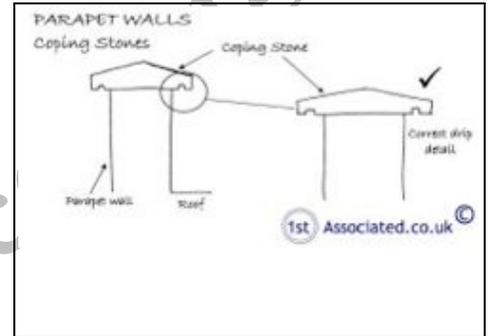
Coping stones

ACTION REQUIRED: Add mortar. At the same time check the other parapet wall and the rear parapet wall and chimney as it is in need of some repointing work.

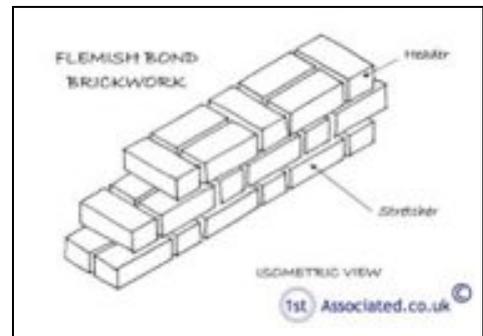
To the rear we can see that brickwork stitching has taken place which is unusual to see in this age, type and style of property. It typically indicates where rebuilding work has taken place.

Flemish bond brickwork

ACTION REQUIRED: Your legal advisor to specifically, in writing, ask the existing owners are they aware of any building work to the property. We would also recommend that you speak to insurance companies to check and confirm whether there have been any issues with this building.

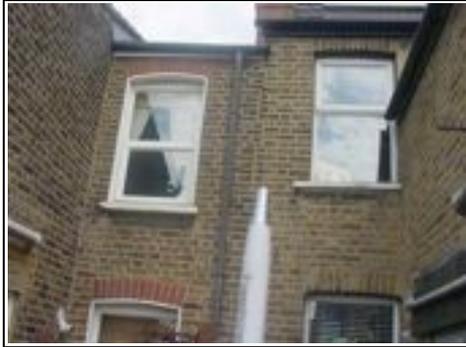
Flemish bond brickwork stitched together indicates some rebuilding has taken place

This, together with the unusual joint on the front bay window leads us to believe there may have been considerable rebuilding carried out on this property.

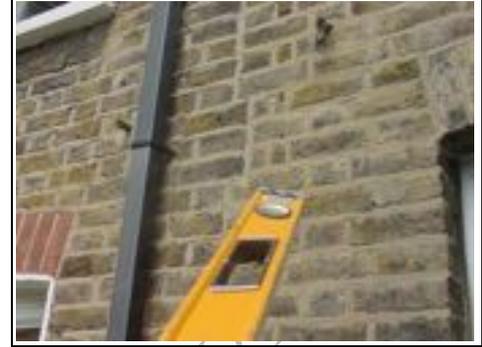
Stitching on brickwork

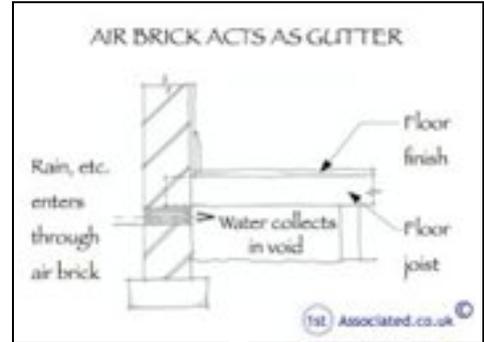
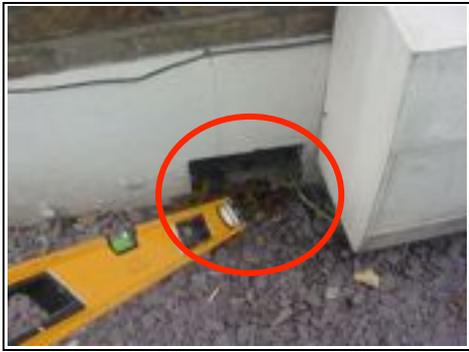
The airbricks which should ventilate the floor unfortunately are so low they are acting as gutters particularly to the rear of the property. This property has a suspended timber floor and does need an airflow underneath it and certainly doesn't need extra dampness coming into it from the airbricks acting as gutters.

Airbrick acting as gutter

ACTION REQUIRED: Protect airbricks.

ANTICIPATED COST: In the region of £500 - £2,000; quotations required.

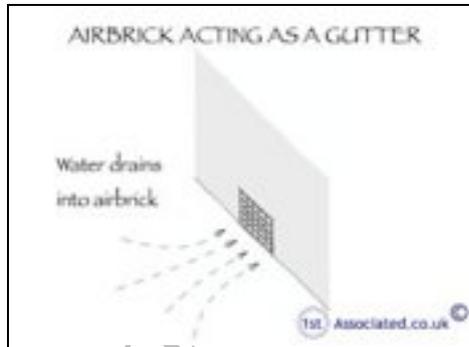
Airbrick acts as gutter

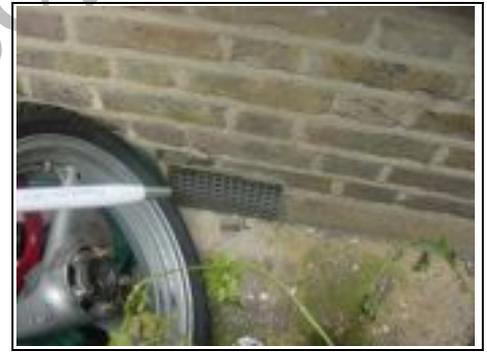
Airbrick acting as gutter

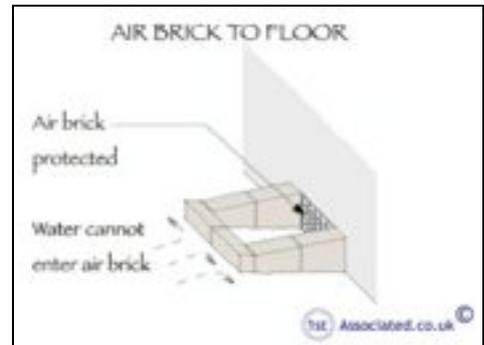
Protect airbrick

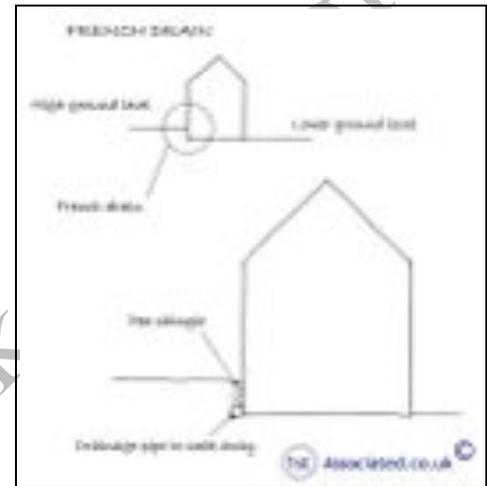
We were surprised that the property did not have rising damp due to the high ground levels which may be because of the dry weather, but we would also recommend the lowering of the ground level around the property.

ACTION REQUIRED: Lower ground level and add French drain.

ANTICIPATED COST: DIY type job or in the region of £500 - £1,500; quotations required

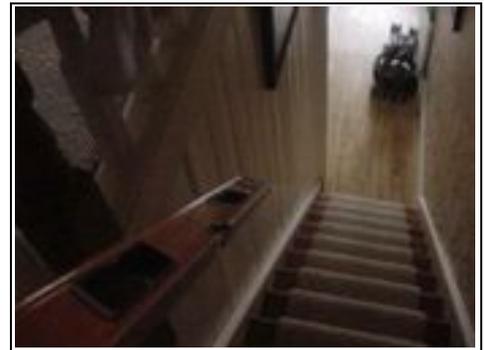
There is no handrail on the staircase from the ground to the first floor which is unusual and generally considered to building regulation requirements.

No handrail

ACTION REQUIRED: Add handrail.

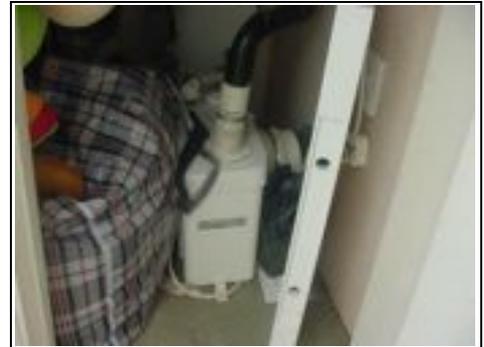
There is a macerator in the roof extension for the W.C. which is not ideal particularly due to the noise it makes; we know that some people are unhappy with these, but as far as we can see it is the best way to get waste material to the back of the property where the drains are.

Macerator

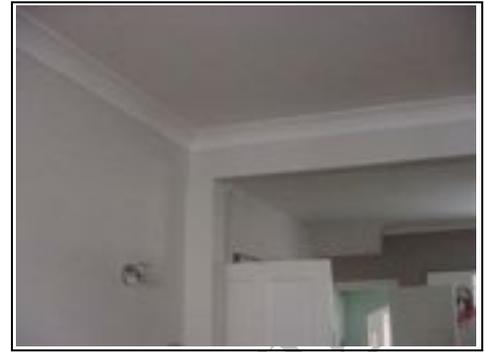
A wall in the lounge has been removed to make a through lounge. The return should be 450mm; it is nearer to 300mm.

Wall removed

ACTION REQUIRED: You need to be aware that this is unusual. It sometimes means that the upper floors deflect slightly more which you need to accept and consider this as a characteristic of the building.

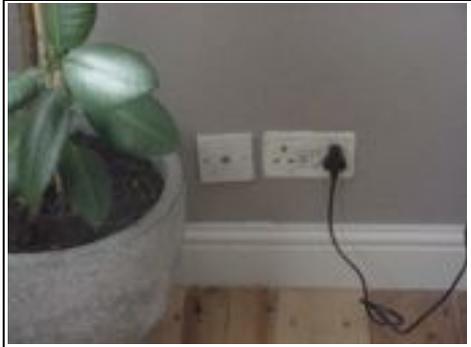
The property has dated socket points and a blanked off socket point within the bathroom which is not ideal.

Old socket points

ACTION REQUIRED: We would recommend you have an Institute of Electrical Engineers test and report carried out by an NICEIC approved electrician or equivalent.

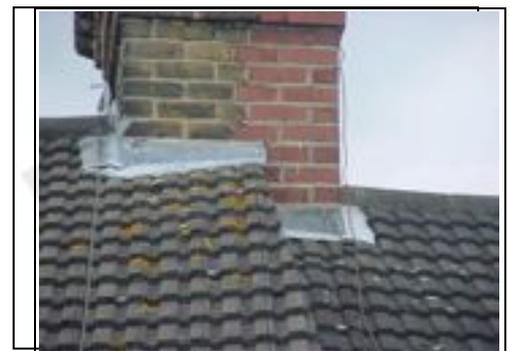
Lead flashing

This chimney is brick finished with a lead flashing and four chimney pots. From what we could see from ground level it looked in slightly below average condition considering its age, type and style with deteriorating chimney pots.

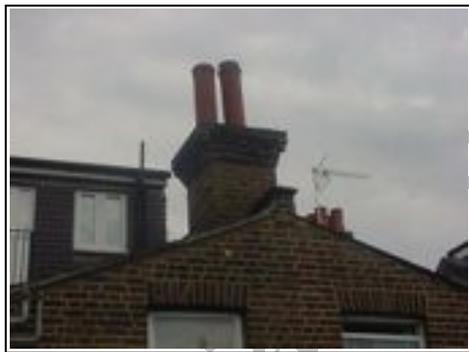
Rear chimney

This chimney is also brick built with a lead flashing. This chimney is in below average condition and in need of repointing.

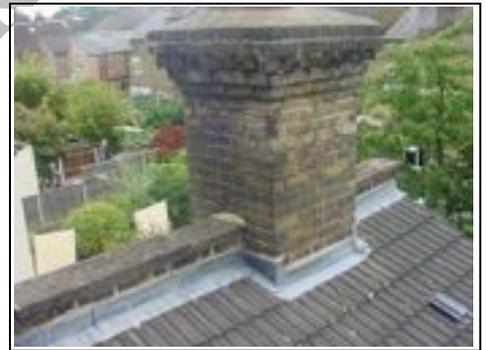
Repointing required to rear chimney

ACTION REQUIRED: Repoint, the difficulty is access. Please see our comments in the Executive Summary.

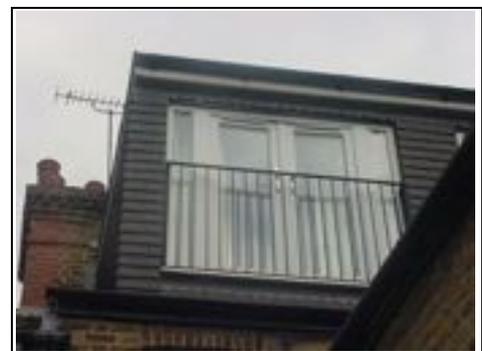
The property has a Juliet balcony to the loft conversion which is a good feature and also can cause planning problems with over viewing gardens.

ACTION REQUIRED: Your legal Advisor needs to check and confirm that permission has been obtained for the loft conversion.

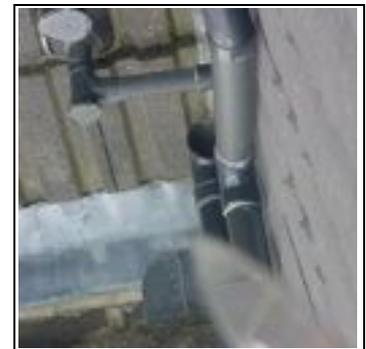
Main roof discharges onto rear roof in one area. There should be wider piece of lead flashing known as deflector

ACTION REQUIRED: Carry out periodic inspections and maintenance of the roof, as required.

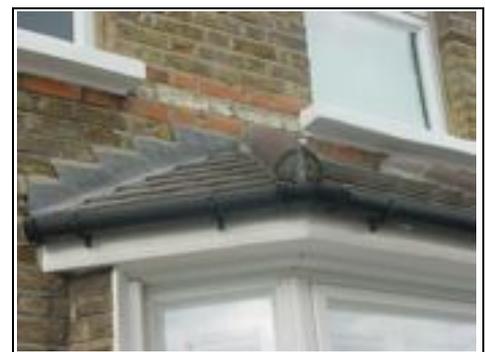
The roof has a more shallow pitch than we are keen on for concrete tiles and you can get some wind driven rain problems.

Concrete tile to bay window

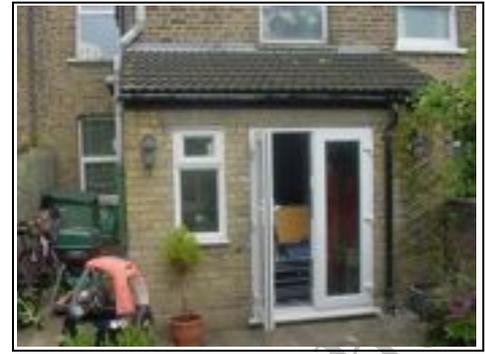
Rear single storey roof

The rear single storey roof is pitched with a concrete tile. As above, the roof has a shallow pitch.

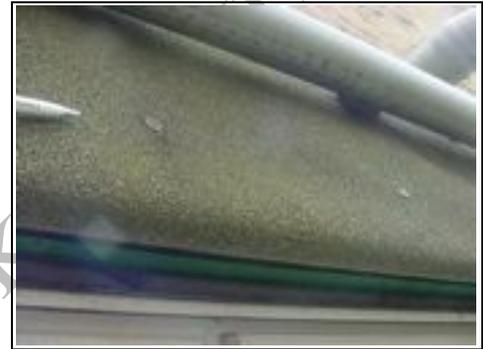
We believe there was previously a bay window to the rear of the property which has been removed and a felt detail nailed in place.

Felt return possibly to removed rear bay

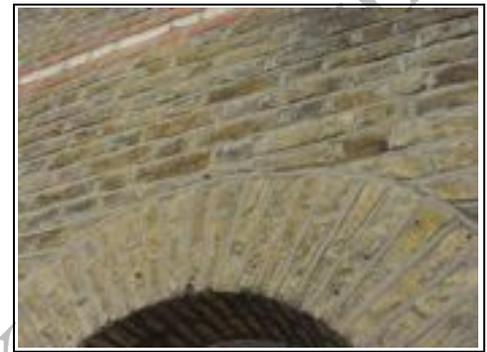
The property is built in a brick originally in a lime mortar in what is known as Flemish bond brickwork wrongly repointed in cement mortar which stops them from breathing.

Wrongly repointed in cement mortar

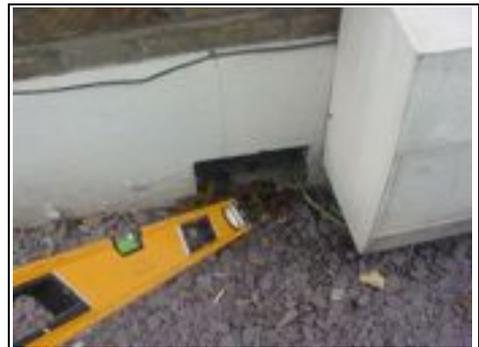
Air brick acting as gutter

ACTION REQUIRED: Please see our comments in the Executive Summary.

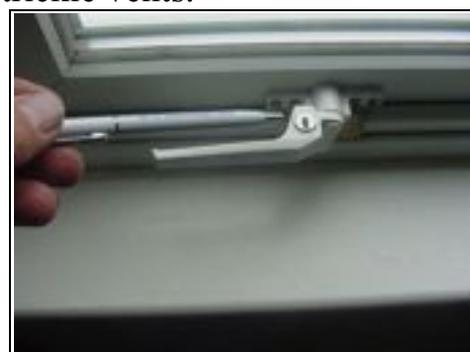
Could not open window due to locks

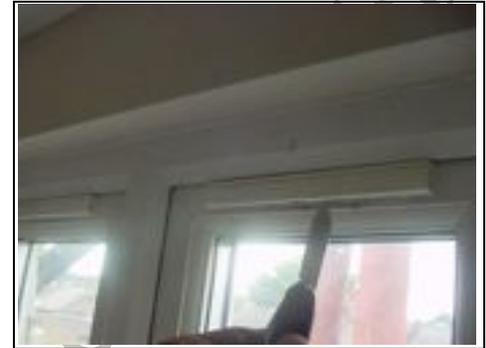
Trickle vent to top floor only

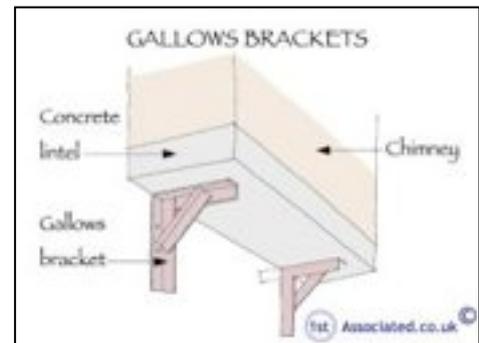
Gallows bracket

We note a chimney has been removed on the front right. Sometimes gallows bracket supports are added.

ACTION REQUIRED: Please see our comments in the Executive Summary.

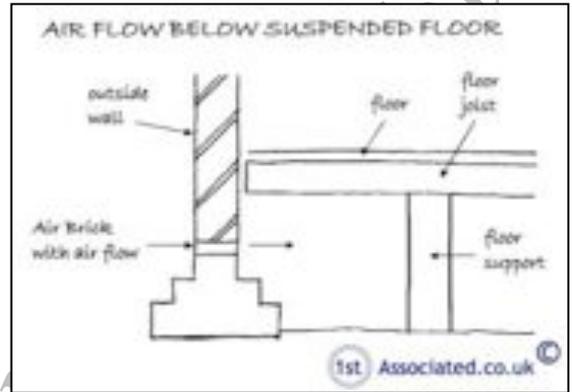
There is a mixture of a suspended timber floor to the front of the property, which require air movement underneath to minimise wet rot, dry rot and woodworm, and a solid floor to the rear.

Suspended timber floor

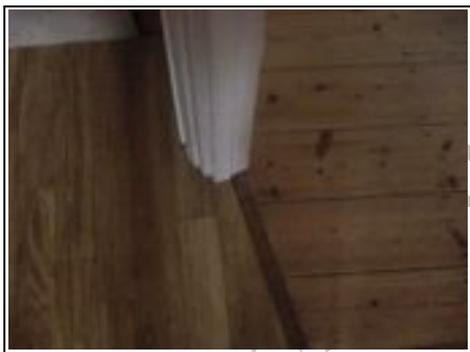
Original timbers sanded and polished

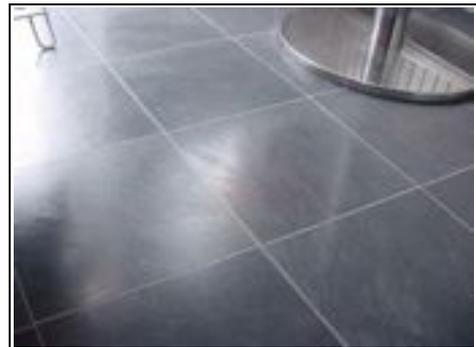
Laminate flooring over rear concrete floor

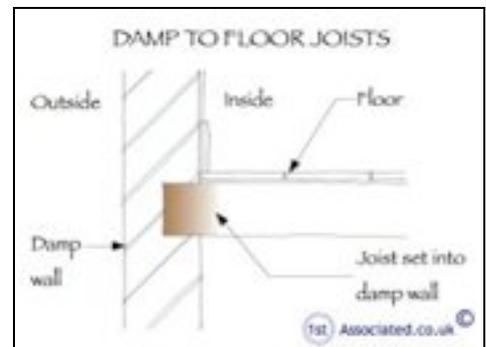
We have assumed that the first floor construction is joist and floorboards with embedded timbers, as this is typical in this age of property.

Embedded timbers

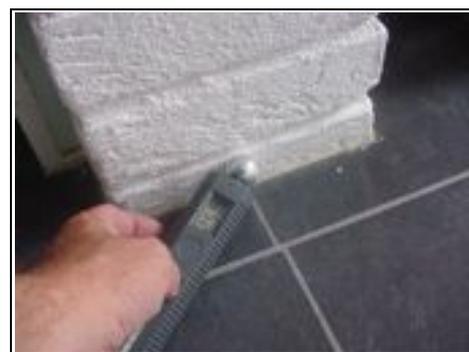
A random visual inspection and tests with a moisture meter have been taken to the perimeter walls. In this particular case we have found no significant rising damp.

Testing for rising damp

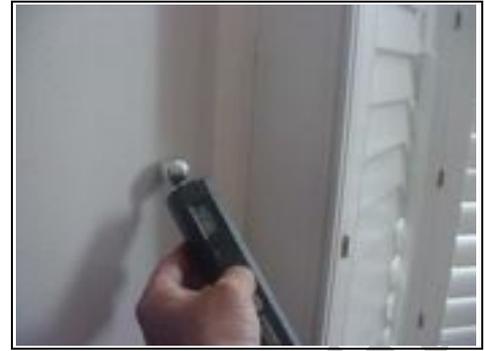
We used a resistance meter on the external walls. We have not found significant dampness.

Testing for lateral dampness

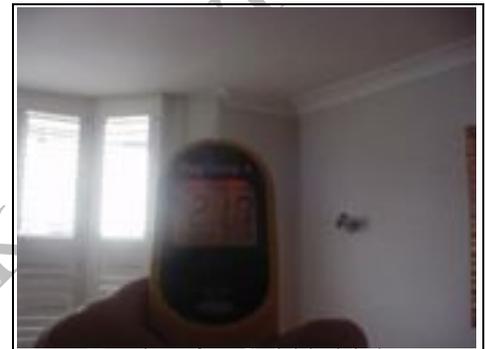
Cold bridging is a feature of this era of property particularly around the tops of windows. You need to ensure the property is kept well ventilated.

Testing for Cold bridging

ACTION REQUIRED: We would recommend large humidity controlled extract fans be added to kitchens, bathrooms and drying areas. Please see our comments in the Executive Summary.

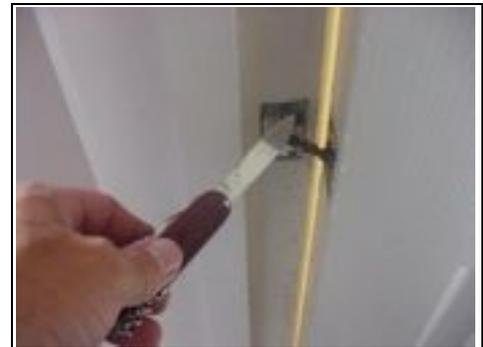
Some of the doors have central door closers known by their trade name of perco door closers.

Door closer

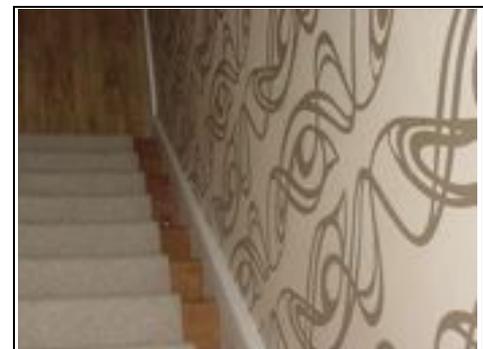
We were unable to examine the underside of the stair timbers due to it being lined at the bottom, which precluded our inspection, so we cannot comment further upon the stair structure.

No handrail to stairs

We noted that the underside of the staircase was exposed at the top. It is more normal today to have a half hour fire barrier to stop fire spreading from the ground floor to the first floor in a worse case scenario. You may wish to take a view on whether you add this.

ACTION REQUIRED: We would recommend the staircase is lined at the top. Please see our comments in the Executive Summary.

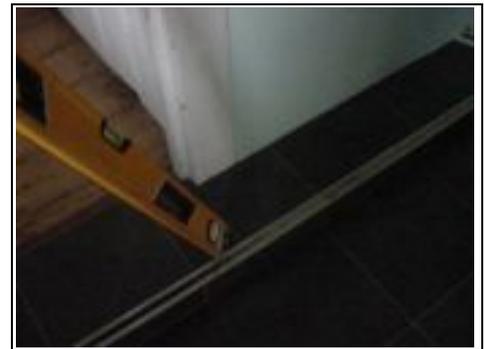
There are steps into and out of the kitchen.

Step down into kitchen

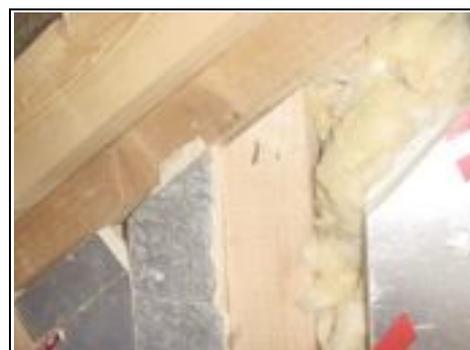
Some roof insulation was present although not to current Building Regulations requirements of 300mm. In this case we could not see the roof so can only take an educated guess that as it has insulation it has also been insulated. In the limited view of where we could see it we could see a small amount of foil backed insulation.

Foil backed insulation

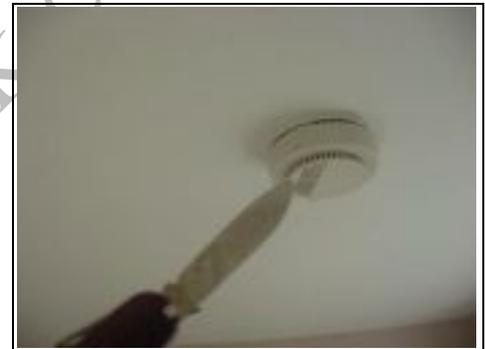
Some smoke detectors were noted. The current Building Regulations require that they be wired into the main power supply. Obviously in a property of this age this is difficult, as it would mean having surface mounted wires or cutting wiring into the plaster.

Smoke alarm

ACTION REQUIRED: We would recommend, for your own safety, that additional smoke detectors are installed. We would always recommend a hard wired fire alarm system and are also aware that some now work from a wireless signal which may be worth investigating. Whilst fire is relatively rare it is in a worst case scenario obviously devastating.

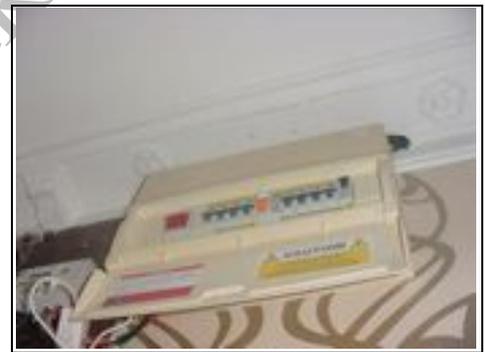
Fuse Board

The electric fuses and consumer units were located in the hallway to the left hand side. The fuse board looked 1980's/1990's and better are now available.

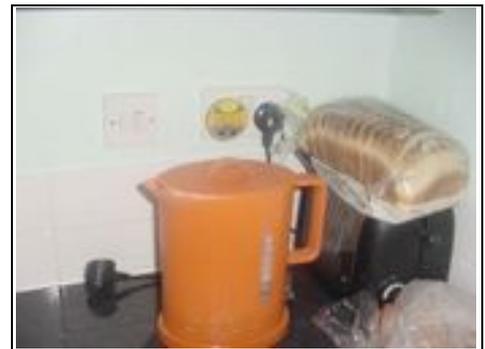
We carried out an earth test in the kitchen area to the socket point that is normally used for the kettle, this proved satisfactory.

Earth test

ACTION REQUIRED: As the property is changing occupancy an Institute of Electrical Engineers (IEE) test and report should be carried

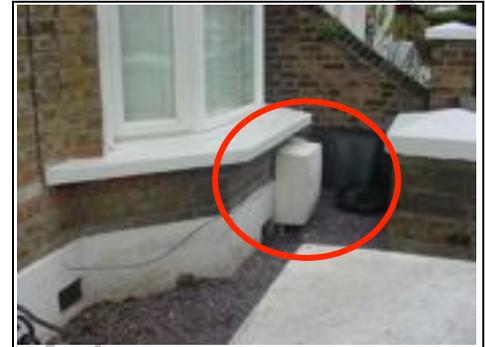
We are advised that the property has mains gas. The consumer unit is located to the front bay window.

Consumer unit

ACTION REQUIRED: As a matter of course it is recommended that the entire gas installation is inspected and made good, as necessary, by a Gas Safe registered contractor. Thereafter the installation should be serviced annually.

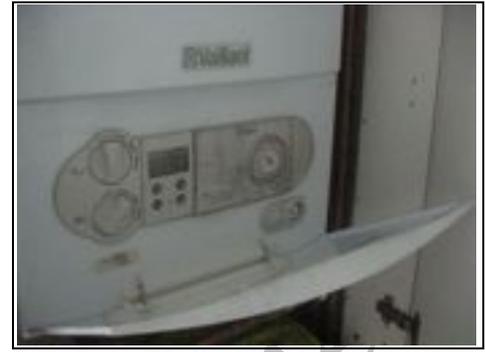
The boiler was located in the kitchen, it is manufactured by Vaillant.

Our limited inspection of the hot water and central heating system revealed no evidence to suggest any serious defects but we would nevertheless recommend that the system be tested and overhauled before exchange of contracts and that a regular maintenance contract be placed with an approved heating engineer.

Vaillant boiler

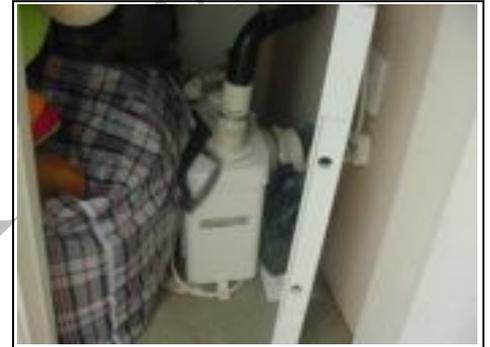
Macerator

The shower room on the top floor has a W.C., shower and wash hand basin. The W.C. is a macerator system which is noisy.

ACTION REQUIRED: Please see our comments in the Executive Summary.

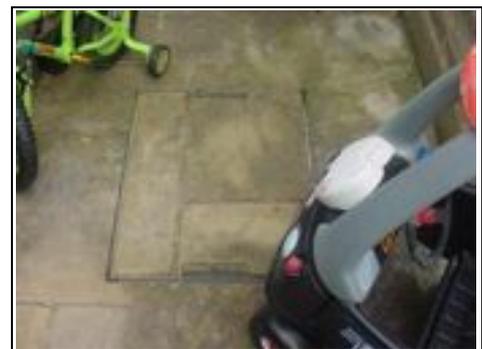
We were unable to lift the manhole therefore are unable to comment further. There are sometimes problems with these manholes so we would like to have opened it up.

Manhole to rear

ACTION REQUIRED: To be 100% certain a close circuit TV camera report is necessary.

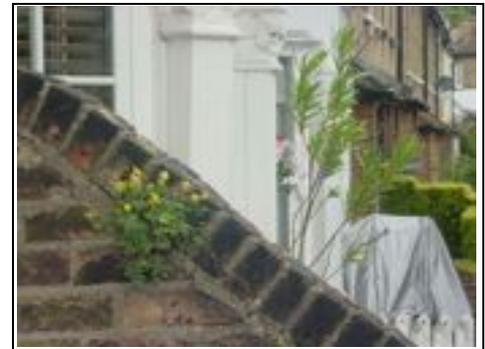
Plants growing on garden wall to right side

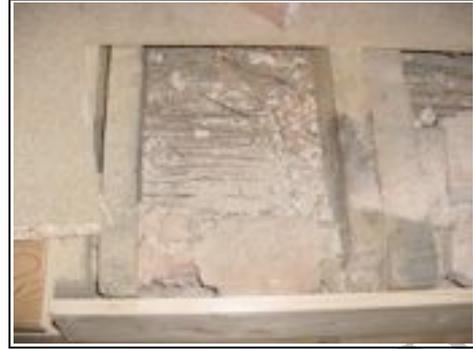
Reed on the first floor

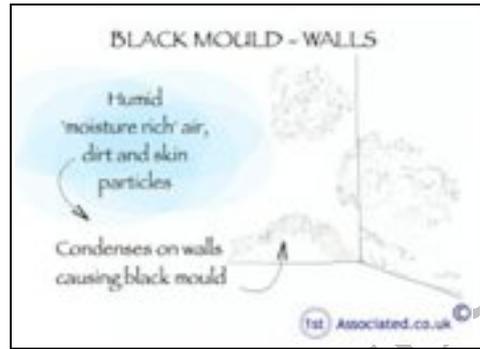
Mould to walls

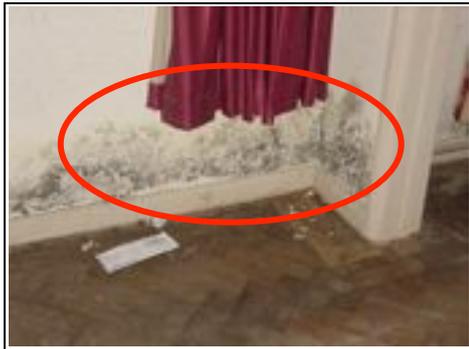
Black mould

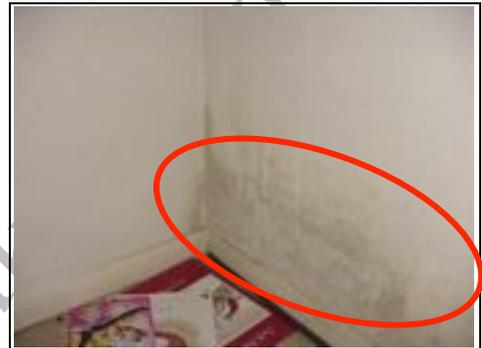
Mould

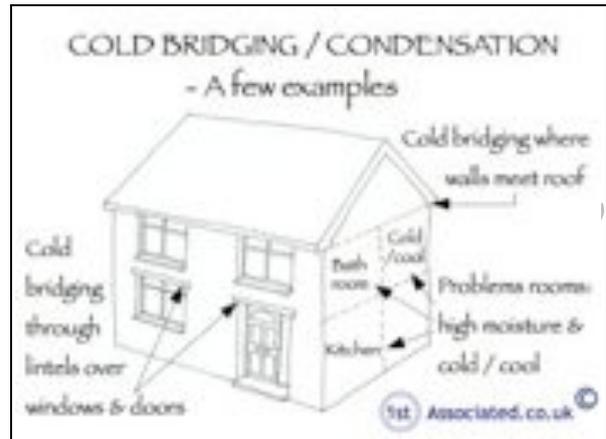
Cold Bridging/Condensation

Thermal Bridging or Cold Bridging is where elements of the structure are colder than the main elements of the structure and condensation occurs on the surface, sometimes interstitially which is inside the surface. We have come across many examples of Cold Bridging; we will give you a few examples here:

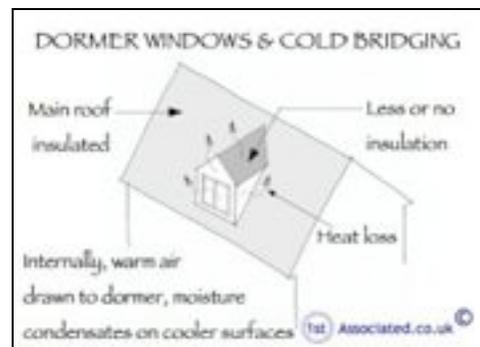
Dormer Windows & Cold Bridging

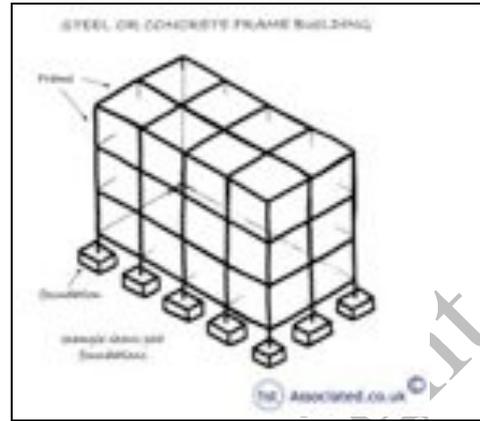
The next example we will look at was within a top floor flat where one of the residents was concerned about the black mould they found within the property. This was later diagnosed to be a concrete frame building and as such the concrete frame caused cold bridging which as the residents showered regularly without an extract fan caused mould. As well as being unsightly we would have said it was probably a health hazard too.

Concrete frame building

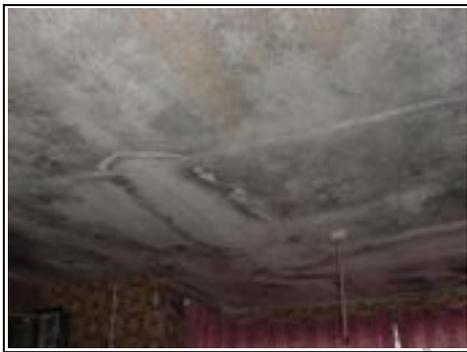
Mould to ceiling

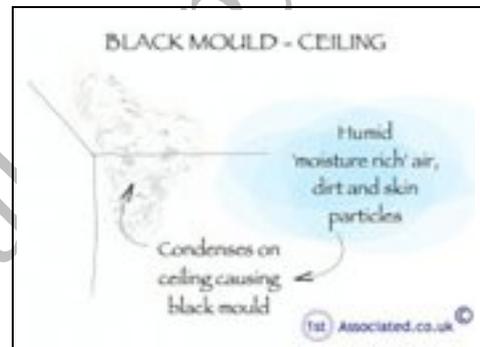
Black mould to ceiling

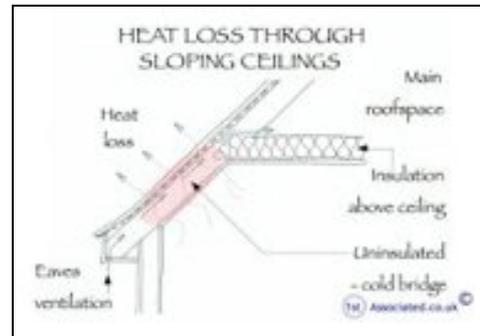
Thermal bridging also known as cold bridging occurs in between where the walls meet the ceiling on the sloping section and is a characteristic of this type of building.

Heat loss through sloping ceilings

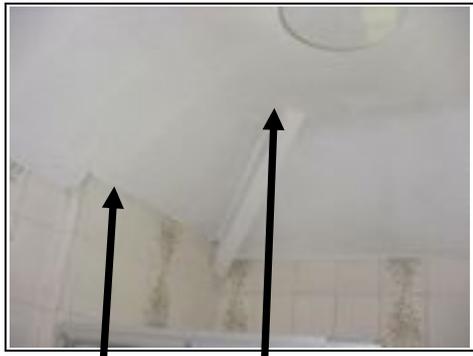
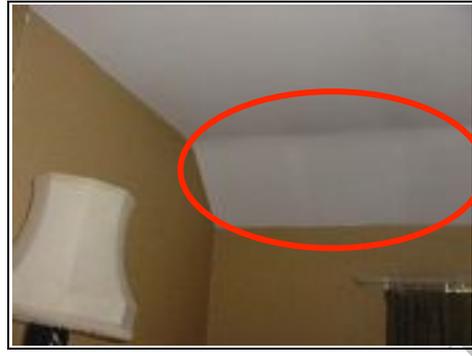
Cold bridging

These cold elements then attract general dirt, dust, skin particles etc within the environment and then blackening occurs.

In this case we recommended ventilation at high level to soffits to help reduce condensation.

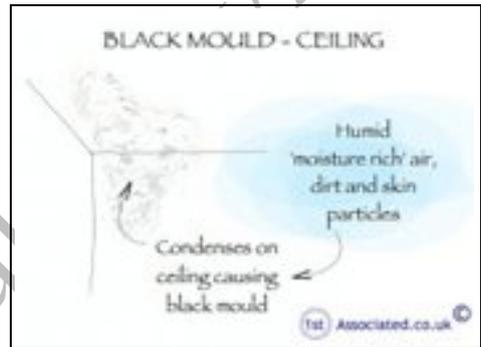
Black mould

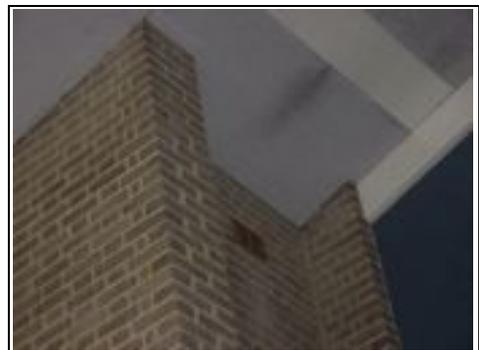
High level air vent

The addition of ventilation and insulation will help this but it does need careful consideration.

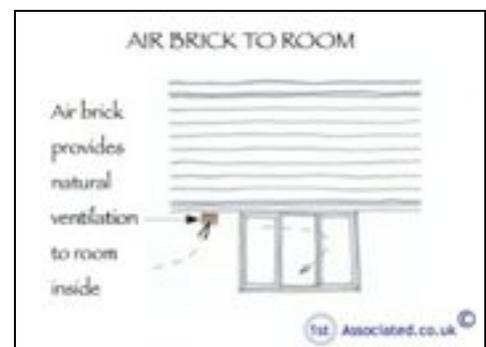
High level air brick
