RESIDENTIAL BUILDING SURVEY

London Borough of Camden

NW6

**Victorian
Apartment**

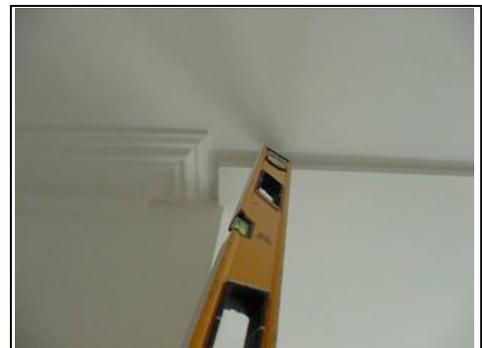
We can see that the bay window ceiling to the lounge looks to have been replaced which may indicate there has been problems with the flat roofs.

Underside of bay window which looks to us as if there has been work carried out

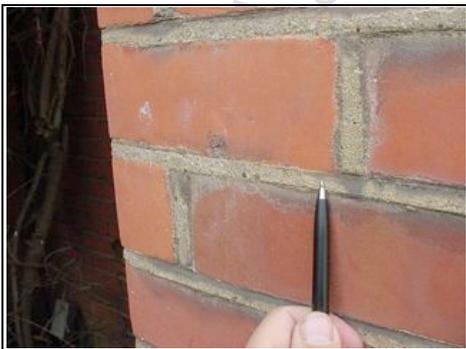
We would draw your attention to the cement mortar re-pointing that has been carried out on the exterior of the property that we feel is not appropriate to this building. Originally it will have been built with a lime-based mortar and this is what should be used for any re-pointing in the future.

Cement mortar

ACTION REQUIRED: We would recommend that a time served older bricklayer is employed to repair the damage caused, removing cement mortar with a soft brush and repointing in a lime mortar which will allow the building to breathe.

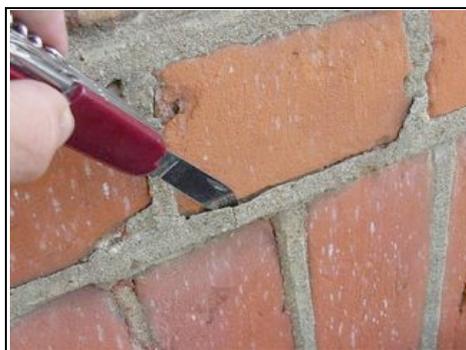
Cement mortar coming away

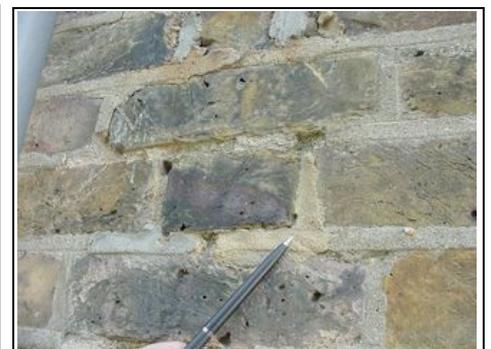
A mixture of cement and mortars including the pen pointing to the more modern very hard cement mortar

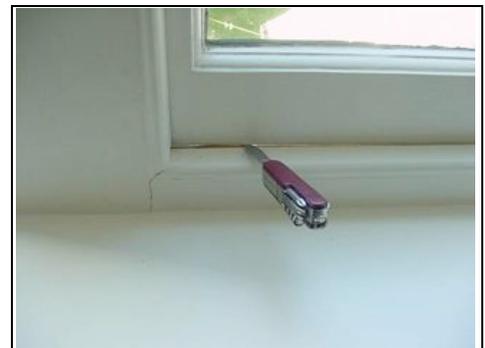
The sliding sash windows don't close properly and as such will be draughty and rattle. They generally need easing and adjusting. There are also ways of adding seals to them appropriate to a conservation area to make them less draughty. Often we also find that secondary internal glazing is added.

Windows not fitting very well

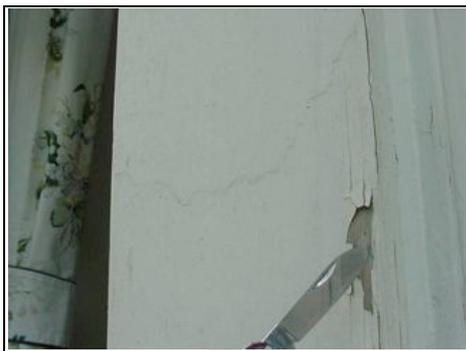
The sliding sash windows externally are in need of repair and redecoration with paint flaking and rust spots to the handles.

Paint flaking

ACTION REQUIRED: Generally properties such as this are repainted as a whole. However it does very much depend upon the arrangements made between each party. Either way we would recommend redecoration in the summer of 2013 to limit any further deterioration.

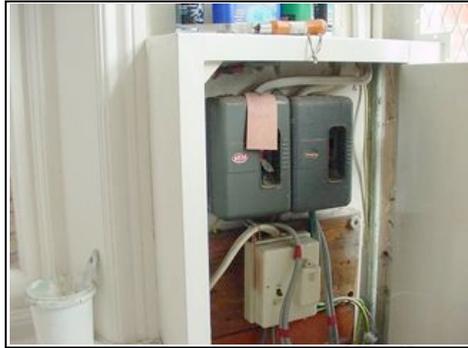
The electrics looked dated and better are now available. In multi occupied properties a defective fuse board can be particularly dangerous.

Electrics

ACTION REQUIRED: Replace with new fuse boards. The Institute of Electrical Engineers standards (IEE) recommend a test and report whenever a property changes occupancy. This should be carried out by an NICEIC registered and approved electrical contractor or equivalent. Again this is the sort of thing that would be covered by a sinking fund/planned maintenance.

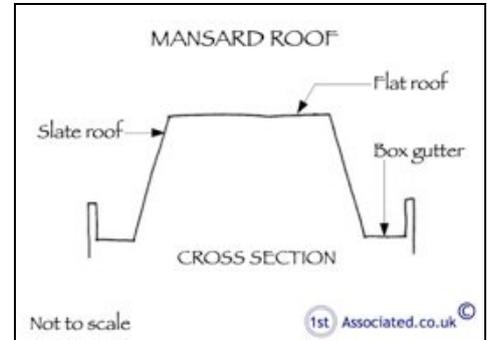
Mansard roof

There are roofs that we cannot see which you are likely to have a shared liability for. The main roof is a mansard roof which means that we couldn't see the very top of it and we have had no access to the main roof space.

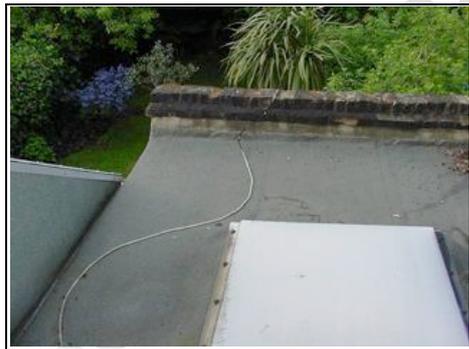
We have however been able to view the flat roof which is allowing water in on the parapet wall and possibly to the felt flashing.

Rear flat roof

ACTION REQUIRED: A sinking fund/planned maintenance should include this type of work. We think it is unlikely that anyone has prepared a sinking fund/planned maintenance schedule as currently the internal decorations were being carried out and we can see there are external issues that need addressing.

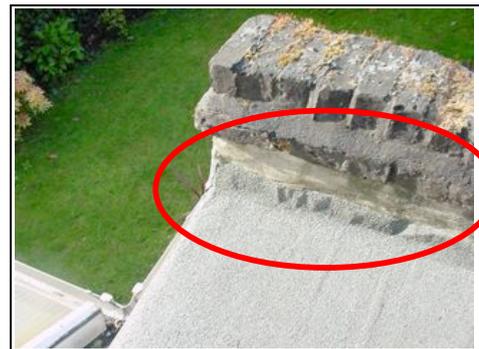
Felt flashing is also not particularly good and may be attributing to dampness getting in

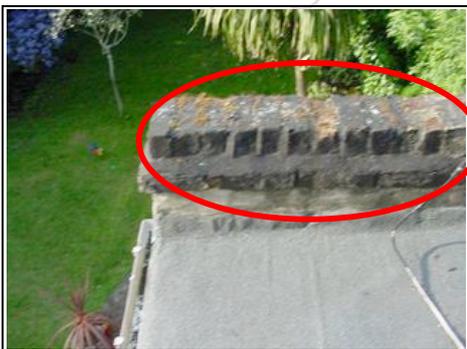
Parapet wall which is allowing water into flat below

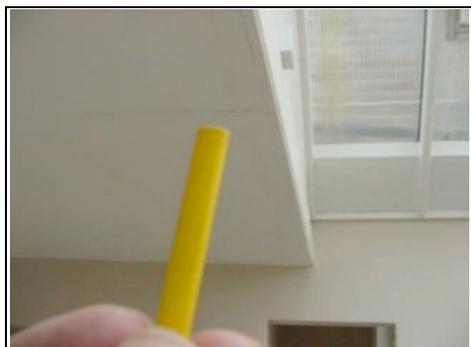
Dampness coming through from flat roof

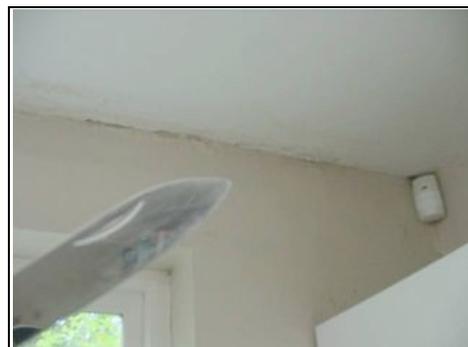
Dampness coming in from parapet wall

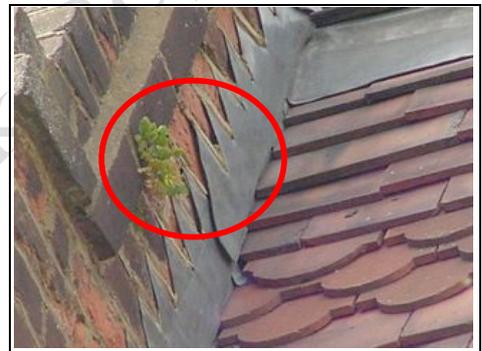
In this case there are parapet walls to the left and right hand side of the main roof and also to the rear flat roof built from brick with a coping stone of brick and lead flashings. We can comment that generally they are in average to below average condition. We could see some spalling and we could see some plants growing. The right hand parapet wall looks to have had some rendering to the brickwork at the top.

Plant growing from parapet wall on left hand side

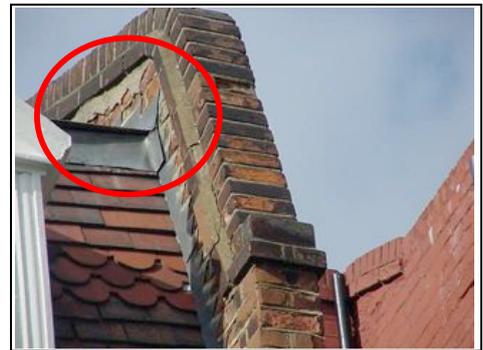
Close up of parapet wall right hand side, rendering to top

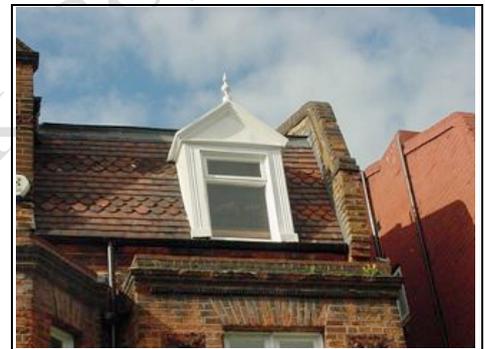
Main roof

The main roof is a mansard roof clad with decorative tiles to the front and tiles to the rear. The tiles to the rear look to have been replaced. From what we can see they look in average condition. A mansard roof generally has a flat area to the top which has a slight slope on, traditionally this was in lead but often it has been replaced with felt.

ACTION REQUIRED: Carry out periodic inspections and maintenance of the roof, as required.

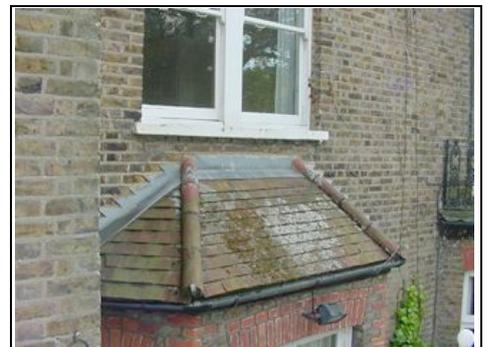
Rear bay window

The rear bay window is part of the apartment below but you may have liability for it. It looks in average condition.

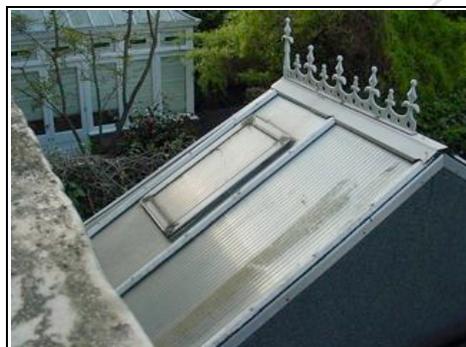
Conservatory

Having been in the apartment below we could see that the flat roof, the conservatory and the box gutter are all leaking into the kitchen and breakfast room area below.

ACTION REQUIRED: Please see our comments in the Executive Summary.

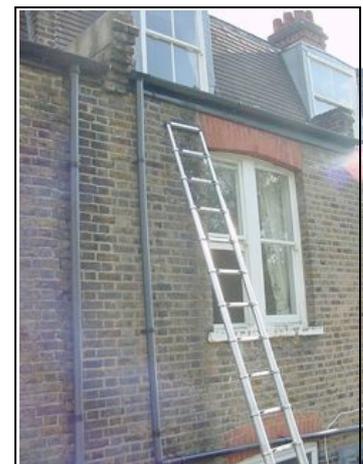
We can see that there is a metal roof. We are not 100% sure whether this is lead or not. From the look of it, it doesn't look to be, it looks to be a galvanised metal but please bear in mind we were at the top of the ladder taking photos over the parapet.

Difficult to access/view

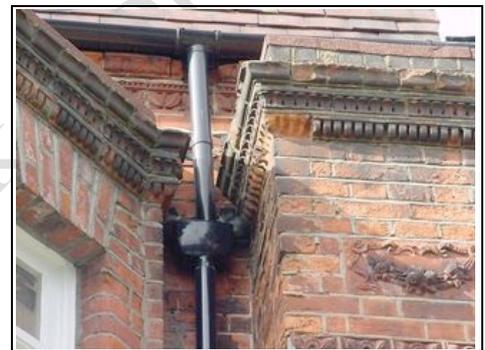
The property has the original cast iron gutters and downpipes and hopperheads, the majority of which look to have been replaced in plastic. We can see a hopper head to the front which we think will overflow.

There may be some minor leaks but most people would be happy to live with these providing repairs are carried out within the next six to twelve months.

Gutters, downpipes and hopperhead

ACTION REQUIRED: We would always recommend you stand outside the property next time it rains heavily and see how well the drains cope with the rainwater particularly looking at the guttering and the joints.

We would also recommend that the gutters and downpipes are cleaned out, the joints are checked and the alignment checked to ensure that the gutters fall towards the downpipes.

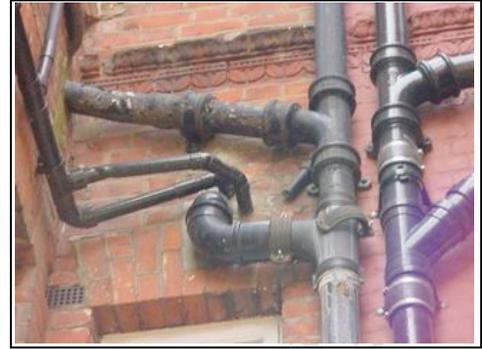
Soil and vent pipe

The property has a mixture of cast iron and plastic soil and vent pipes.

ACTION REQUIRED: Please see our comments in the Executive Summary.

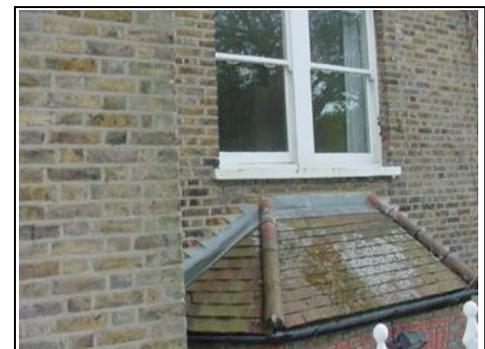
The property is built in a brick predominantly in a soft red brick to the front and a yellow stock brick to the rear, originally in a lime mortar in what is known as Flemish bond brickwork which has been wrongly repointed in a cement mortar which is causing spalling.

Brickwork to rear is a yellow London stock which is harder than the reds

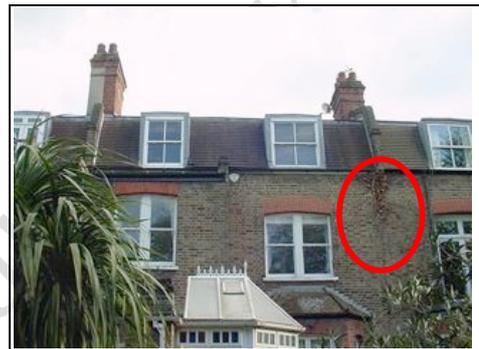
Ivy

There are trees to the rear of the property and in the neighbouring garden but they do not look to be within what insurance companies would term as influencing distance of the property. We noted to the rear of the property some ivy has been cut back, this may have damaged the brickwork.

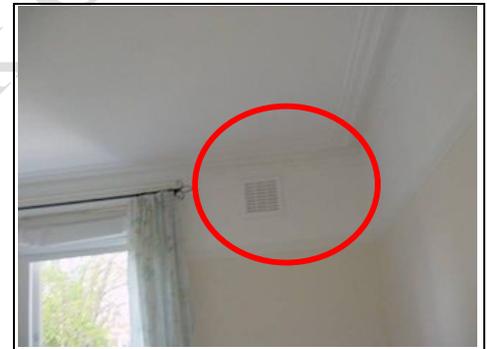
High level air vent

There are vents at high level. High level air bricks are to help air circulation within the property.

ACTION REQUIRED: Ensure the air bricks are clear.

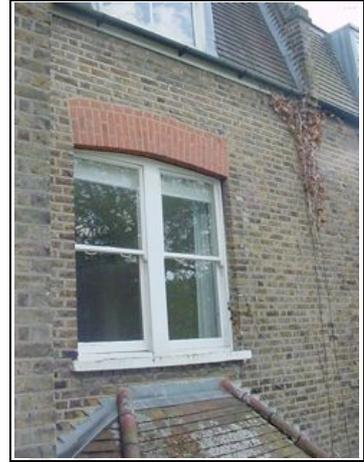
Timber sliding sash windows

The property has single glazed timber sliding sash windows. We would specifically comment that they do need redecoration and repair externally and that they don't fit very well and will be draughty.

ACTION REQUIRED: Please see our comments in the Executive Summary.

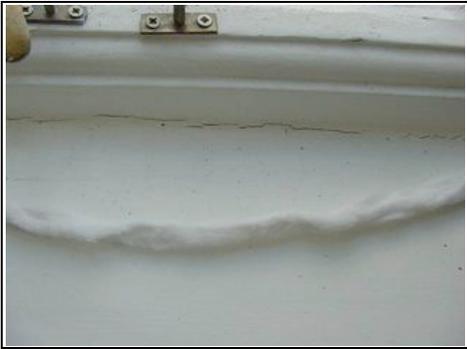
Windows packed

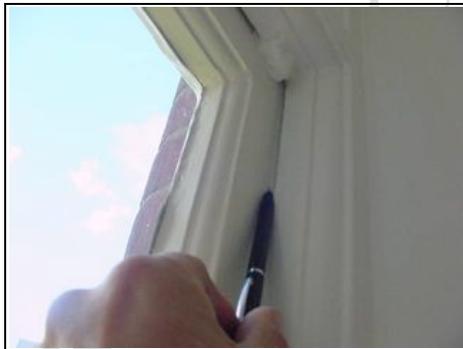
Gap to windows

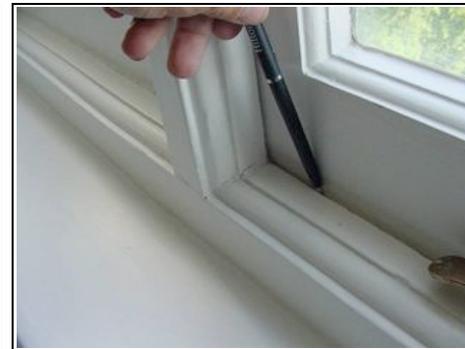
Gap

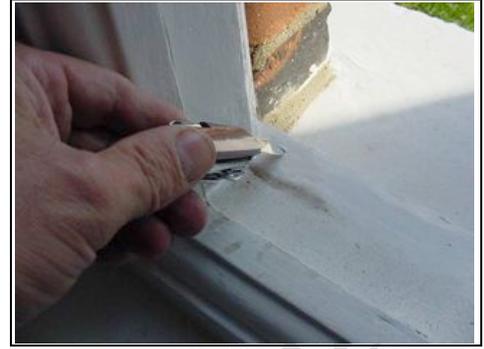
Knife test

We found the windows generally to be in average condition with no obvious soft spots.

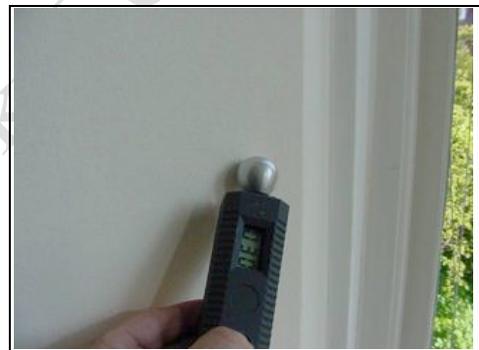
Testing for lateral dampness

We used a damp meter on the external walls. We were surprised that we didn't find lateral dampness given the condition of the brickwork. It may be

that during the winter months you do get dampness.

ACTION REQUIRED: Please see our comments in the Executive Summary.

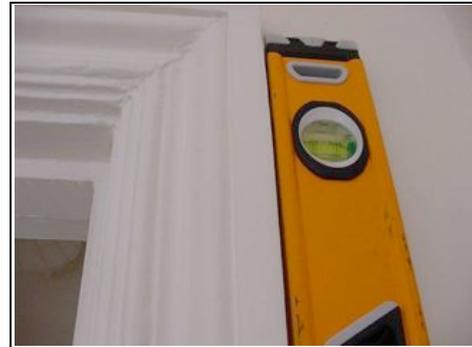
Rear bedroom door slightly out

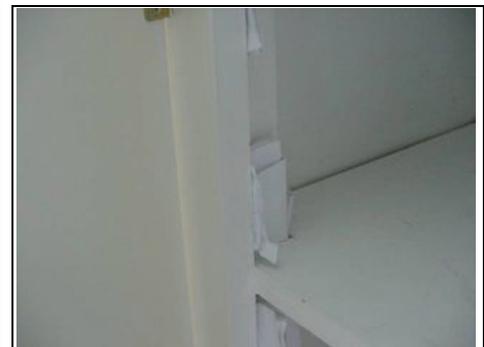
Built in cupboards to front cupboard in lounge are packed out with paper which needs redoing!

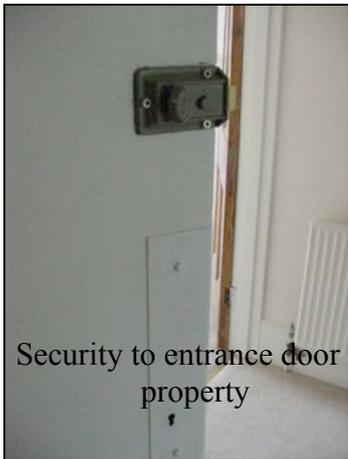
Security to entrance door of property

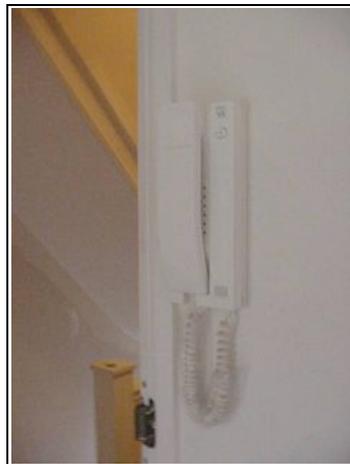
Voice entry system

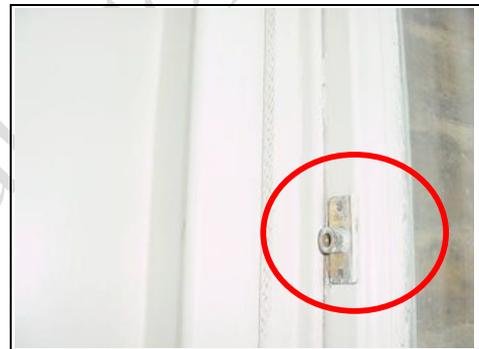
Security locks to windows

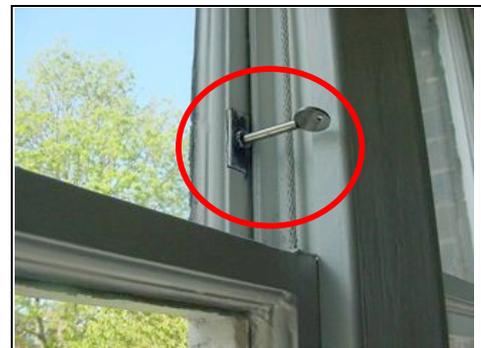
If you turn the key the lock becomes flush

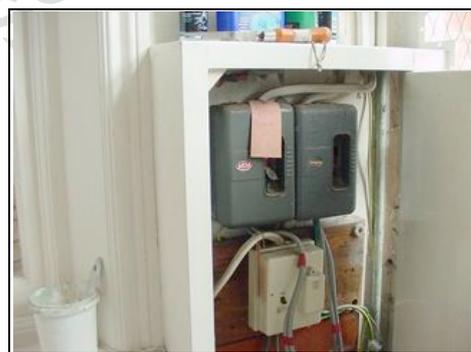
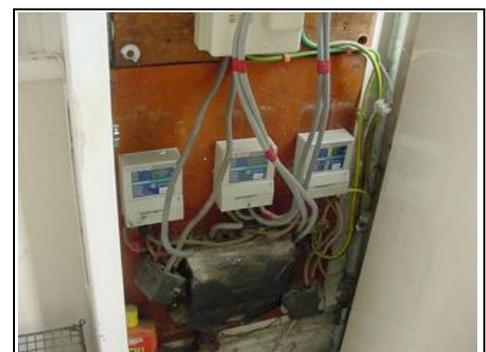
Electrics

The electric fuses and consumer units were located in the hallway. The fuse board in the apartment looked to be 1980's – 2000 which we would recommend has an hour half fire resistant box around it. The ground floor electrics looked 1960's/1970's. We would recommend all fuse boards are updated. In multi occupied properties a defective fuse board can be particularly dangerous.

ACTION REQUIRED: Replace all fuse boards. Again this is something that should be covered by the sinking fund/planned maintenance.

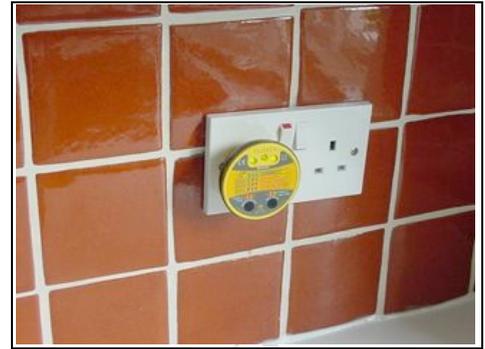
Earth Test

We carried out an earth test in the kitchen area to the socket point that is normally used for the kettle, this proved satisfactory.

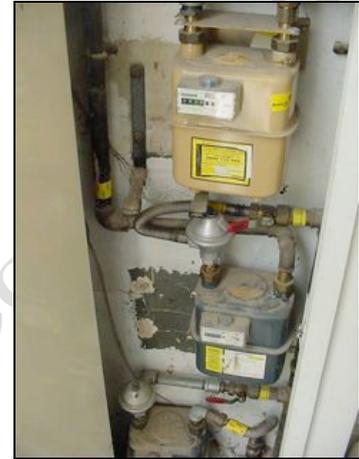
Gas unit

We are advised that the property has mains gas. The consumer unit is located on the ground floor. This should be vented; we didn't see any vents to it.

ACTION REQUIRED: As a matter of course it is recommended that the entire gas installation is inspected and made good, as necessary, by a Gas Safe registered contractor. Thereafter the installation should be serviced annually.

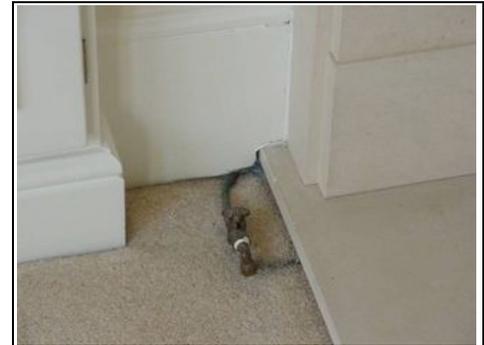
Gas pipe for fireplace

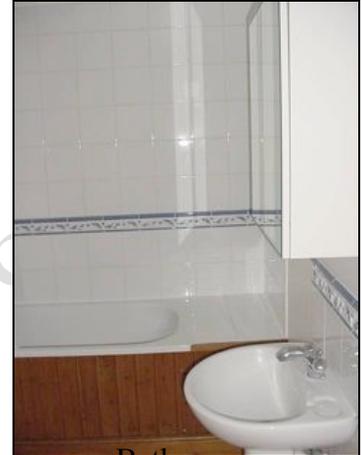
Bathroom

The property has a three piece bathroom suite, consisting of a bath, wash hand basin and WC, which looks in average condition.

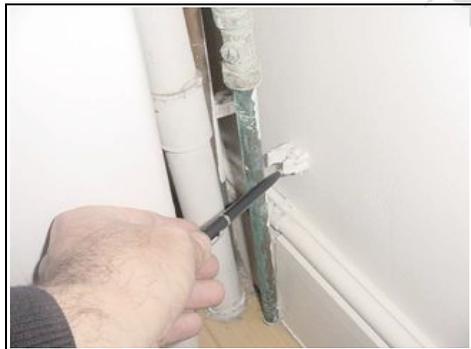
We did note unsupported pipes to the wash hand basin.

Unsupported pipes to wash hand basin in bathroom

ACTION REQUIRED: Secure pipes.

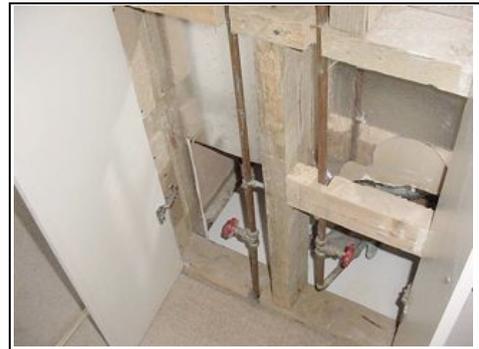
Cupboard to back of bath within hallway

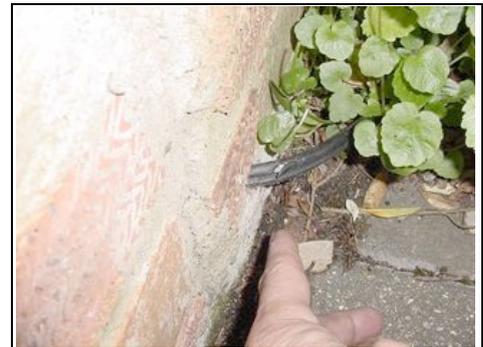
To the front we noticed a cable coming through the wall which we couldn't see what it was for, which looks like it has been chewed by rodents.

Cable outside coming through wall

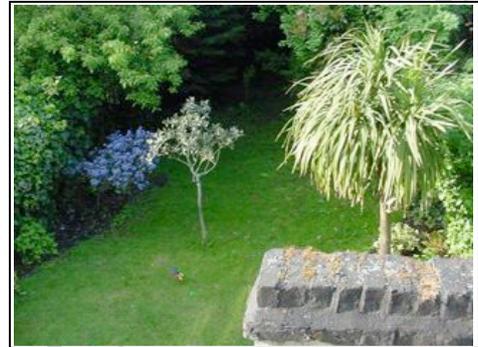
The rear garden we assume is for the use of the ground floor apartment only.

Garden which is used by ground floor apartment
