DEFECTS REPORT AND BUILDING SURVEY

XXX
Hackney,
London.
E8 XXX

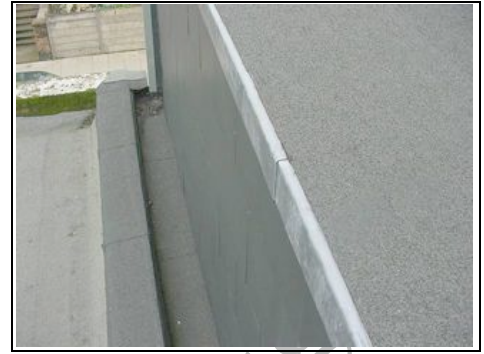
We have not had a close inspection of the vertical slates on the right hand side but they look to have been nailed in place. It needs to be checked that the correct nails have been used (non-ferrous).

Vertical slates - right

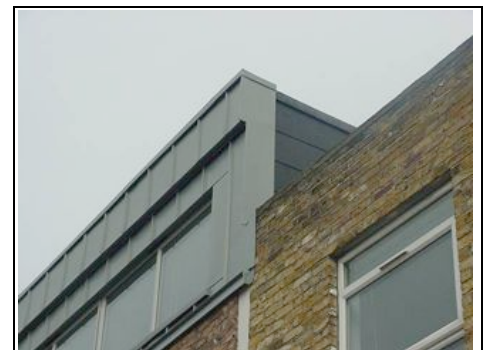
Whilst this type of cladding is a modernist style of construction we believe the detailing to be poor without suitable drip details.

Metal cladding at high level

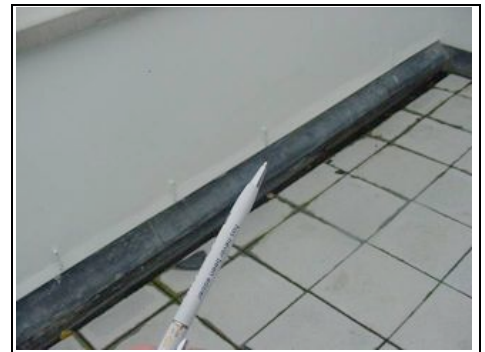
Terrace

Detailing to terrace
